# Risk Assessment

Closed Landfills  
Southern Grampians  
Shire

Barwon South West  
Waste and Resource  
Recovery Group

February 2020

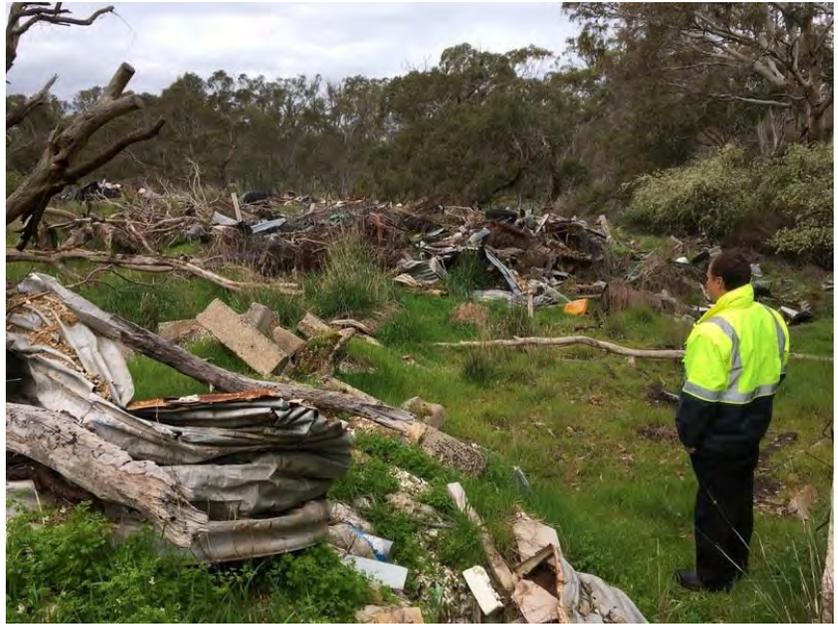
Unburied waste

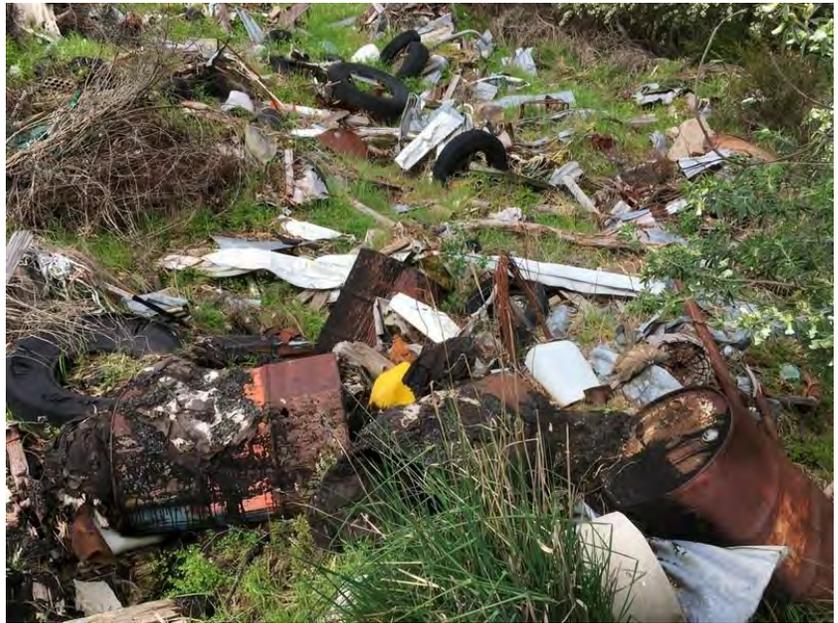
Drum waste

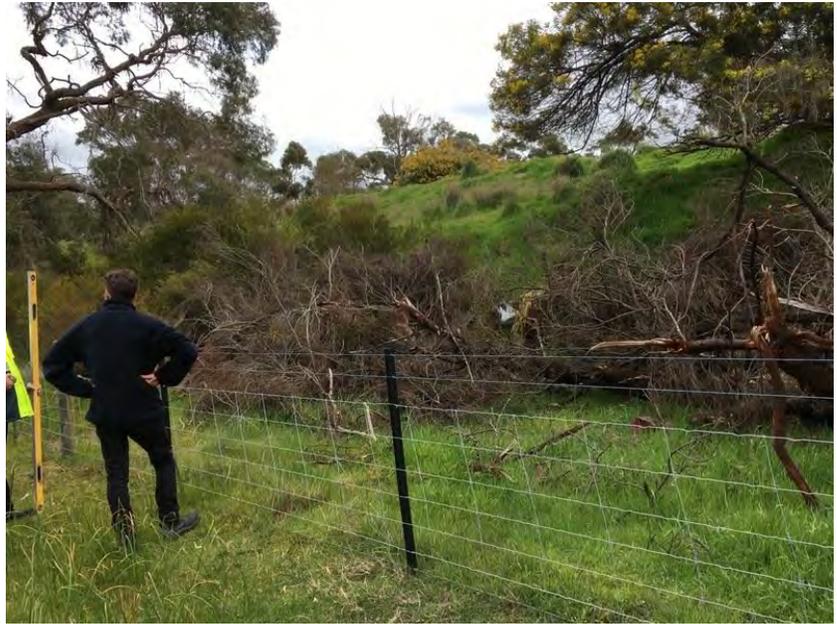
View northward of southern edge of site. Mounding of >5m

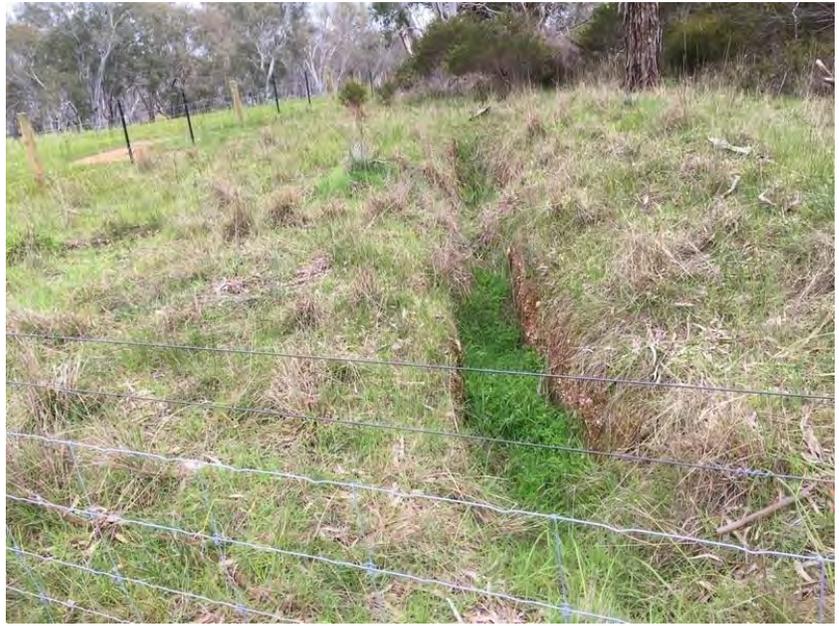
Remnant unused trench for waste? Southeast corner of site

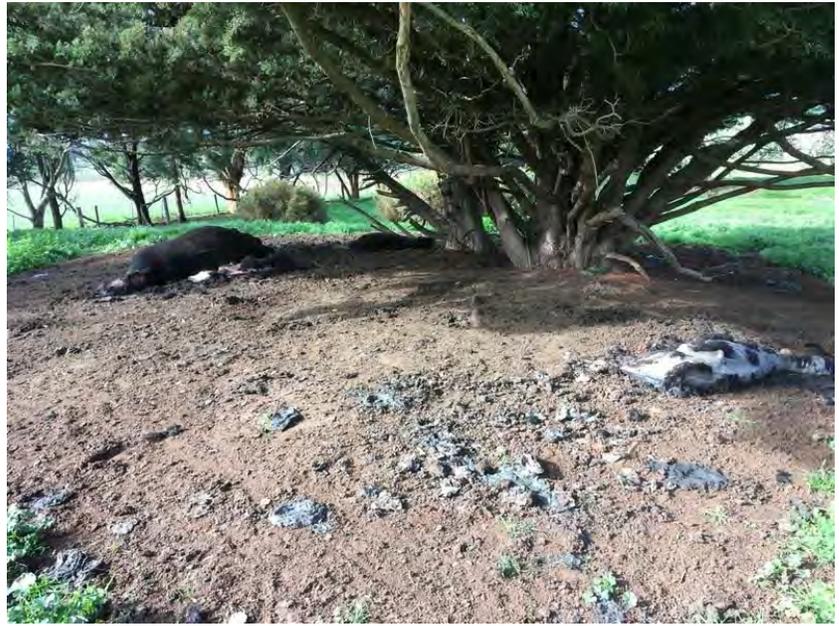
Dead cattle under tree

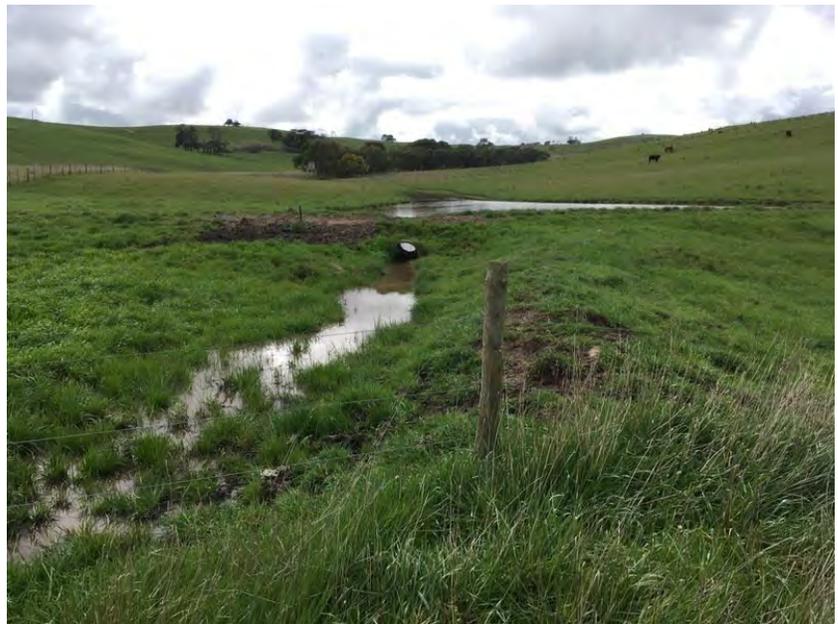
Damned creek outside western end of site - with culvert discharging to swale through landfill site

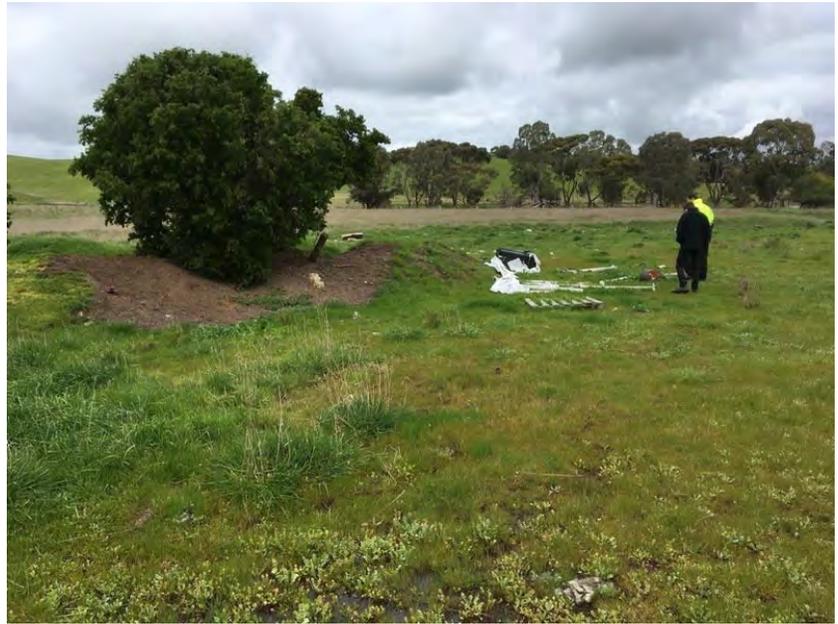
Illegal dumping at centre of site

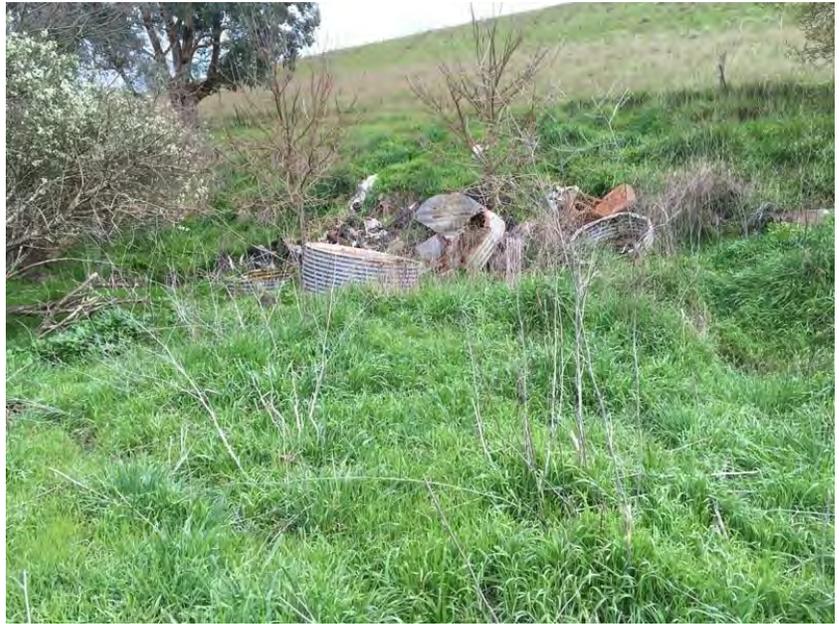
Illegal dumping on north eastern edge of site

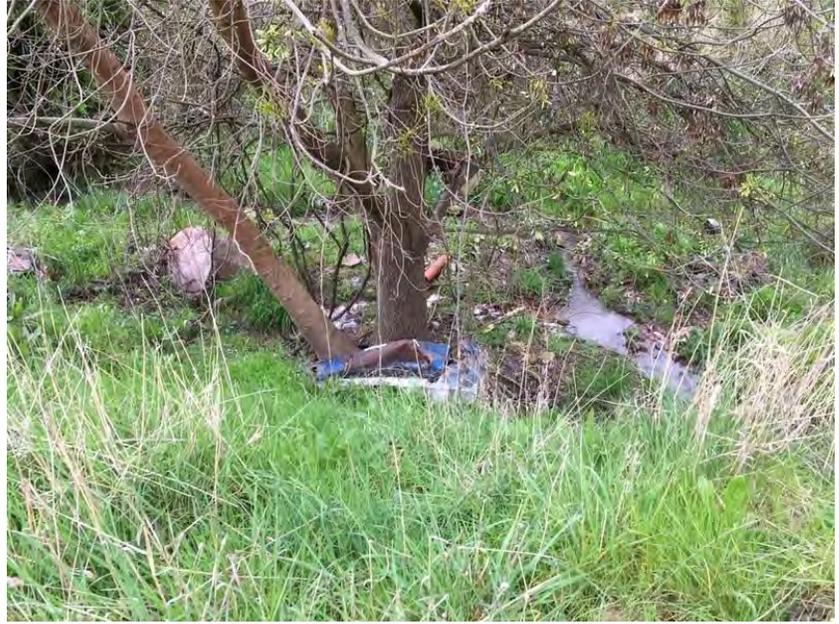
Waste in a gully - western portion of site

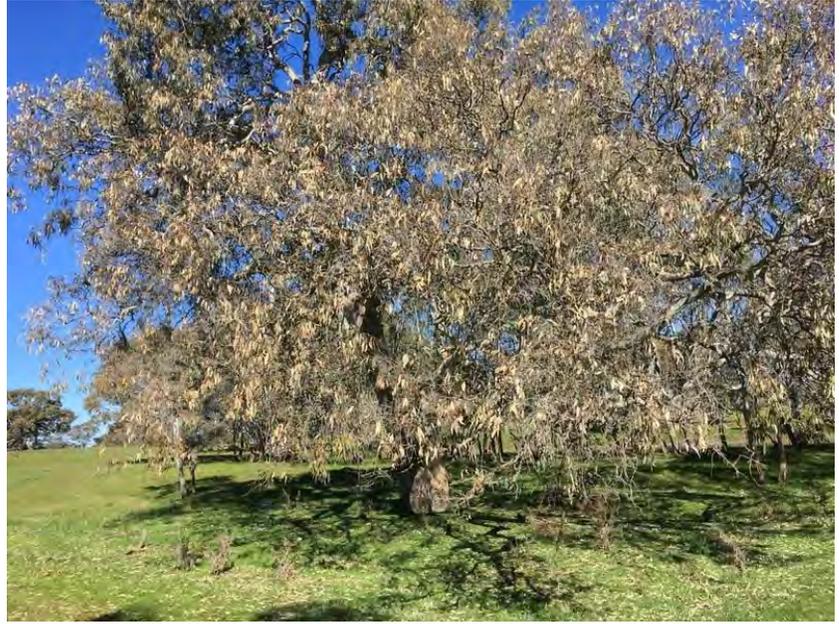
Distressed tree at northern end of site

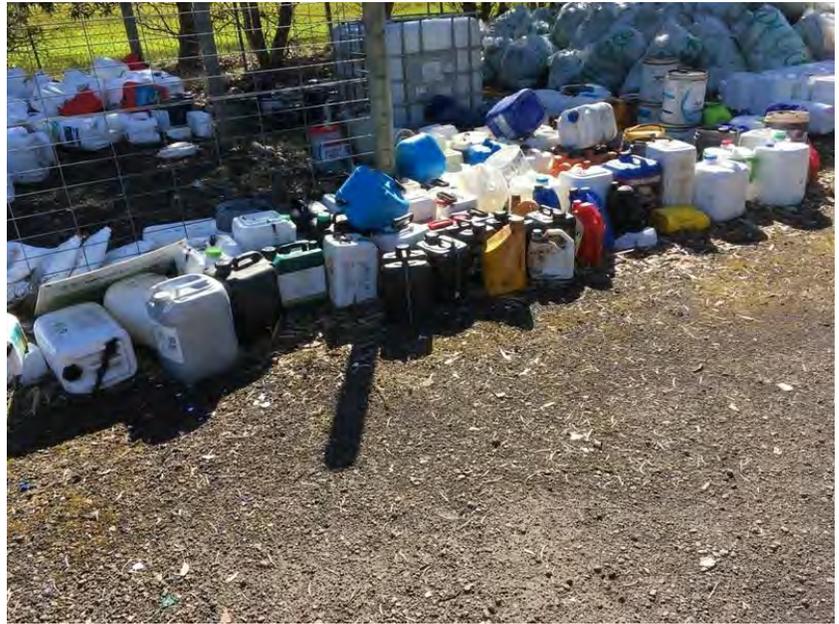
Waste oil containers in transfer station area

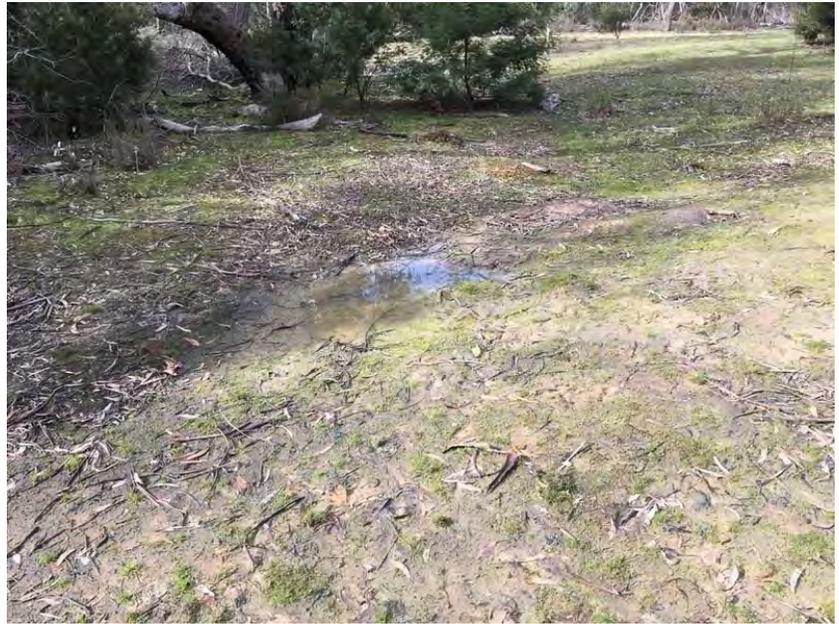
Wet low point (possible settlement of trench fill) at western side of site

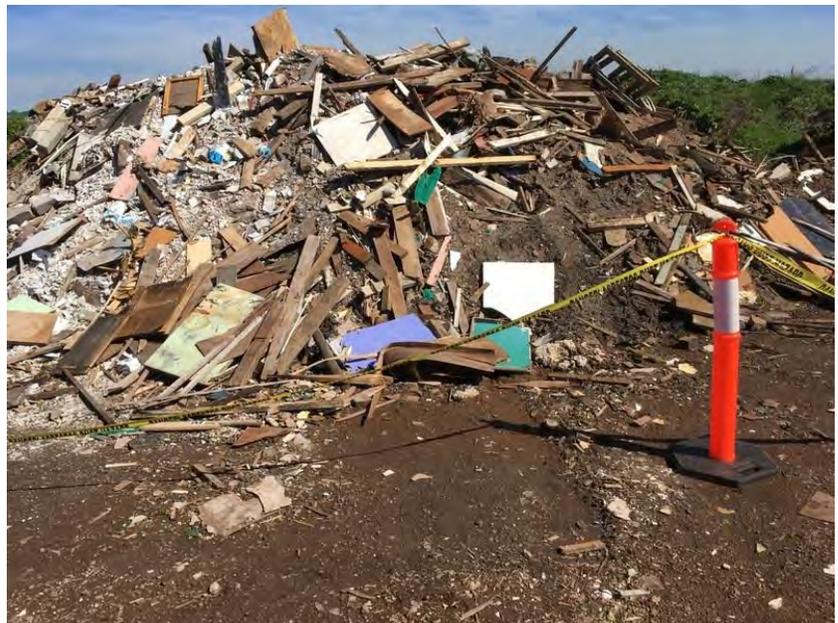
Building waste including ACM

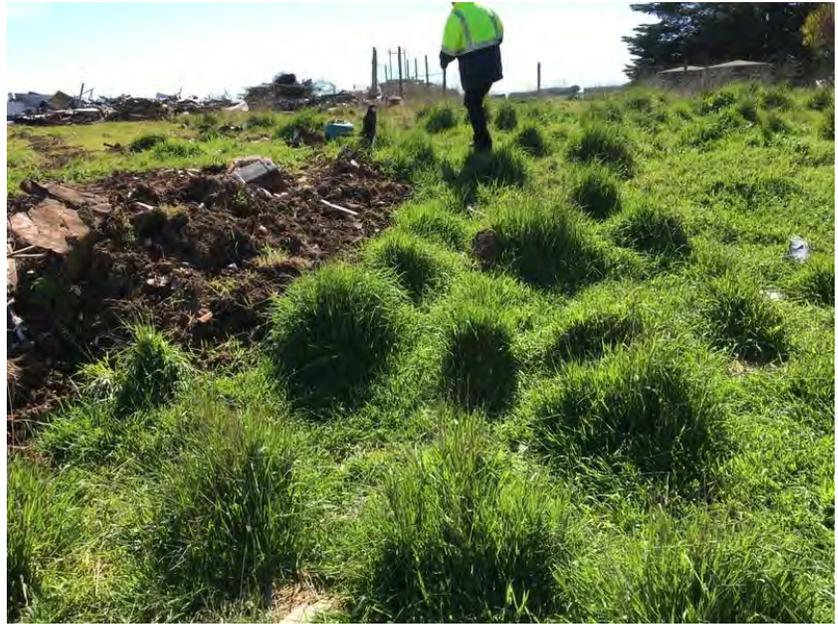
Southern edge of landfill - with disturbance as part of transfer station operations

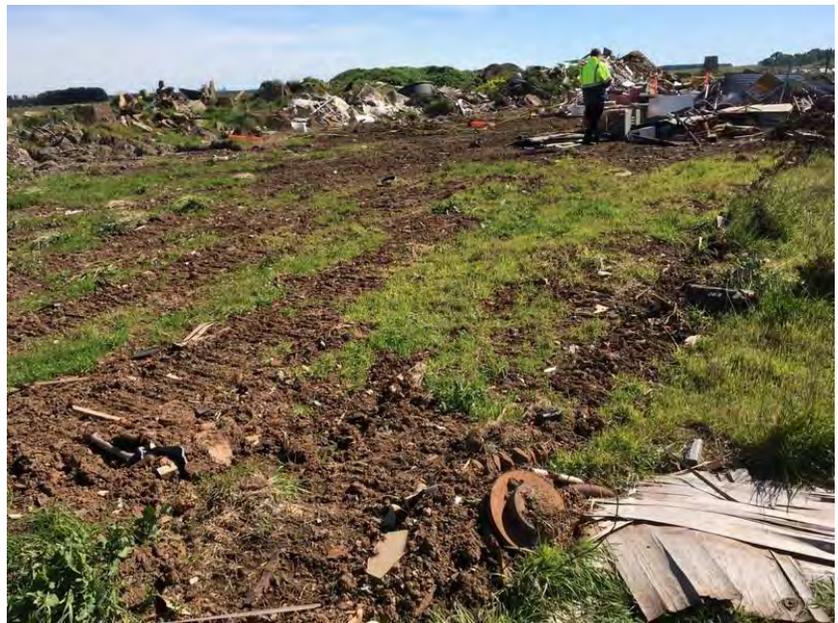
Landfill surface disturbance at southern end of transfer station operations
