Southern Grampians Shire Council

Glenthompson Pool

Report R-06 (of 8 reports)

TECHNICAL CONDITION & COMPLIANCE ASSESSMENT

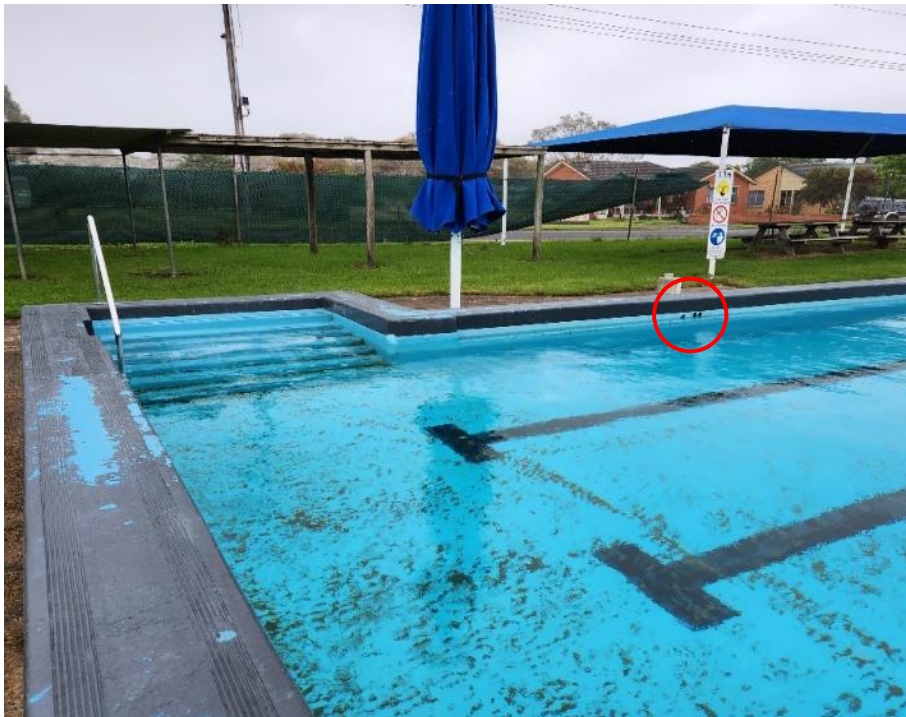
Image 8: Main pool, Shallow end steps. Looking west. Depth signs partially obscured.

- a) Depth signage appears adequate. There are located on signs on posts around the outside of the concourse.
- b) Some are on the inside face of the hob above the gutter tile. In this location legibility is difficult because the water level in the gutter can obscure the lower part of the numerals.

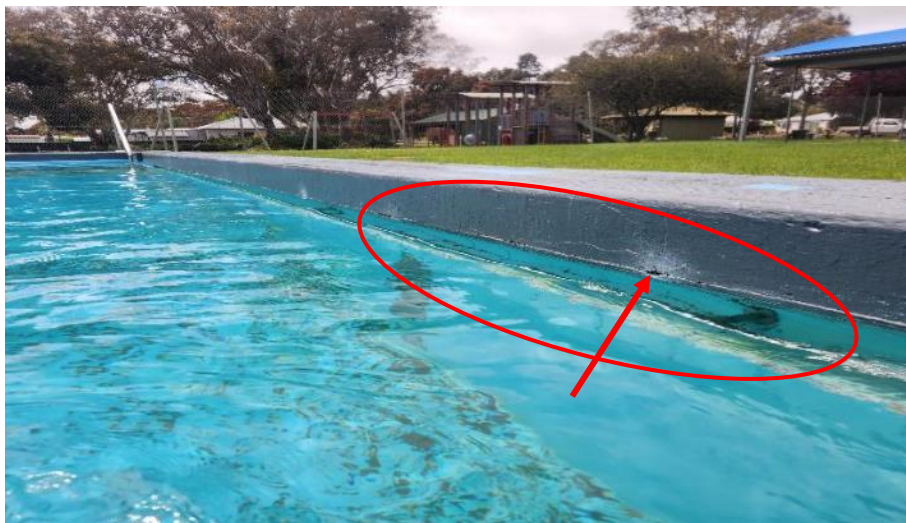
- a) The pool is essentially level with very little differential settlement (about 1-2cm range). This is acceptable and indicative of good ground conditions.
- b) There is cracking in the hob in various places that is indicative of corroding reinforcement. This will only get progressively worse and increase the cost of remedial works if delayed for a substantial period.
- c) There is cracking (Y-shaped) in the floor at the deep end but this seems a legacy issue.
- d) The expansion joint across the middle of the pool is quite rough and in only fair condition. At the outside face of the hob, it has bulged out and will need remedial work in due course.

Image 11: Main pool, Shallow end hob on water side. Cracks starting due to reinforcement corrosion.

No	Location	Item	Total unesc. cost	Escalated Cost & Year					Annualised Esc. cost	
				1	2	3	4	5		10
1	Main pool - cracking	Hob crack along shallow end just above tiling. Chase out, neutralise any rust found and re-instate with epoxy filler & paint. Treat floor crack in deep end similarly.	\$10,000			\$10,927				\$1,000
2	Main pool - Expansion Joint	Repair Expansion Joint on outside of hob, both sides. Remove dislodged concrete, chase out, neutralise any rust found and re-instate joint concrete with new sealant. This is additional to normal EJ maintenance / replacement in pool.	\$10,000			\$10,927				\$1,000
3	Toddlrs pool - crack	Chase out crack to form Vee, neutralise any rust spots, reinstate with epoxy filler.	\$3,000			\$3,278				\$300
4	Main pool - solar blankets	Replace. Allowance.	\$35,000			\$38,245				\$3,500
5	Shade Structure (Toddlers pool)	Replace bent tube strut. Strengthen entire structure as/if required. Requires engineering input	\$10,000	\$10,300						\$1,000

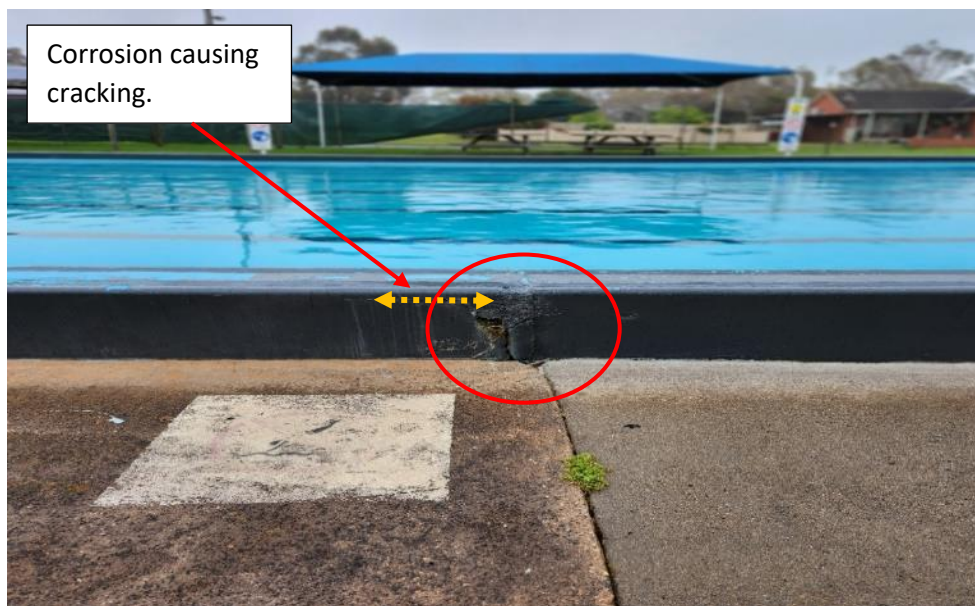
Image 13: Main pool. 'Bulging' expansion joint, east side. Hob cracking due to reinforcement corrosion.

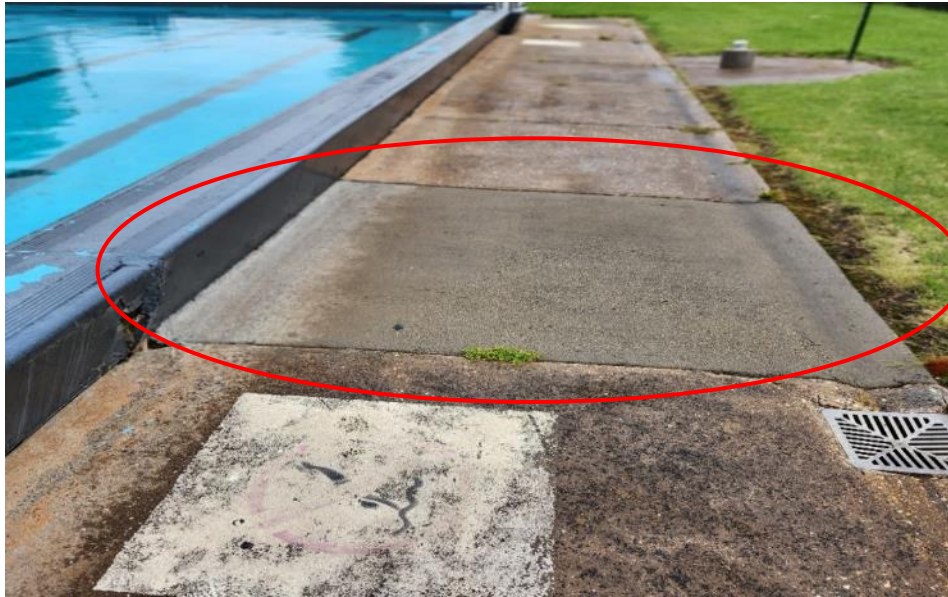
Image 14: Main pool. 'Bulging' expansion joint in previous image probably linked to this concourse panel replacement.

- a) The concourse slabs are good condition for their age.
- b) There is some differential settlement and near the NE corner some slab panels have subsided slightly and pulled away from the pool (about 2cm) but this is not causing any concerns at this stage.
- c) There are some replacement panels with one beside the east side expansion joint where it is not in good condition. There was a probably a link between the condition of the joint and the panel replacement.
- d) There has been some grinding on the concourse slab panels on the west side .

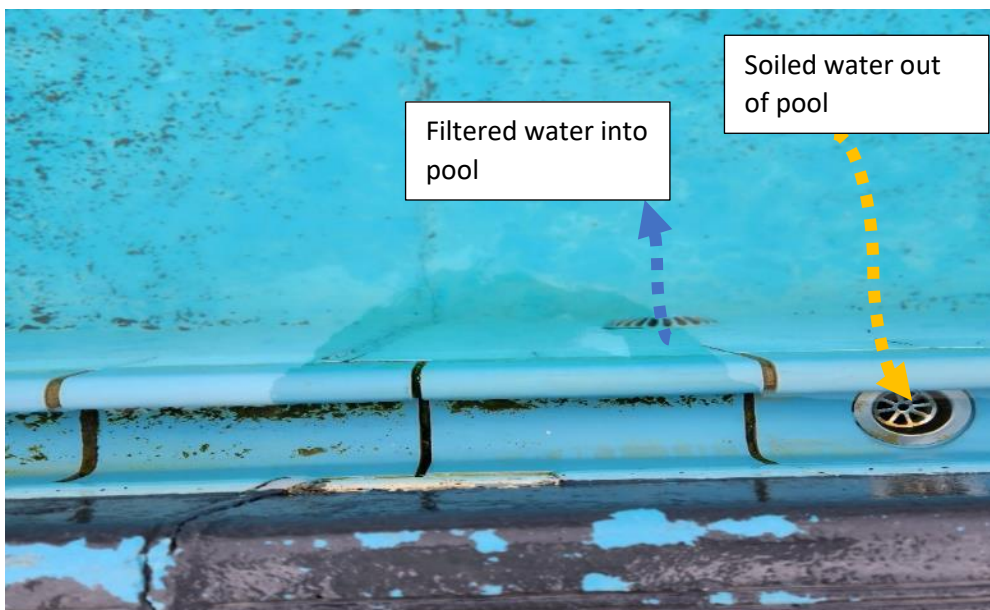
Image 15: Main pool. Filtered water wall inlet directly below gutter / soiled water outlet, could lead to short-circuiting.

- c) This arrangement where filtered water is delivered via wall outlets, just below the gutter, elevates the risk of the filtered water 'short circuiting' to the gutters and leaving dead spots in the pool centre.

- d) Unfortunately, it would be difficult and costly to remediate, and the potential situation is only saved by the low bather numbers at Glenthompson which would not tend to threaten water quality limits in the pool itself (as opposed to the auto-samplers).

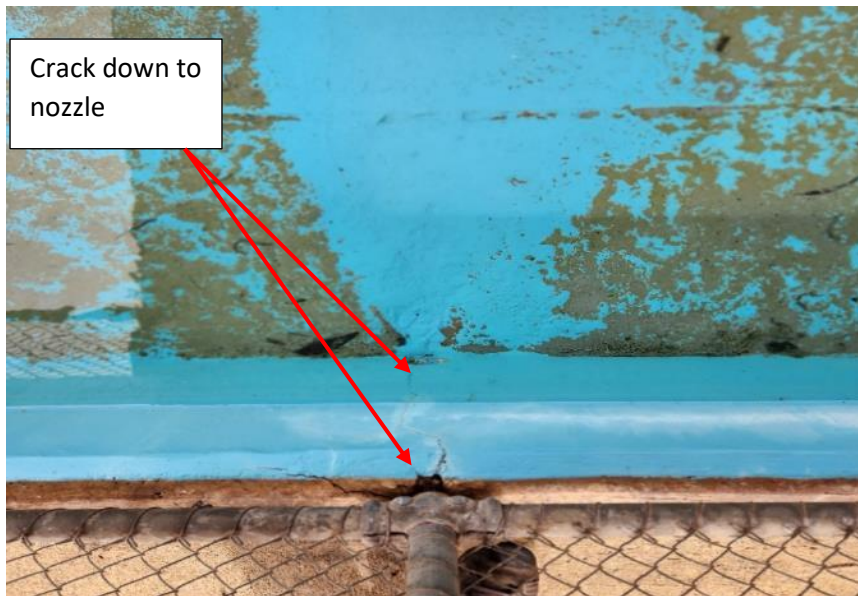
- a) The pool is in average condition but does have some structural issues that will need attention in due course.
- b) There is a reasonably significant horizontal crack in the floor / wall joint on the west side. There are some small rust spots along the crack.
- c) There is a vertical wall crack above one of the nozzles at the base of the wall to the top but this seems a legacy issue and not that material.
- d) Both will need remedial work in due course.

Image 20: Toddler's Pool. Crack in floor/wall through centre of pool, east side. Looking down vertically.

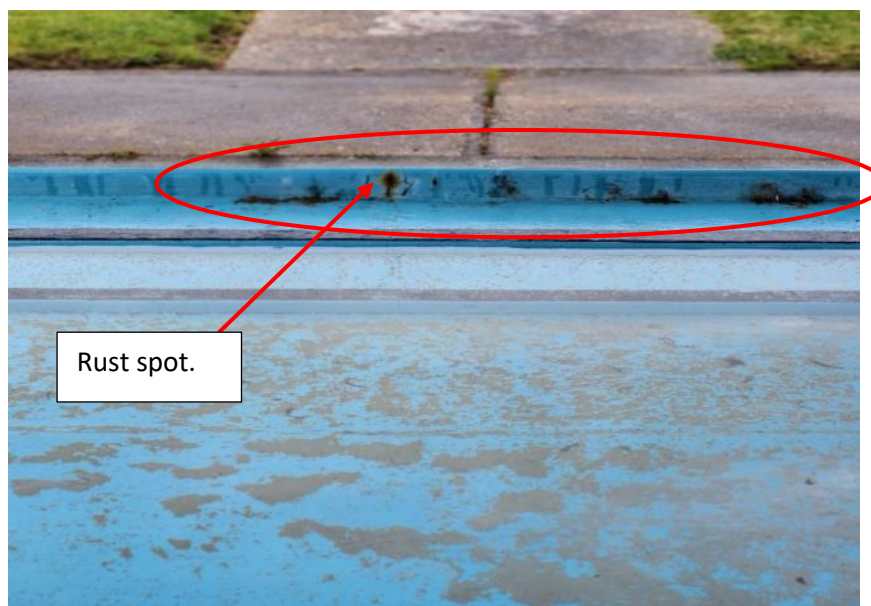
Image 21: Toddler's Pool. Crack in floor/wall through centre of pool, west side

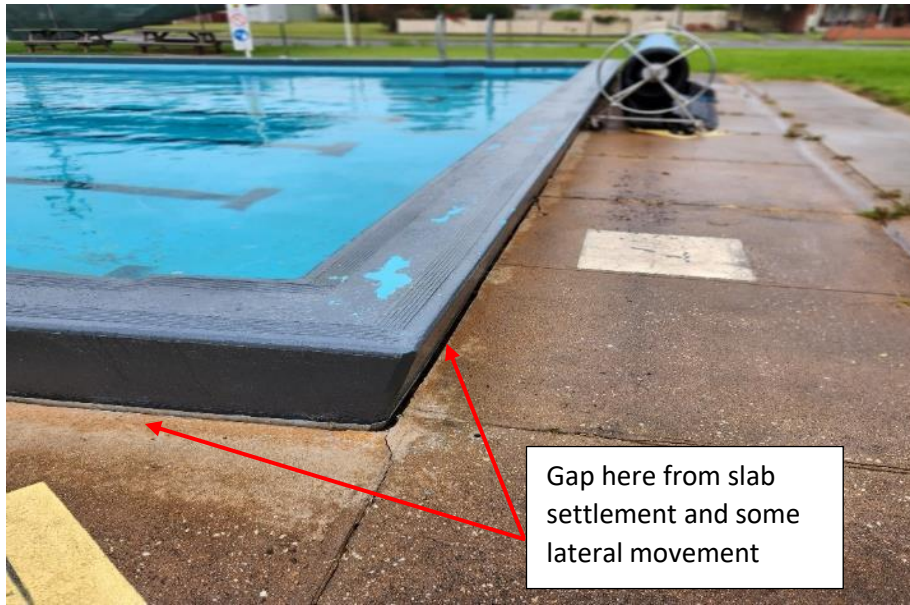
Image 23: Concourse at deep end of pool. Note gap here between hob and slabs

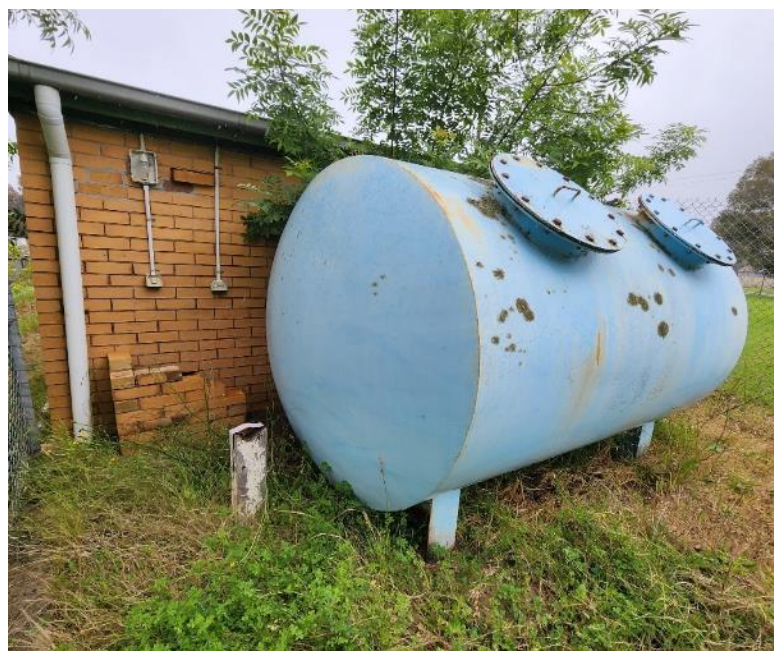
Image 26 – Steel filter vessel

- a) The steel filter looks in average condition for its age.
- b) The steel shell will need to be monitored as corrosion will no doubt be developing on the inside. When the sand is next inspected (for possible replacement) the thickness of the steel should be tested (with ultrasound test unit, over a semi-grid pattern) to gain an understanding of the range of current thickness and the likely original plate thickness. This should be documented for future reference.

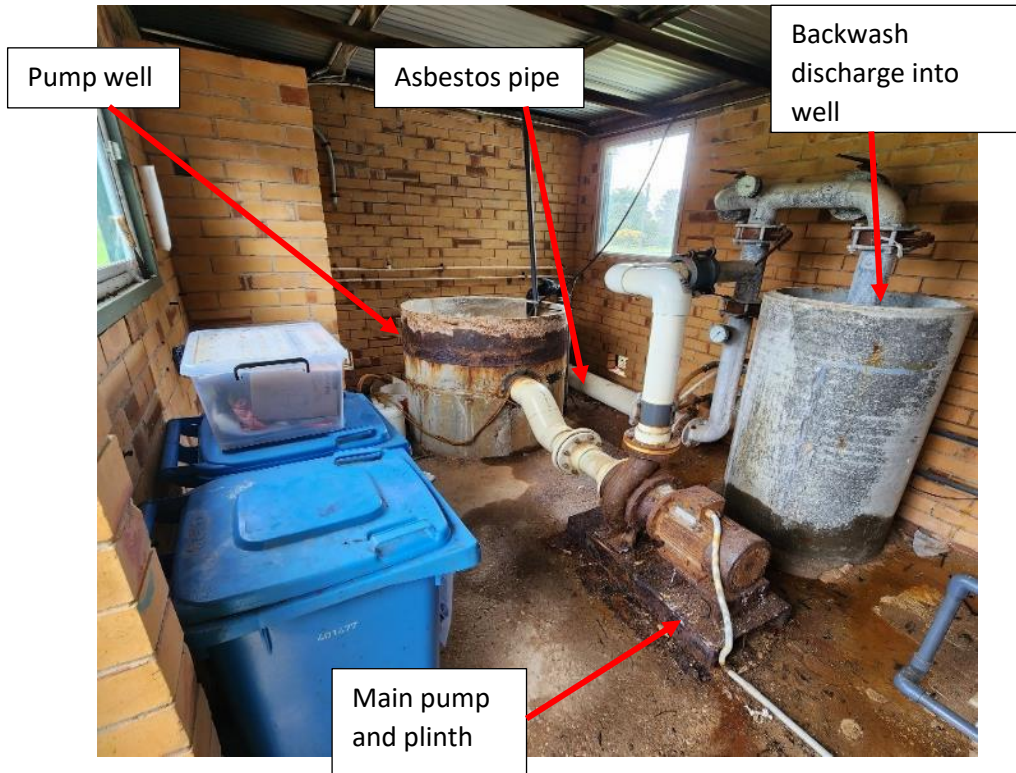
Image 27 – Main pump and pump well

- a) The pump is in very poor condition externally. Both the casing and base plate plinth are heavily corroded. This would indicate the pump is near the end of its design life.
- b) The pipework is a mixture of PVC, galvanised steel, and in one case asbestos cement.
- c) There is a 'Gibault' joint downstream of the pump where PVC changes to steel. Gibault joints are not designed to resist tension along the pipe and thus for the pipe system to resist the longitudinal hydraulic pressure forces requires other pipe restraint system. These are not present and were there to be a spike in pressure from the pump (e.g. blockage in the filtered water to the pool) then there is a risk of the pipe blowing apart at the Gibault.

- d) The pump pipework on the suction side has an elevated u-bend that could entrap air as there is no air release valve. As a result, there is probably reduced hydraulic capacity.
- e) Either an air relief valve could be installed or, with the likely replacement of the pump and plinth soon there is the opportunity to raise the pump and suction pipework to eliminate the air entrapment.
- f) Space in the pump shed is constrained.

- a) The main pool drains directly to a pump well inside of the plantroom. This pump well is a large diameter pipe embedded vertically into the ground.
- b) The concrete pipe well is in poor condition with leaks (and previous repairs) and corrosion evident.
- c) The pump well will provide a very notional amount of 'balance' volume for the pool and with the low bather numbers at Glenthompson it may suffice.

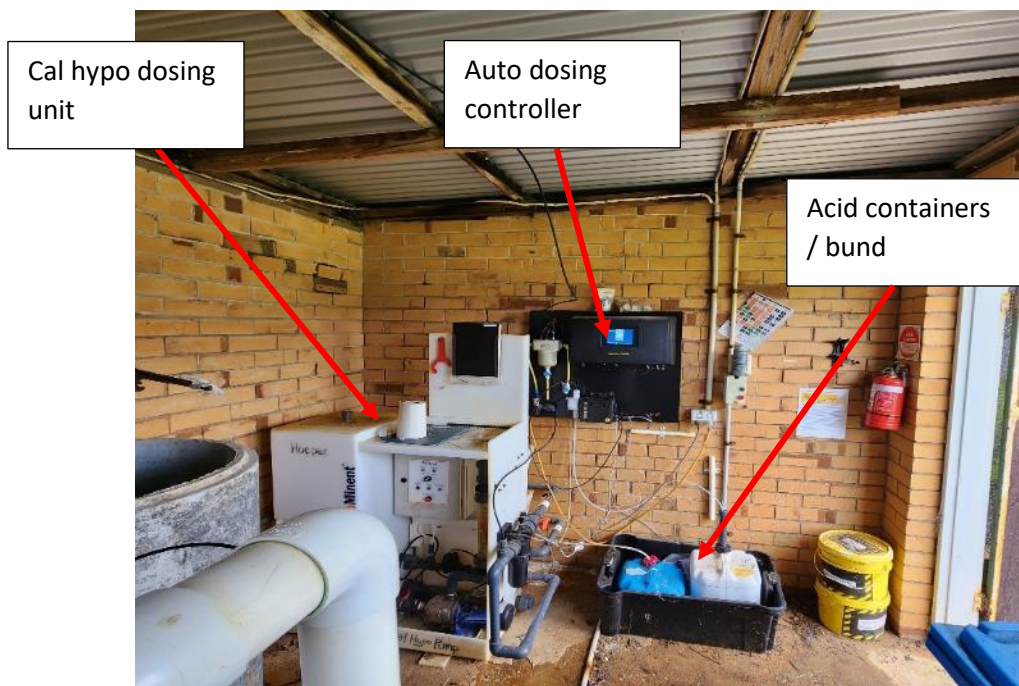
Image 28- Chemical dosing system

- d) Hydrochloric acid is used for pH control. This is delivered in 15litre containers. The containers are stored inside a larger plastic box which provides the bunding. However, it is very close to the Prominent unit and the risk of calcium hypochlorite coming in contact with acid is high. This will produce highly toxic chlorine gas. Significantly increased separation is strongly recommended.

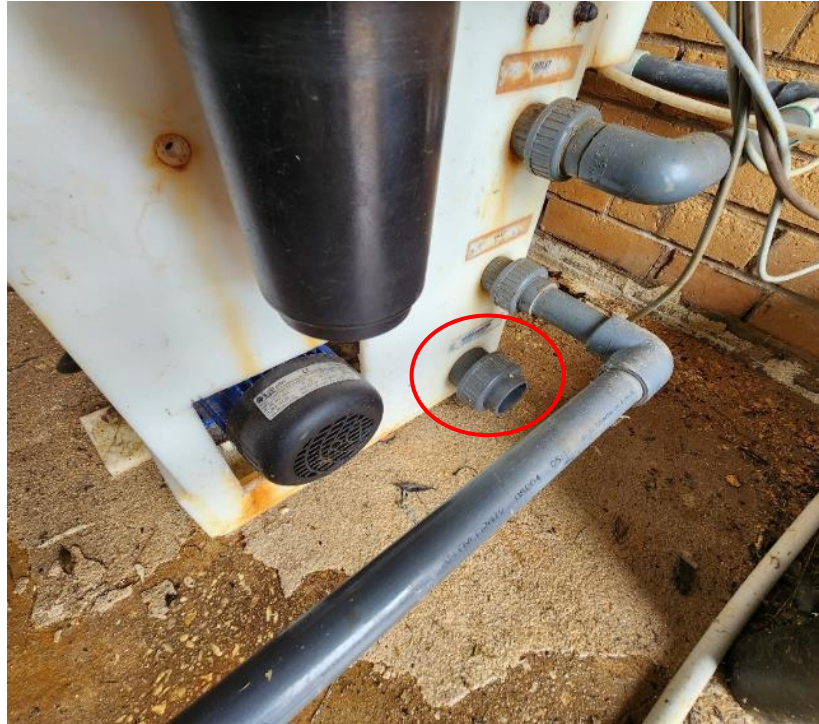
- g) The calcium hypo unit has an overflow that will operate whenever the pump stops unexpectedly. The overflow level is very low to the floor and is not connected to a pipe, meaning it easily floods the room. A remedy could be to raise the slightly, and the overflow could then be piped to waste.

Image 29: Over-flow from cal-hypo unit discharges to floor

6	Rainwater harvest tanks / irrigation pump	Reinstate pipes & pump to make system serviceable. (System has been disabled for some time). Allowance	\$5,000			\$5,464				\$500
7	WTP - make up water	Automate water supply with control valve & level control. Install water meter (cumulative flow volume).	\$5,000	\$5,150						\$500
8	WTP - pump well	Allowance for supplementary leaks repairs to pump well conc. (vertical conc. pipe).	\$5,000			\$5,464				\$500
9	WTP - pump & plinth	Replace main pump and corroded steel plinth.	\$10,000			\$10,927				\$1,000
10	WTP - suction pipe	Provide valved offtake and open riser pipe to apex of U-bend on main pump suction side to allow for removal of any air entrapment	\$500			\$546				\$50
11	WTP - delivery pipe	Gibault joint needs additional pipe support so that it is not reliant on friction to resist tensile forces	\$1,000			\$1,093				
12	WTP - Cal hypo unit	Provide pipe from unit overflow (near floor level) to outside / waste pipe.	\$500			\$546

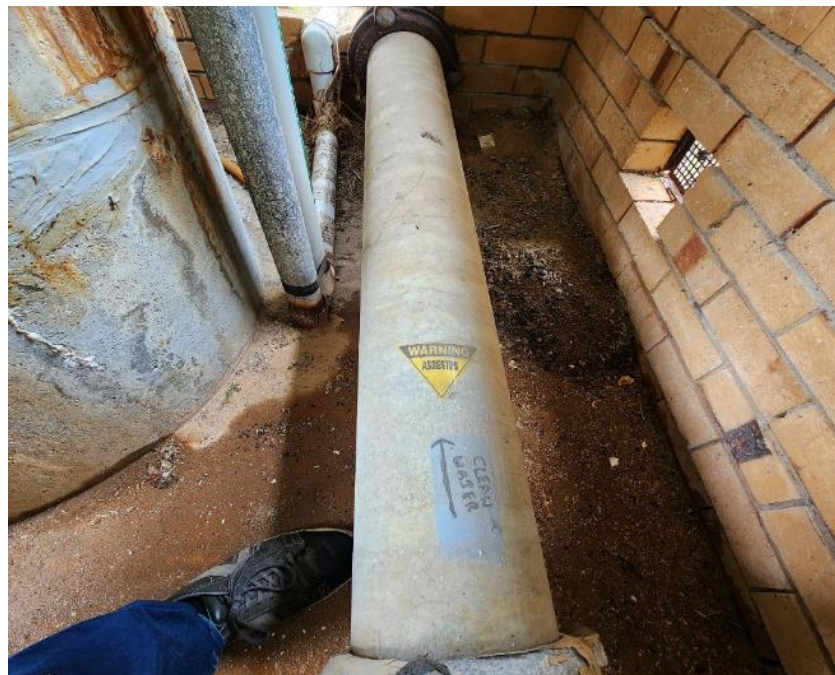
Image 30: Filtered water / asbestos pipe

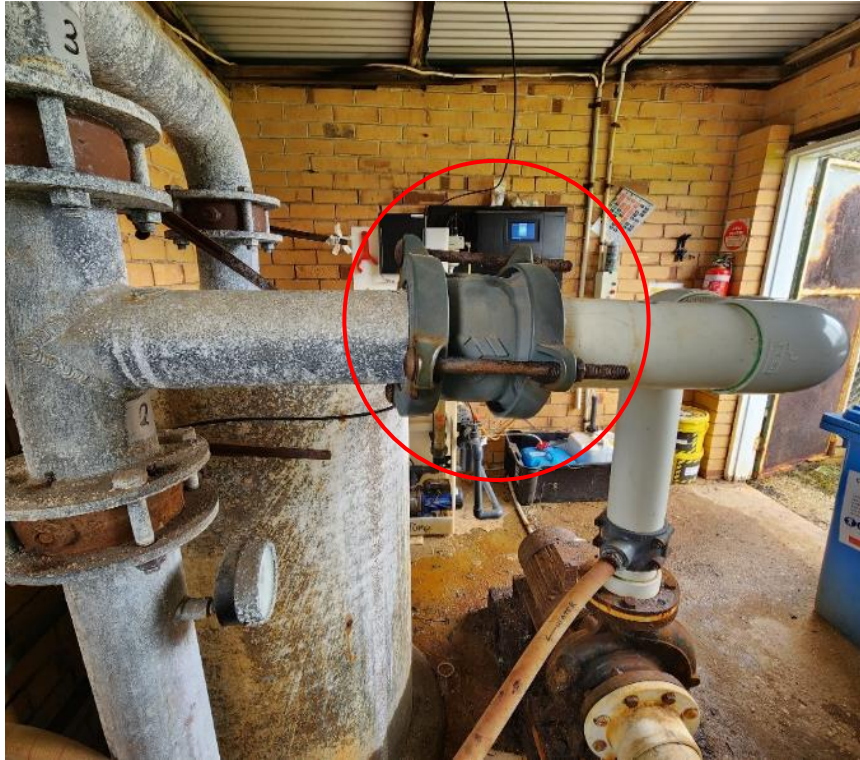
Image 31: Unsupported Gibault joint in discharge pipework

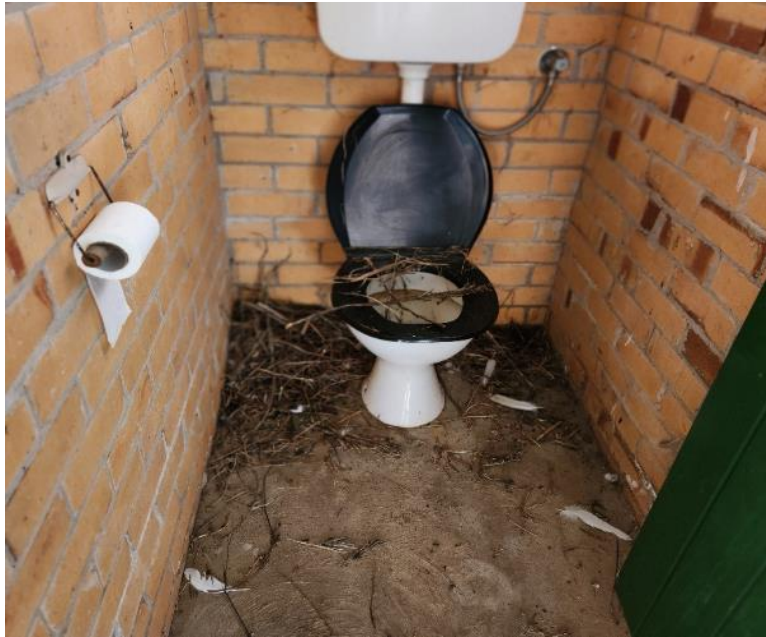
- b) The changerooms while spacious are very rudimentary with exposed plumbing on brick walls, group shower (male) areas with bare concrete floors, and of particular note is the high level of wind-blown debris inside as well as bird and vermin droppings. This is due to the wide openings above part height walls and the roof. These are up to 0.5m high and provide easy access.

Image 35: Changeroom (male) – debris from wind, and bird entry

14	Entry / Changerooms	Crack in slab edge of concrete slab along full width of entry to facility. Not in critical location but break out loose concrete, neutralise any rust and repair / fill with high quality mortar	\$3,000			\$3,278				
15	Changerooms	Install bird-proof wire screens over high-level openings. Similar to Dunkeld (with lattice timber support).	\$5,000			\$5,464				\$500
16	Allowance for Contingencies / Prelims etc		\$22,759	\$3,090	\$0	\$19,669	\$0	\$0	\$0	\$2,276
			\$127,759	\$18,540	\$0	\$118,015	\$0	\$0	\$0	\$12,326

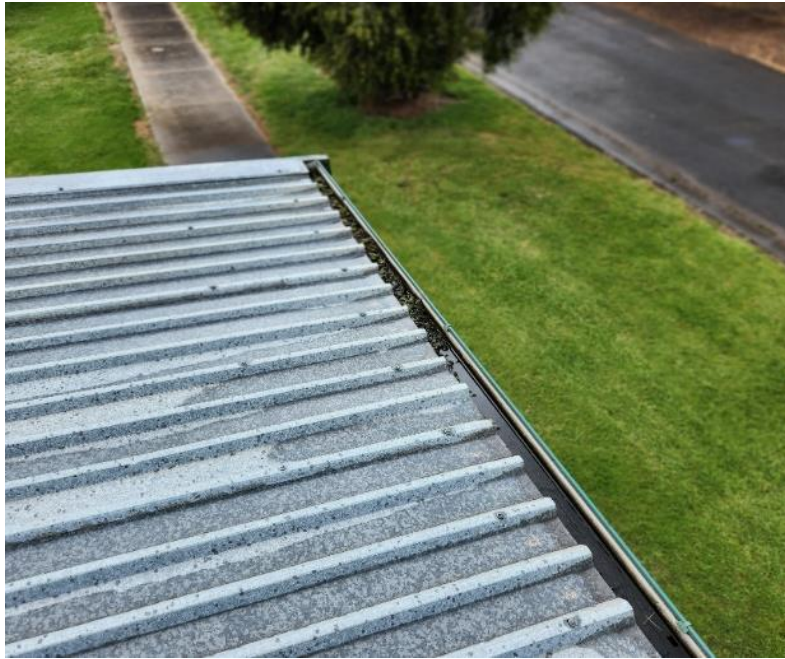
- c) The roof structure is timber and appears in good condition.
- d) The roof sheeting is galvanised and is in reasonable condition for its age. There are some patch repairs of leaks, and the gutters were part flooded (i.e. from blockage. inadequate fall) but these are minor maintenance issues.

Image 37: Changeroom roof- blocked gutters holding water.

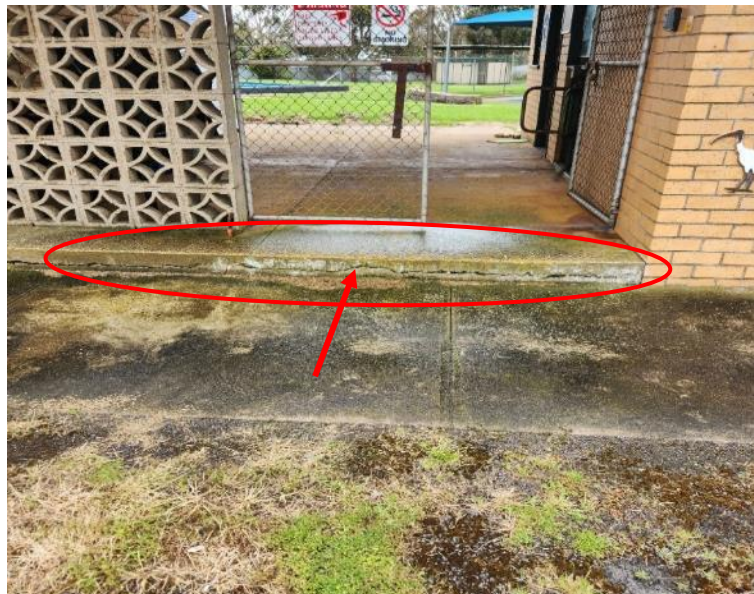
- e) There is a long crack along the front edge of the entry slab at the main street entry. This is from reinforcement corrosion but appears likely to have developed many years ago. It is not in a critical location and treatment of the corrosion and sealing of the crack can be undertaken under general maintenance in due course.

Image 38: Entry to facility. Long crack along front of slab edge due to reinforcement corrosion.

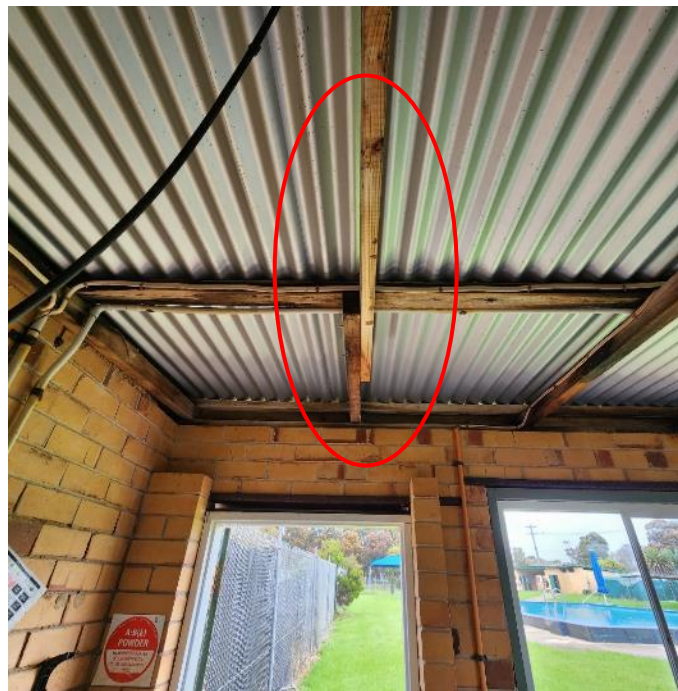
- c) The most significant issue is the failure / repair of one of the timber roof rafters. The splice repair is totally inadequate. The rafter needs to be replaced in its entirety (full length) not just partial length and all other rafters should be checked for rot.

Image 39: WTP new roofing iron but with inadequately spliced rafter

13	WTP - building	Replace corroded steel entry door. Previously repaired / spliced rafter needs to be replaced (or supplemented) with new timber spanning full length. Replace rotten window frame.	\$2,000			\$2,185				\$200

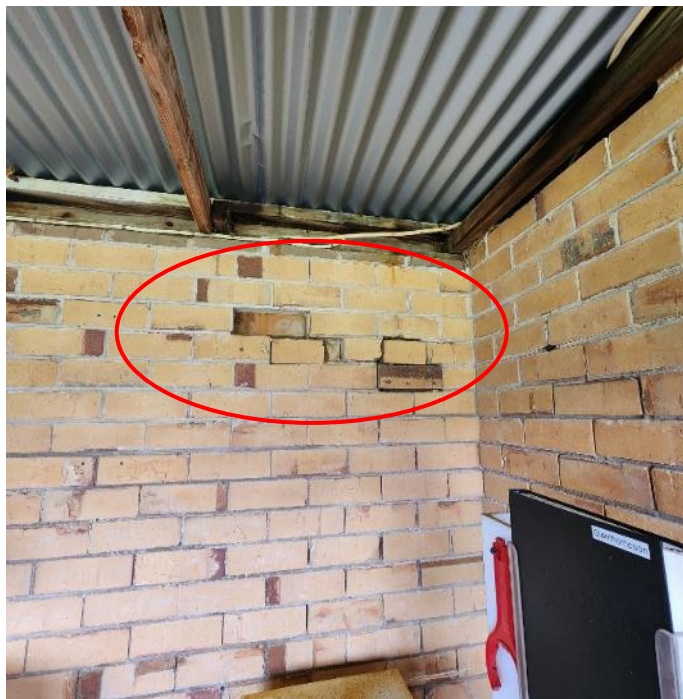
- d) There is extensive corrosion in the metal framed & sheeted door, and it needs to be replaced.
- e) Bricks in the rear wall have become dislodged indicating poor mortar. Otherwise, the brickwork is satisfactory. Fortunately, there seems no sign of cracking in brickwork that would indicate poor ground conditions. This is consistent with the pool shell stability.

Image 40: WTP dislodged bricks in north wall

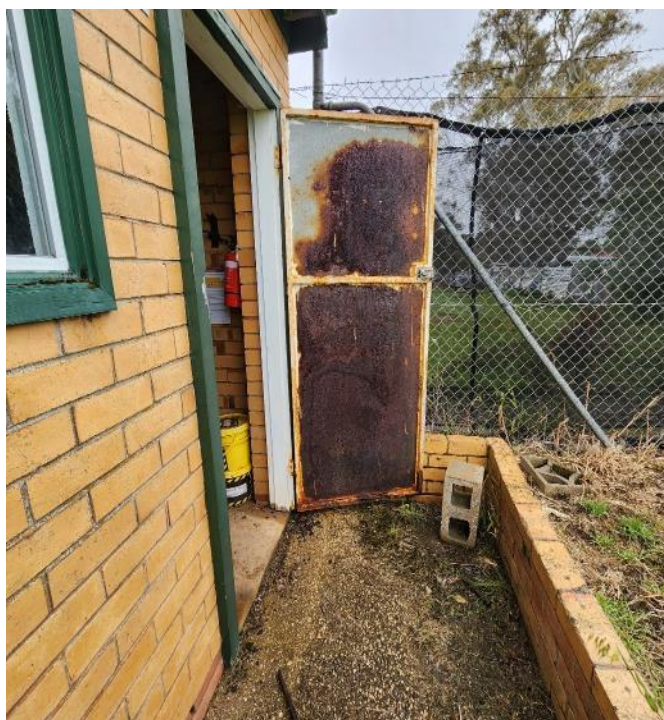
Image 41: WTP door is badly corroded.

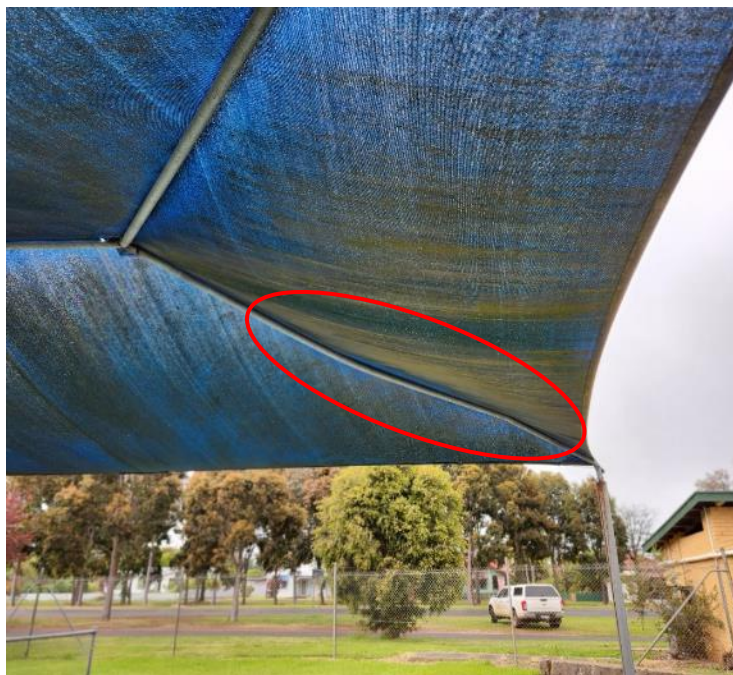
- a) The shade structure over the Toddler's pool has (technically) failed structurally. One of the hip ridge tubes is bent. This deformation will weaken the structure holistically. Fortunately, this structure is lightweight and with a perforated shade cloth it does not present high windage, and thus the structure has not collapsed further.
- b) The bent tube will need to be replaced and consideration should be given to replacing the entire structure with a stronger one such as the similar one at Balmoral.

Image 42: Toddler's pool, shade structure. Bent (technically failed) structural support tube.

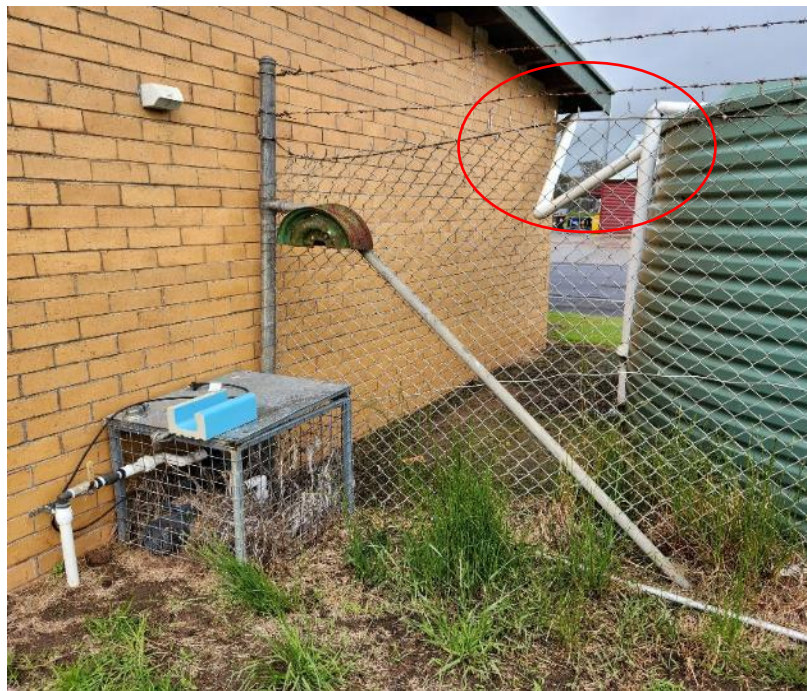
- a) A rainwater harvesting and reuse system has been installed, probably within the past two decades.
- b) While the tanks and pump appear in reasonable condition the fill pipe into the tanks has severely dislodged and is unusable. There has been no attempt to repair. The recycle pump was not plugged into the power (this may simply be an operational issue). Overall, it seems doubtful that the system is operational and has been used in recent times.

Image 44: Rainwater recycle pump. Note dislodged infill pipe.
