## Aquatic Development Strategy

## Volume 1: Technical Assessments & Probable Capitals Costs

## Site Investigation Report

Site:	<b>Balmoral &amp; District Swimming Pool</b>	Date visited:	30 <sup>th</sup> June 2009 PRELIMINARY ISSUE
Project:	South Grampians Council – Aquatic Facility Development Strategy	Project No:	EJ-0763
Client:	Southern Grampians Shire Council	Representative:	Mr Craig Halley
Investigation undertaken by:	Sean Stone Mike Pettigrew	Company:	Etch Architectural Solutions David Powick & Associates
Copies to:	Steve Pallas	Company:	@Leisure
Weather Conditions:	Overcast conditions, high winds and frequent showers. Cold.		
Pages	<b>15 (including this page)</b>

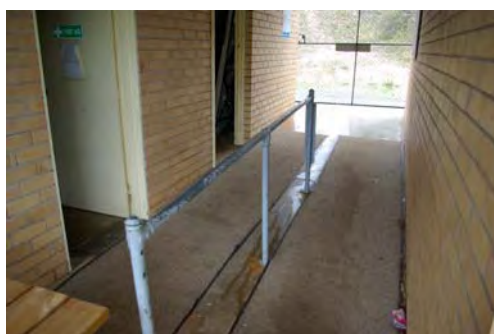
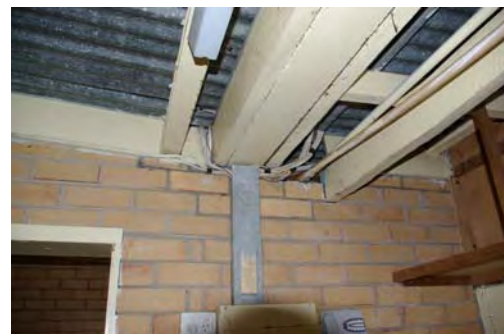
- 9) Restricted access into pool facility via entry. Acceptable for one-way pedestrian traffic only (tight for wheelchair)
- 10) No ceiling lining in office.

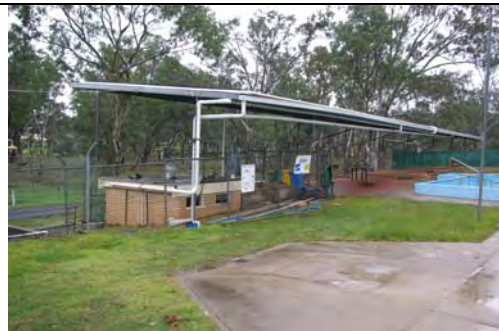
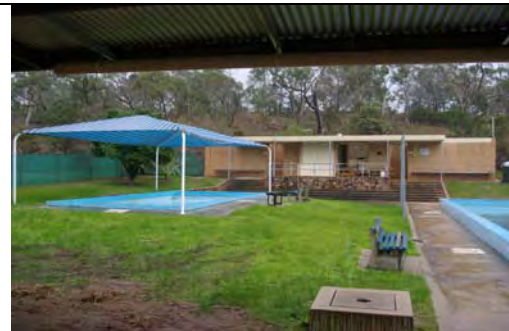
- 15) Solar heater shelter. Adjacent to the main pool.
- 16) Sun shade structure to toddler’s pool in a reasonable condition.

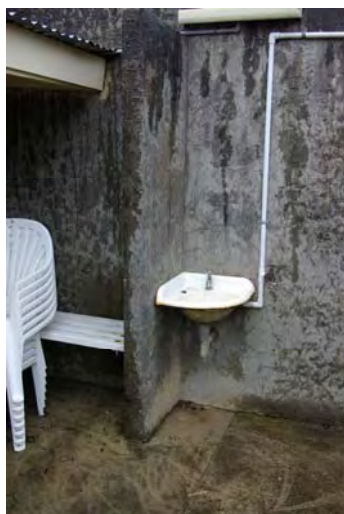
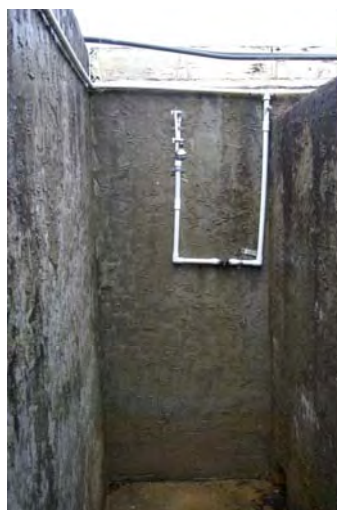
- 17) Typical steel basin with exposed plumbing.
- 18) Typical condition of showers. Shower rose may be water saving but pipe work – very poor.

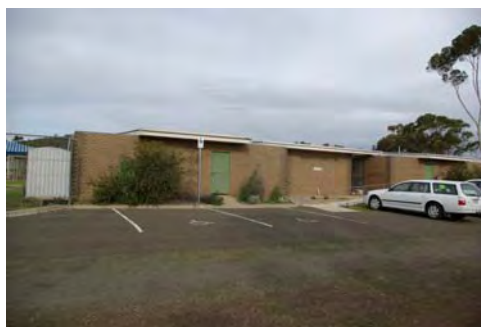
- 1) Coleraine Pool – main entry.
- 2) Typical seating and sun shading structure – located around the pool facility.

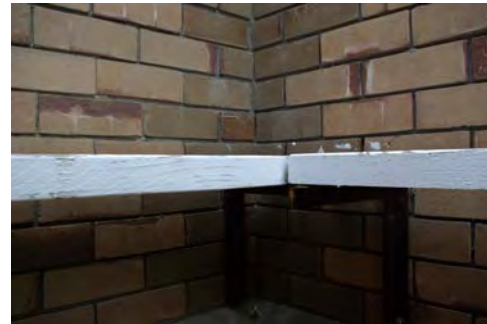
- 6) Metal door frames corroded to pans. Mortar displaced with brickwork
- 7) Bench seating – not safe. All wall mounted brackets loose off wall and corroded.

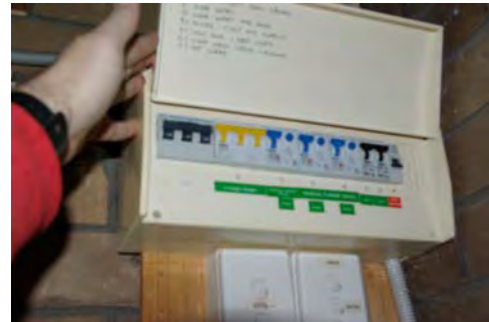
- 10) Main joinery to office / entry room. Very tired and in fair condition
- 11) Existing switchboard, reasonable condition. Current circuit breakers and RCD (safety) switch.

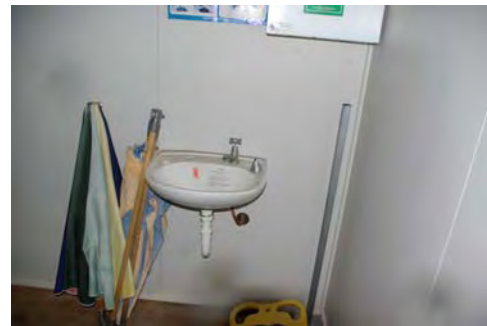
- 12) Access to first aid room – not BCA compliant. Structural crack to landing. (narrow door to room)
- 13) First Aid room – appears more like a store room.

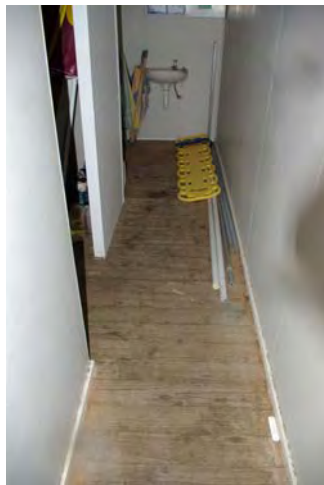
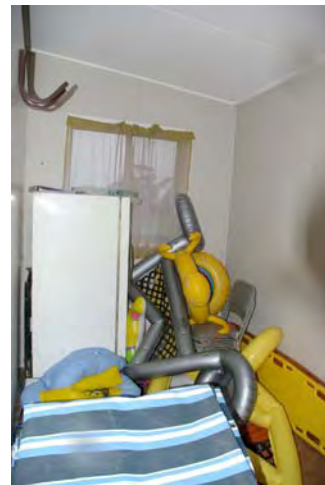
- 14) Passage way from entry door to first aid room – too narrow (max. 900mm width)
- 15) First Aid room – appears more like a store room.

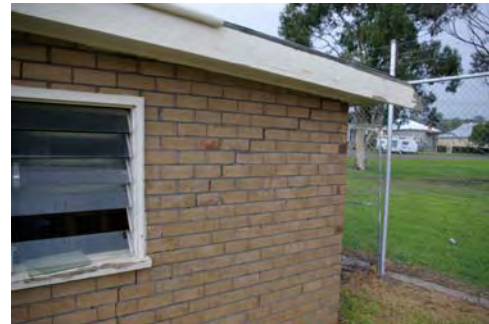
- 16) Plant room / Filtration room appears in a poor condition (internally / externally). Safety shower compliant.
- 17) External window – very poor condition and structural cracking to brickwork.

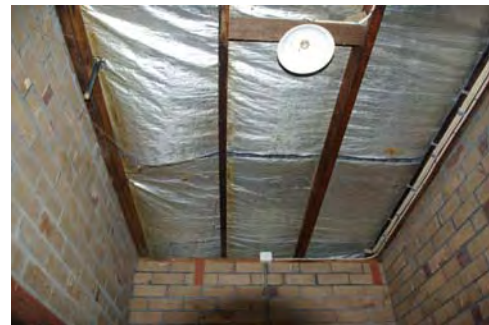
- 18) Step into filtration room too steep – not BCA compliant. No visible warning of step.
- 19) Exposed sislation (thermo – foil). Foil should be taped and sealed. Poor condition.

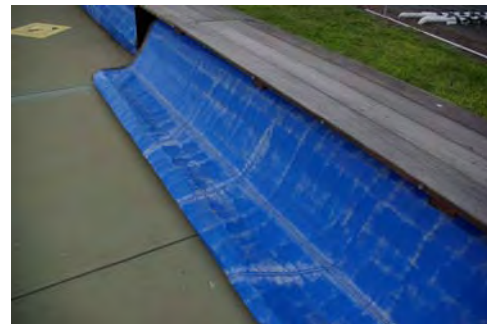
- 22) Typical wall mounted basin to all change rooms – wall brackets corroded.
- 23) Pool blanket – reasonable condition. Top coating of cover is breaking down with exposure.

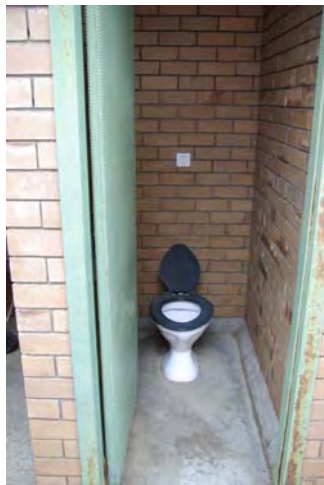
- 24) Pans – very narrow. Reasonable condition. Doors – corroded on frame.
- 25) Shower area – use of water saving shower rose – very tight in area – no partitions.

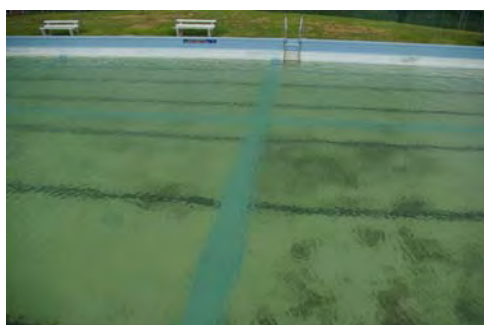
- 26) 50m pool – evidence of recent repairs to pool shell.
- 27) Main 50m pool in reasonable condition, including hand rails.

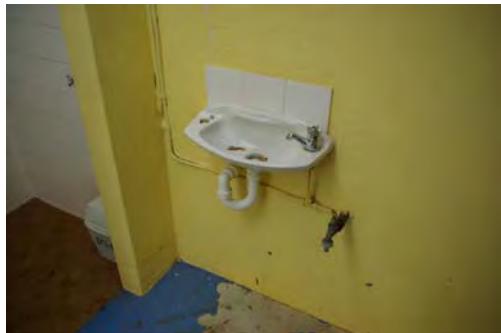
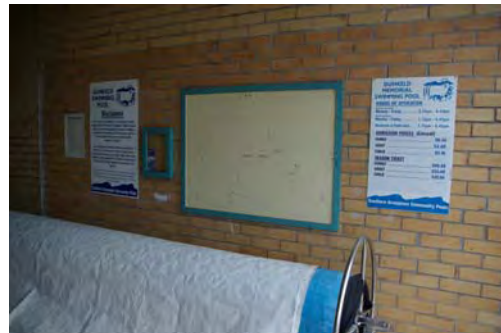
- 19) Wall mounted basin in good condition, however not compliant for disability access. Note epoxy floor coating – in poor condition under basin.
- 20) Pool blanket in good condition – located within entry area of pool facility.

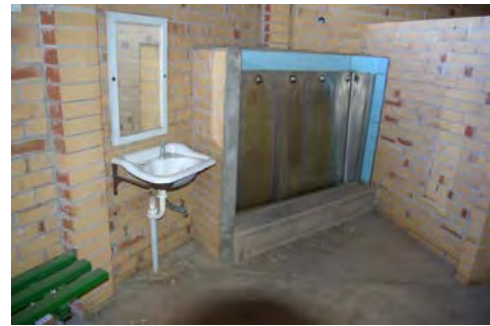
- 5) Change rooms – Male. Clean brickwork, exposed concrete slab and exposed roof (no insulation)
- 6) Corroded urinal and high step. Step is not BCA compliant.

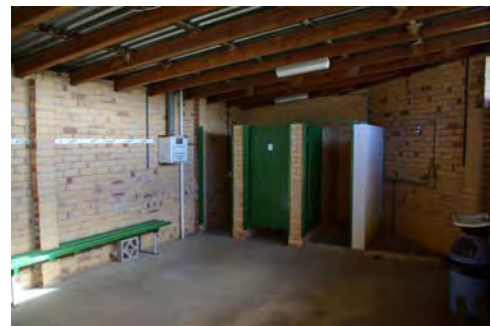
- 7) Female change – very restricted showers (with step).
- 8) Female Change rooms – very similar to male change. Very basic finishes.

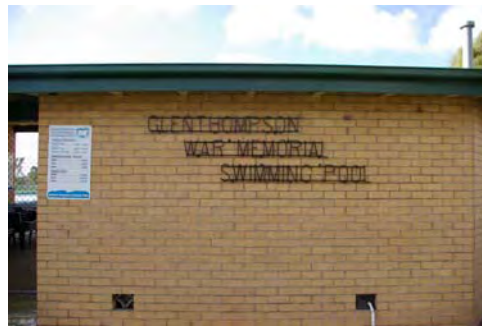
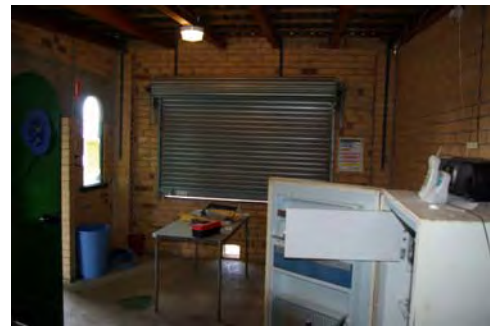
- 9) Typical signage to main entry. Not clearly visible from the street.
- 10) Typical office / entry / first aid room. Roller Door used for kiosk and no joinery.

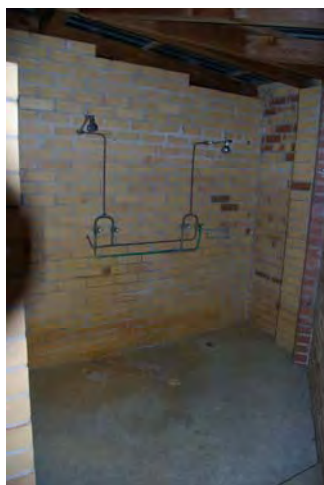
- 18) Showers to both change rooms – poor condition. Both not BCA compliant and no disabled access.
- 19) Typical pans with new cisterns.

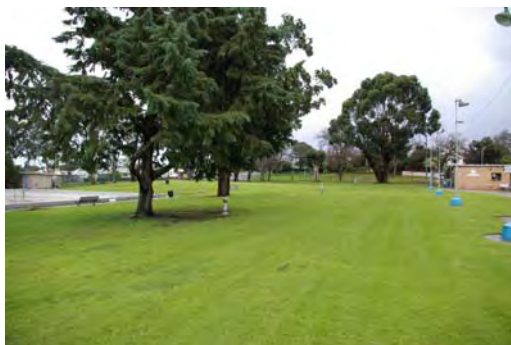
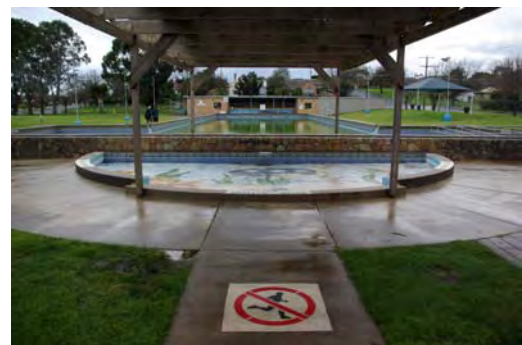
- 1) Hamilton pool – relatively flat site with significant trees located throughout – note playground in the background.
- 2) Main axis from the main entry looking over the toddlers pool, main pool to the plant room.

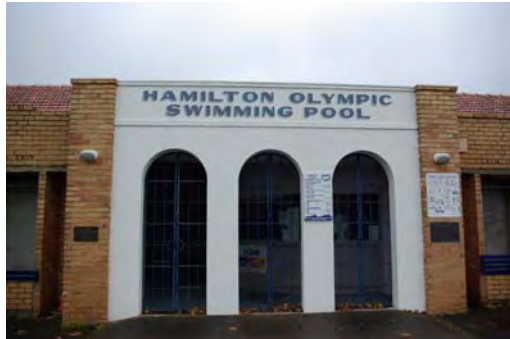
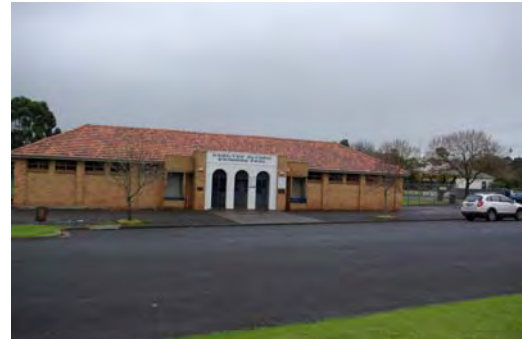
- 3) Pool site – visually linked to Gage Street & Mcconchie Street)
- 4) Very prominent main entry – existing 1950’s building. Consider preserving?

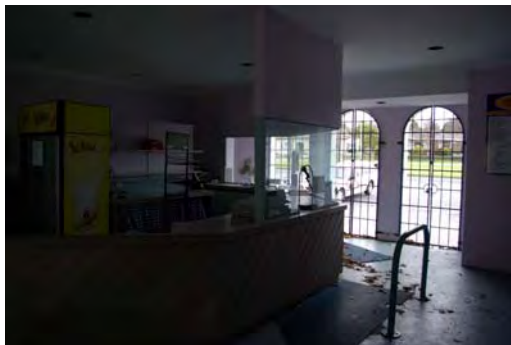
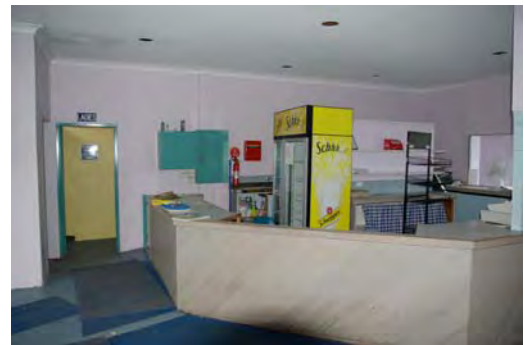
- 10) Main entry from inside the control/ reception area.
- 11) Typical joinery – tired and in fair condition

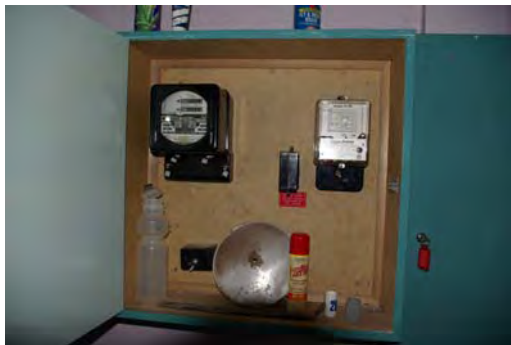
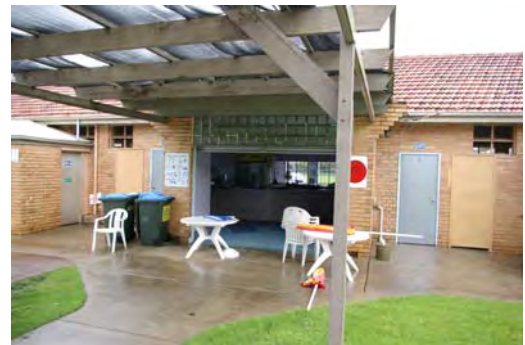
- 12) Main meter board in reasonable condition.
- 13) Main entry to pools from entry building – access way very low due to roller door behind.

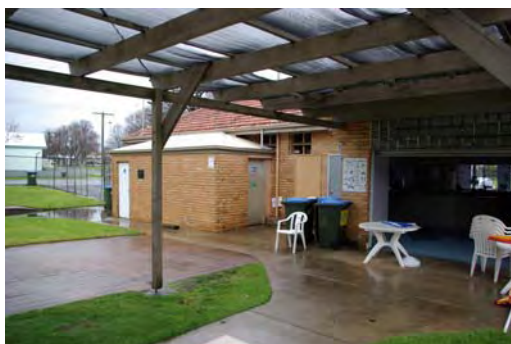
14) First aid room – not clearly accessible from pools – poor location for signage.

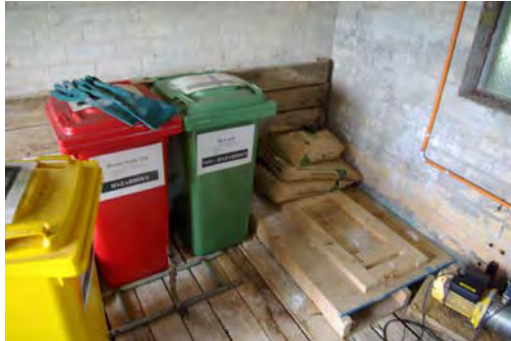
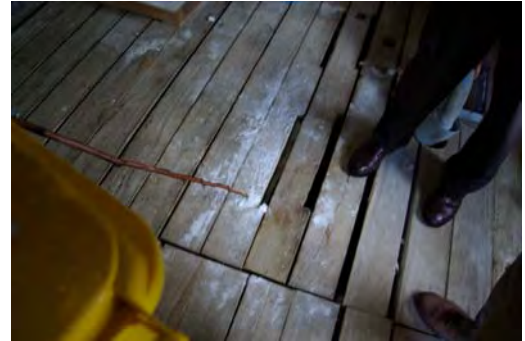
- 15) Chemical store in poor condition.
- 16) Evidence of sodium bicarbonate spilt on timber floor and through slats.

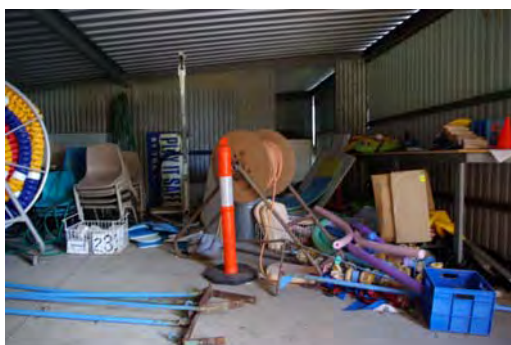
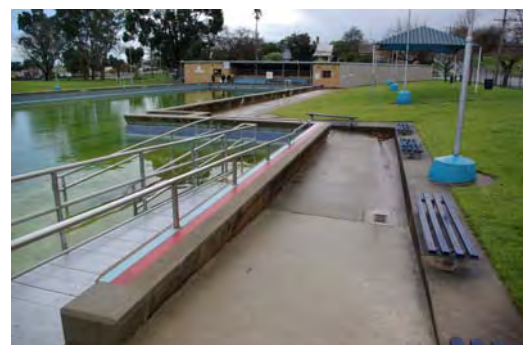
- 20) Store room – a dump.
- 21) View from 50m pool of plant room.

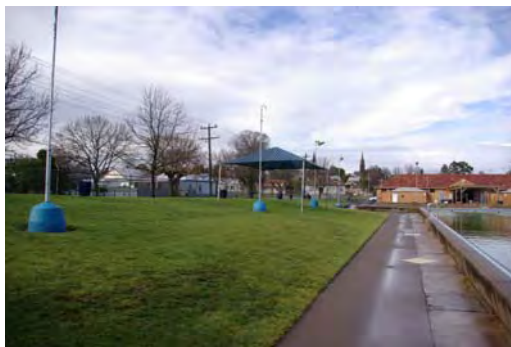
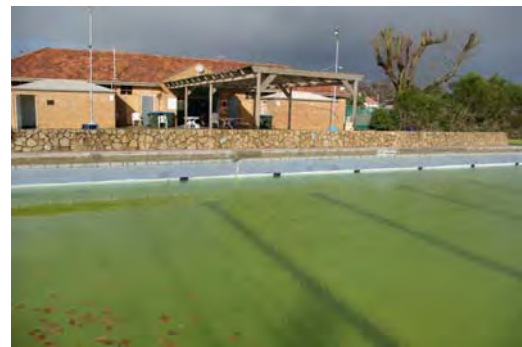
- 22) Fixed sun shade structures – along pool concourse.
- 23) Main toddlers pool – sun structure.

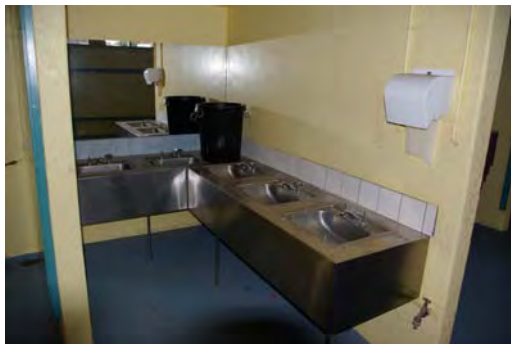
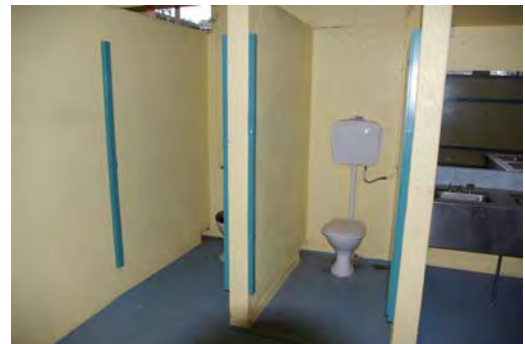
24) Stainless steel wall mounted basins to female change – too close and restricted.  
 25) Typical pan in change rooms

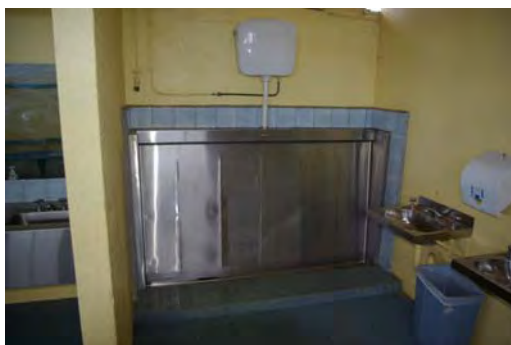
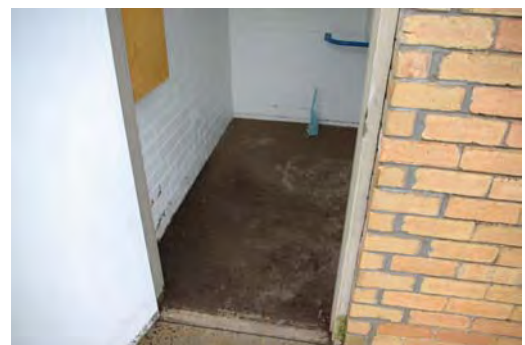
26) Typical urinal and wall mounted basins in male change rooms  
 27) Disabled toilet – subject to flooding. Note door frame corroded at base.

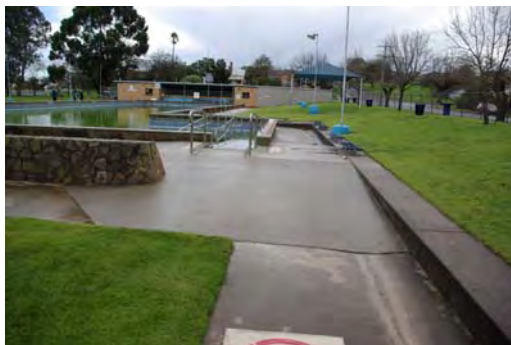
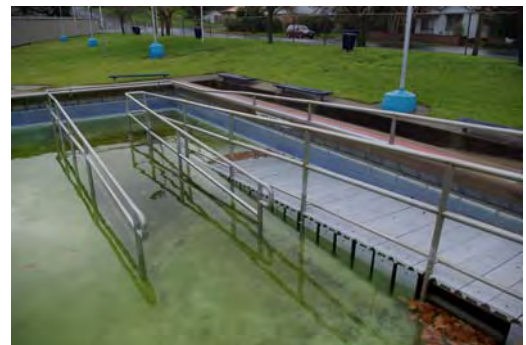
- 33) Pool concourse graded to pool ramp – not compliant
- 34) Disabled ramp – not compliant – note potential hazard with portion of wall open.

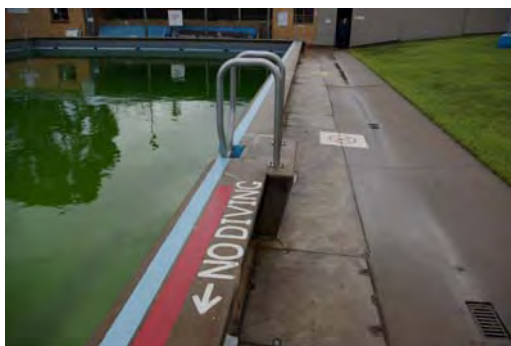
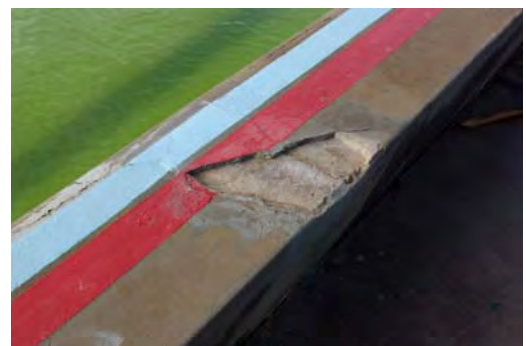
- 35) Typical access ladder – no step from pool concourse.
- 36) Portion pool shell to be repaired.

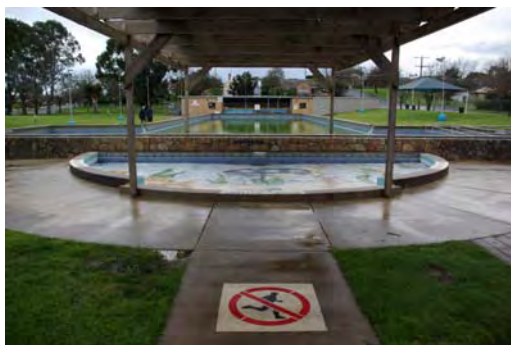
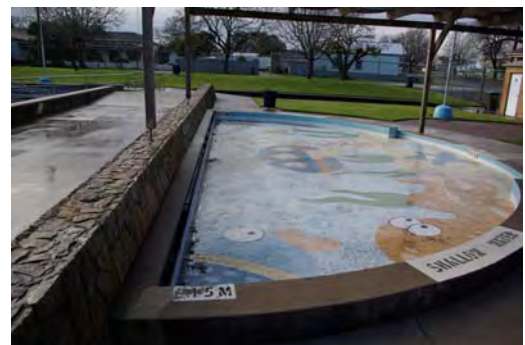
- 37) Toddler’s pool recommended to be removed.
- 38) Toddler’s pool signage in fair condition.

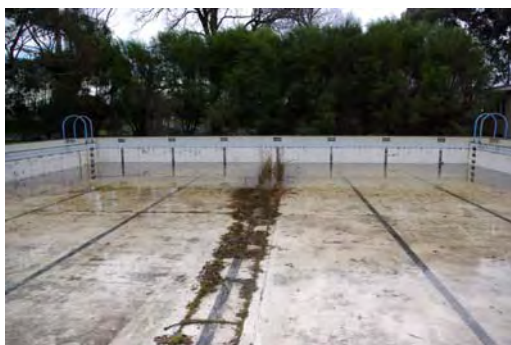
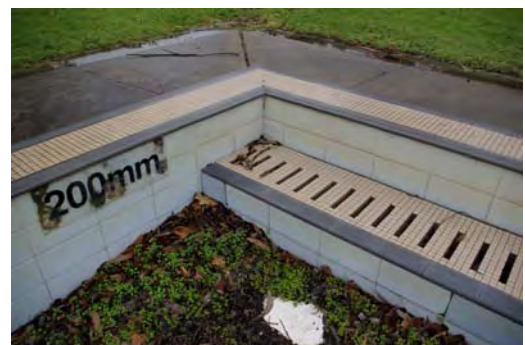
- 39) 25m pool in poor condition – recommend to be removed.

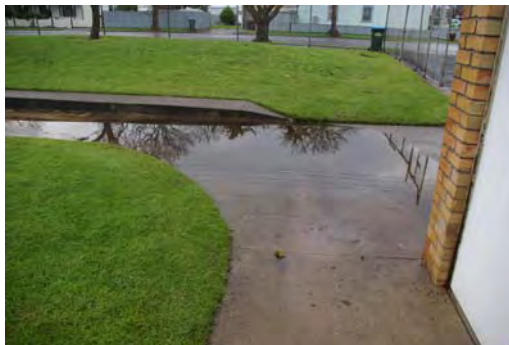
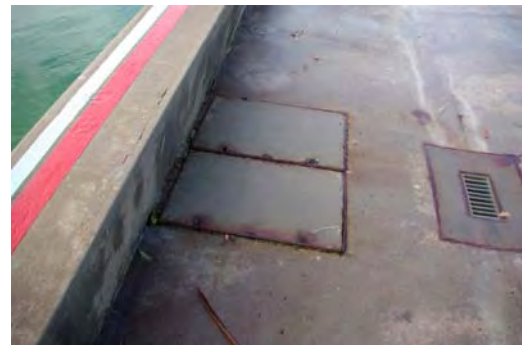
- 41) Sections of pool concourse subject to flooding.
- 42) Corroded pit lids

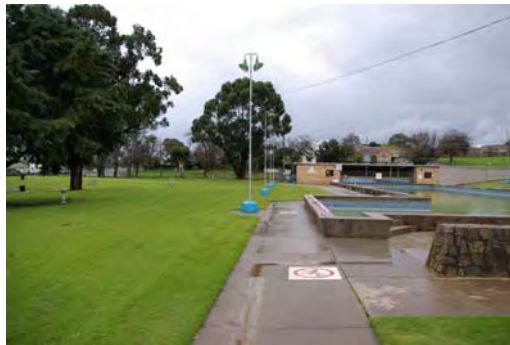
- 43) Main pool concourse in reasonable condition. Width complies with RLS minimum requirements
- 44) Pool lighting in poor condition.

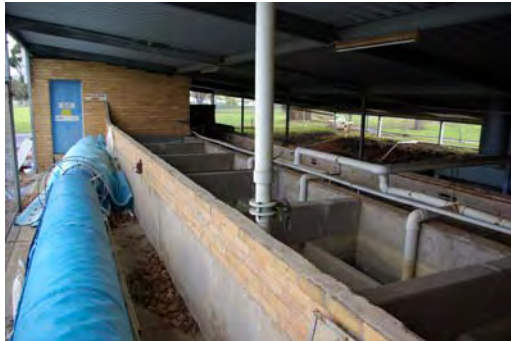
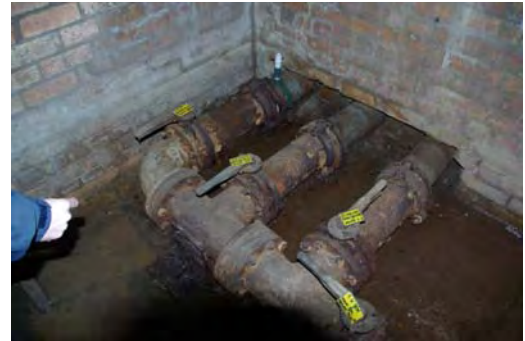
- 45) External gravity sand filters in reasonable condition
- 46) Typical pipe work condition.

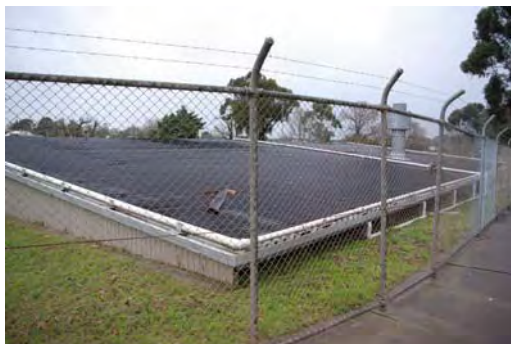
- 47) Typical condition of the solar heating system - located on plant room roof.
- 48) Typical storage condition for pool chemicals – may be deemed dangerous.

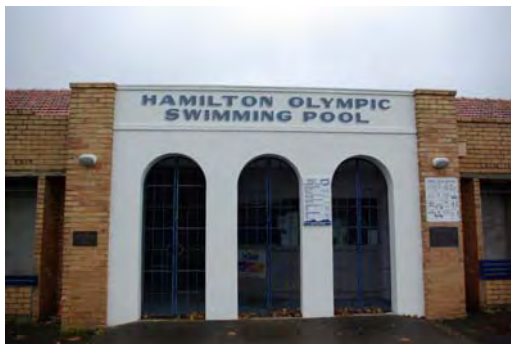
49) Main entry signage – clear from street.

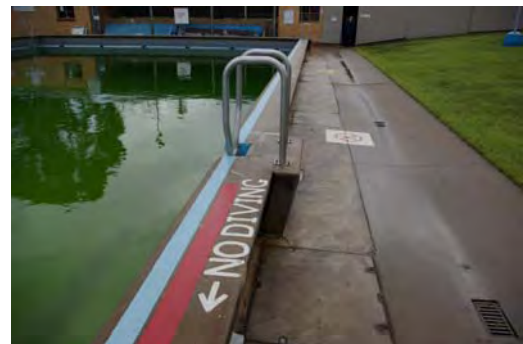
50) Typical signage around pools.

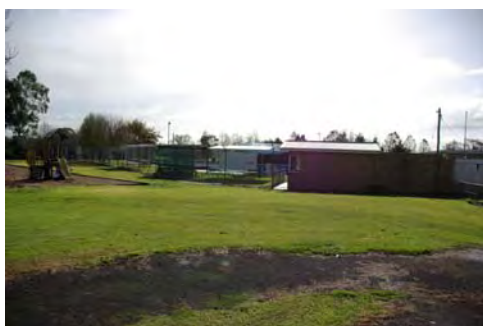
- 1) Penshurst pool – open parkland adjacent to swimming pool site (view from car park).
- 2) Main entry to pool – no clear signage or direct path from main car park.

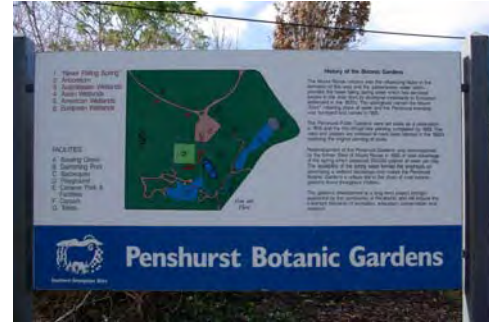
- 3) Main view of pool from play ground.
- 4) Peshurst botanic gardens – precinct (swimming pool included within the gardens).

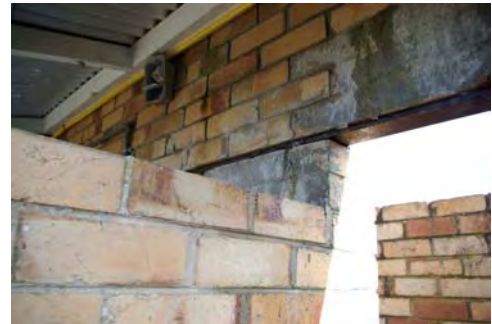
- 7) Concrete flooring to female change – cracked. Potential structural cracking and settlement to slab.
- 8) Corroded steel lintel and damaged lighting.

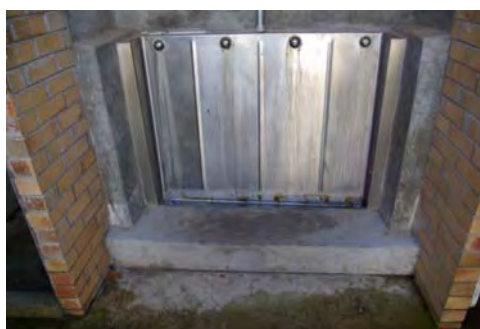
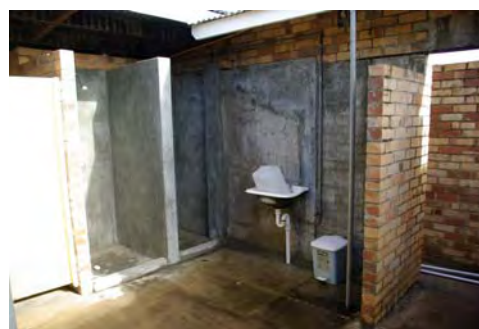
- 15) Corroded men’s urinal.
- 16) Female change rooms – steps to showers, original enamel basin.

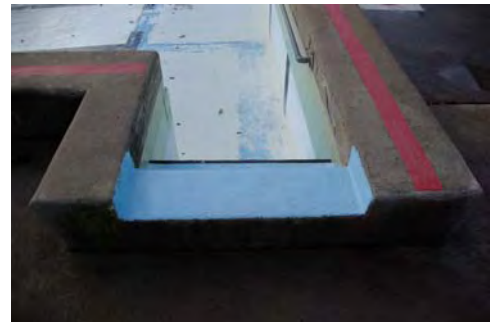
- 21) Access ladders – corroded at base. Recommend to be replaced with new.
- 22) No handrail to narrow steps

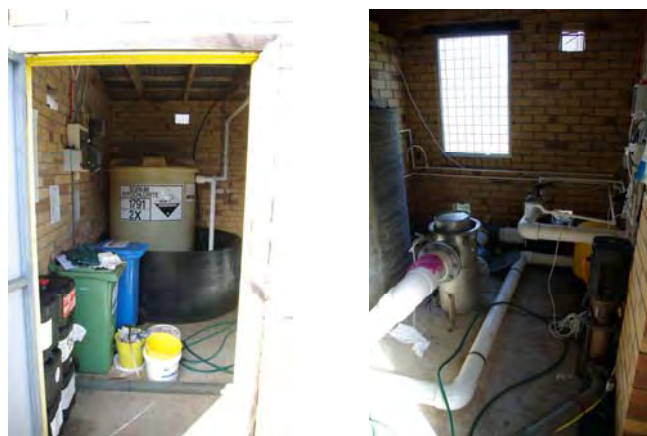
27) Pool Filtration plant – “Hypo- tank’ storage unit with additional chemical store.  
 28) Filter and main pool pump.

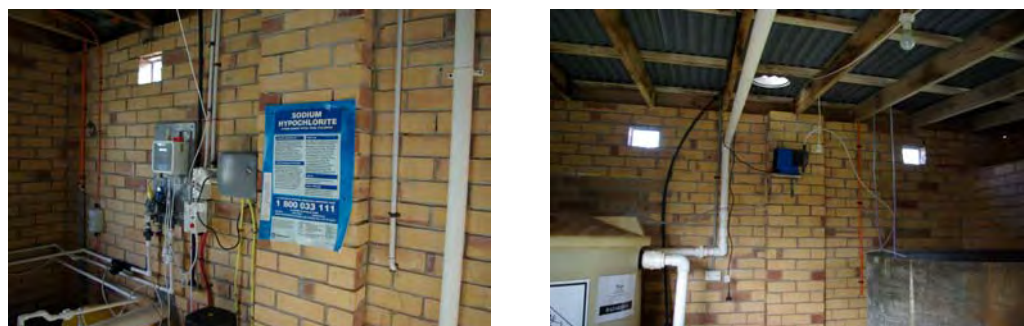
29) Current dosing system  
 30) Chlorine pump – to high.
