## Aquatic Development Strategy

## Volume 1: Technical Assessments & Probable Capitals Costs

## Site Investigation Report

Site:	<b>Balmoral &amp; District Swimming Pool</b>	Date visited:	30 <sup>th</sup> June 2009 PRELIMINARY ISSUE
Project:	South Grampians Council – Aquatic Facility Development Strategy	Project No:	EJ-0763
Client:	Southern Grampians Shire Council	Representative:	Mr Craig Halley
Investigation undertaken by:	Sean Stone Mike Pettigrew	Company:	Etch Architectural Solutions David Powick & Associates
Copies to:	Steve Pallas	Company:	@Leisure
Weather Conditions:	Overcast conditions, high winds and frequent showers. Cold.		
Pages	<b>15 (including this page)</b>

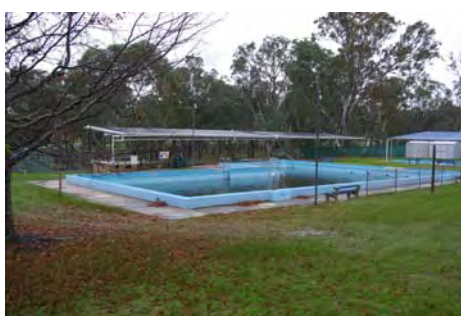
- 1) Balmoral pool – grassed (sloped) site.
- 2) Main road access clash with main pedestrian entry.

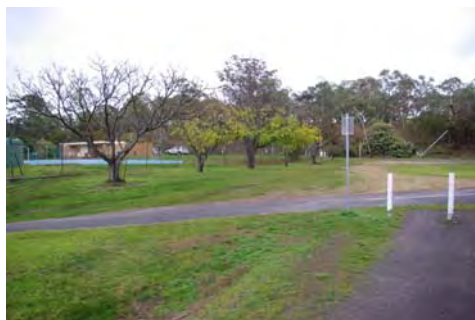
- 3) Main view of pool from main road (from township) – no visible signage.
- 4) Permeable car park at rear of pool facility – no designated disabled car spaces.

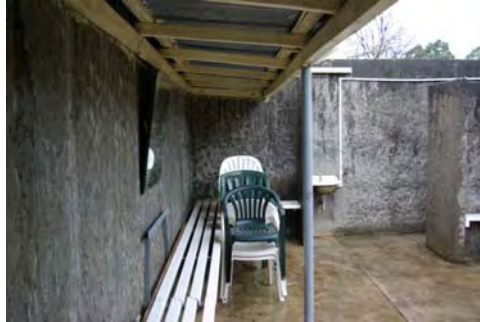
- 5) Typical condition of the change rooms – exposed to the weather.
- 6) Rendered concrete wall finish and exposed concrete flooring.

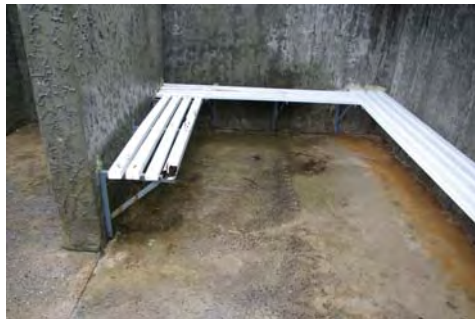
- 7) Typical condition of all bench seating.
- 8) Typical condition of toilet partition doors.

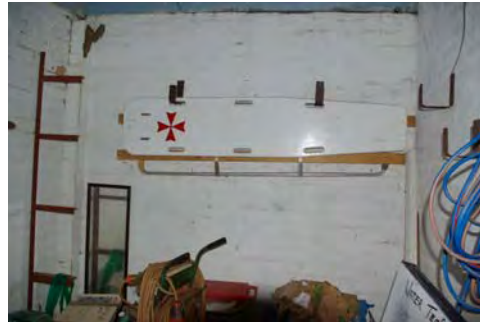
- 11) Typical condition of the first aid room / store
- 12) Typical condition of the first aid room / store – rubbish dump.

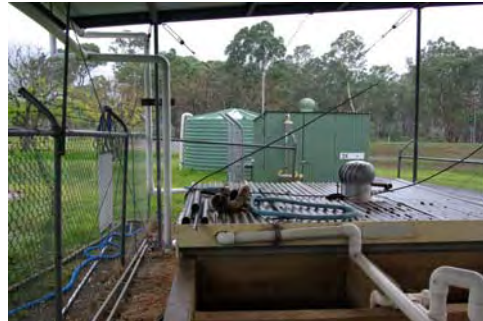
- 13) State of plant room from view of main pool.
- 14) View from main road. No clear access from roadway for deliveries.

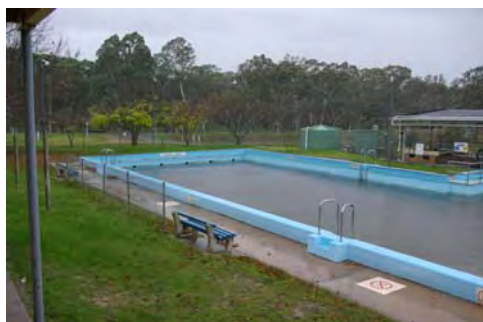
19) Main pool from change rooms.  
20) Main pool showing the existing ramp into the pool.

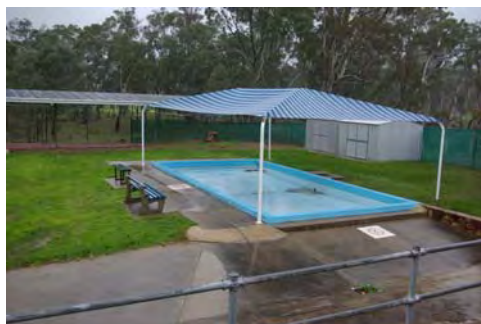
- Toddler's pool – view from main entry. Note the steep gradient to the concourse paving.
- Typical signage around pool. Note several steps into pool – not recommended.

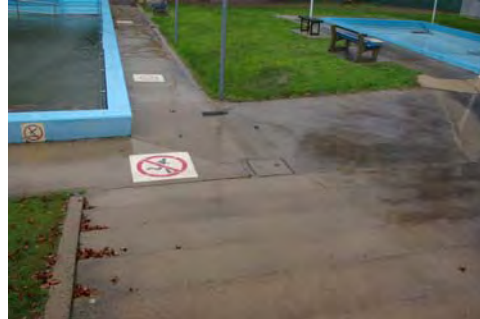
- 23) Steps from main entry to pool levels – not BCA / AS 1428.1 compliant.
- 24) Width of main pool concourse – too narrow.

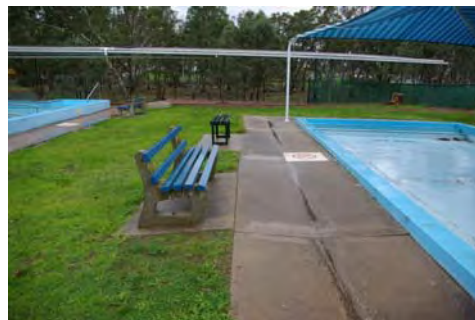
- 25) Toddler's pool – narrow pool concourse. Seating in poor condition, recommend to be replaced.
- 26) Pool concourse adjacent to toddler's pool – too steep.

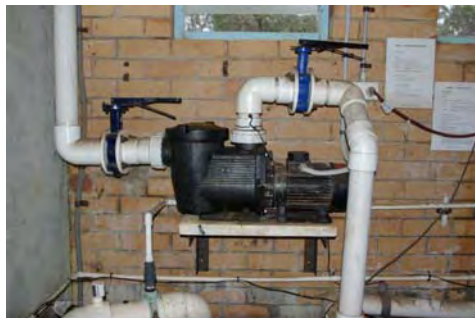
- 27) Elevated pump.
- 28) General pipe work in fair condition.

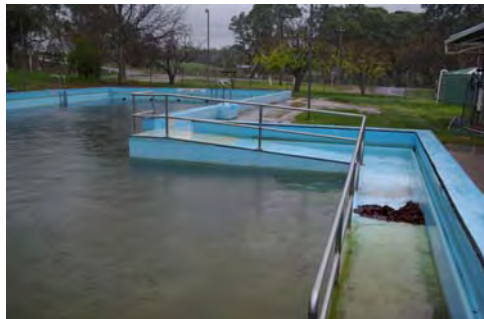
- 29) Main pool – disabled ramp not compliant
- 30) Section of pool ramp above water line is not BCA compliant and is deemed dangerous

- Refurbishment of the solar heating system.
  - Pool ramp to be replaced with new (so to AS 1428.1 compliant)
- Recommendations directed by David Powick & Associates for the filtration room should be implemented.

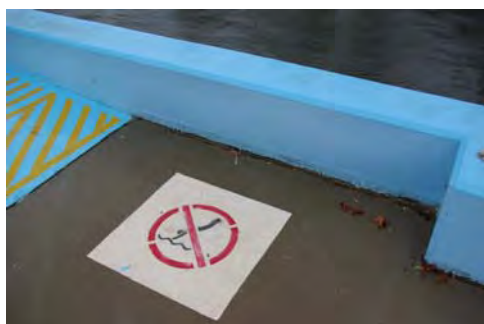
- 31) Typical pool signage does not comply.
- 32) Main signage to the pool facility.

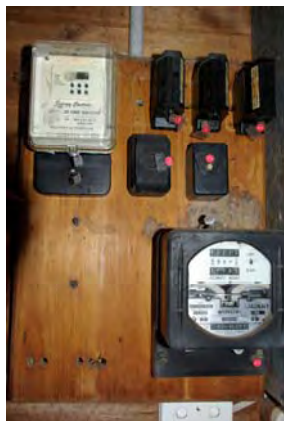
- On visual review of the electrical meter board and switch board located in the pool filtration plant room and the approximate age of the structure, it is very likely that asbestos may be located.
- On the condition of the pipe work associated within the filtration room and the age of the facility – asbestos lined pipes may have been used in its construction.

33) Switch board / meter board – may contain asbestos, due to its age and condition.

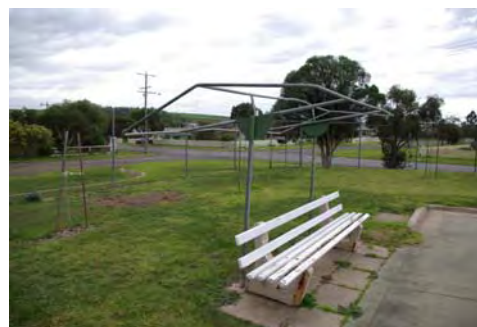
- 1) Coleraine Pool – main entry.
- 2) Typical seating and sun shading structure – located around the pool facility.

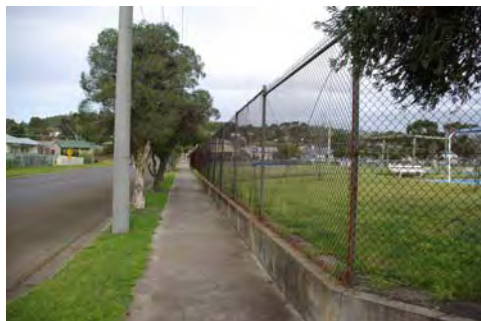
3) Pool site – visually linked to Gage Street & Mcconchie Street).

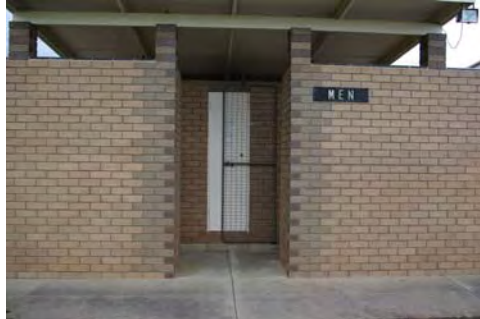
- 4) Main entry to change rooms.
- 5) Female change room – floor grading to floor waste. Structural cracks to slab evident.

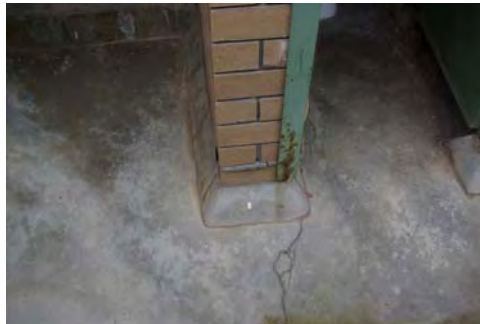
- 6) Metal door frames corroded to pans. Mortar displaced with brickwork
- 7) Bench seating – not safe. All wall mounted brackets loose off wall and corroded.

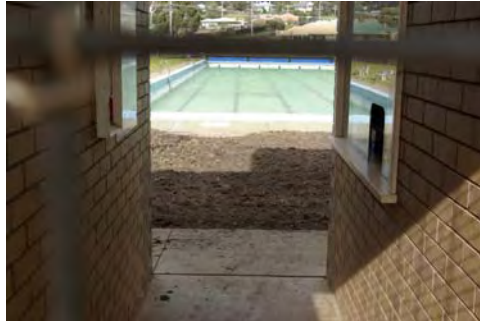
- 8) Main entry access into pool facility – too narrow to cater two-way pedestrian traffic.
- 9) Corroded truss junction between entry and change rooms – also poor condition of signage.

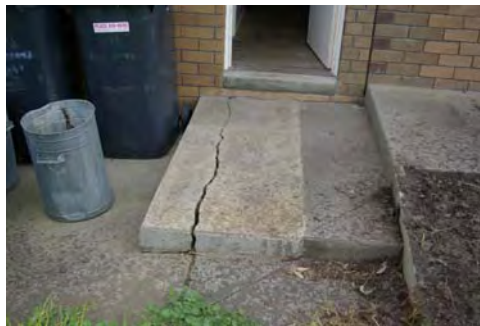
- 12) Access to first aid room – not BCA compliant. Structural crack to landing. (narrow door to room)
- 13) First Aid room – appears more like a store room.

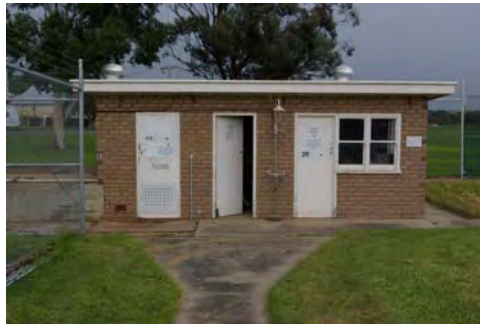
- 16) Plant room / Filtration room appears in a poor condition (internally / externally). Safety shower compliant.
- 17) External window – very poor condition and structural cracking to brickwork.

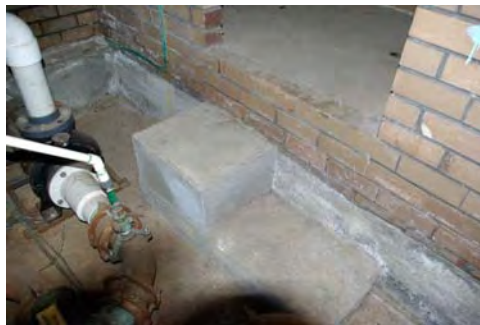
- 18) Step into filtration room too steep – not BCA compliant. No visible warning of step.
- 19) Exposed sislation (thermo – foil). Foil should be taped and sealed. Poor condition.

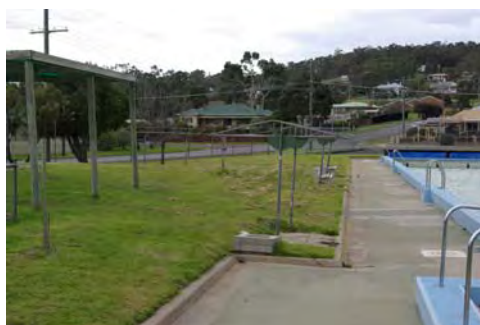
<b>Buildings – Sun shade structures</b>						
General visual condition <i>(see definitions below)</i>	Poor	<b>X</b>	Fair		Reasonable	Good
Comments: <ul style="list-style-type: none"> <li>• A number of steel framed structures – which consist of a stretched sun shade covers. All are not aesthetically pleasing to the eye and may create obstructions to view lines for staff to the pool and to patrons around the facility.</li> <li>• The size and location of these sun shade structures does not allow for localised public communal areas, rather segregated (localised) areas within the pool facility.</li> <li>• Main toddler’s pool sun shade in reasonable condition.</li> </ul>

- 20) Fixed sun shade structures – along pool concourse.
- 21) Main toddler’s pool – sun structure.

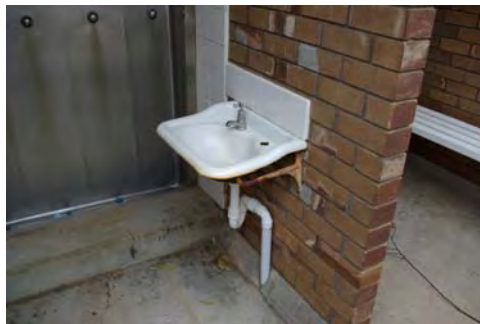
<b>Fixtures &amp; Fittings</b>						
General visual condition <i>(see definitions below)</i>	Poor	<b>X</b>	Fair		Reasonable	Good
Comments: <ul style="list-style-type: none"> <li>• Basins in change rooms – appear to be the original enamel basins. Poor condition. Recommend to be replaced with new. Basins are not BCA compliant for wheel chair access and located within ‘tight’ constraints adjacent to the urinals in the male change area. Wall mounted brackets – showing signs of rust.</li> <li>• Basin within first aid room – appears to be in good condition, with one tap fitting. Tap fitting should be replaced with WELS rated fitting. Basin doesn’t appear to have been used.</li> <li>• Tap fittings to basins – appear circa 1980’s. Should be replaced with water saving “AAA” of WELS rated fittings.</li> <li>• Shower rose in good condition to all showers – Council has already fitted a WELS rated shower rose. Tap fittings in fair condition, should be replaced with a “timed flow” push button device.</li> <li>• Could not locate a hot water unit for the change rooms – assumption is a cold water</li> </ul>

- 22) Typical wall mounted basin to all change rooms – wall brackets corroded.
- 23) Pool blanket – reasonable condition. Top coating of cover is breaking down with exposure.

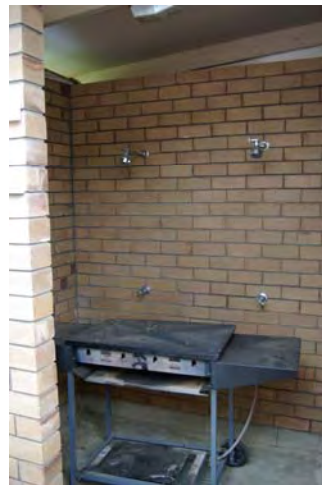
- 24) Pans – very narrow. Reasonable condition. Doors – corroded on frame.
- 25) Shower area – use of water saving shower rose – very tight in area – no partitions.

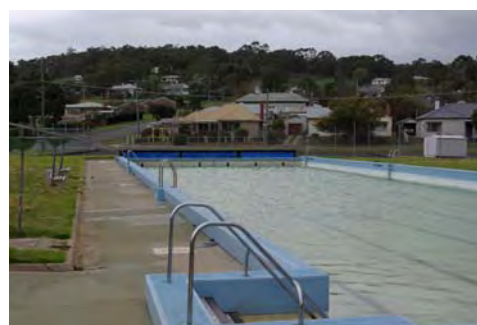
- 26) 50m pool – evidence of recent repairs to pool shell.
- 27) Main 50m pool in reasonable condition, including hand rails.

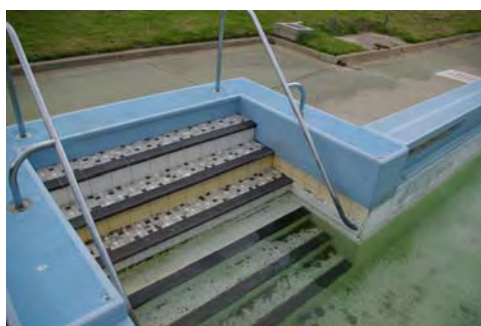
- 28) Steps into main pool – in good condition.
- 29) Main 50m pool in reasonable condition, evidence of more pool shell repairs.

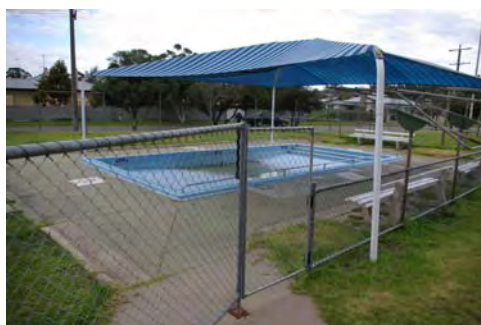
<b>Pool – Toddler’s pool</b>						
General visual condition <i>(see definitions below)</i>	Poor		Fair		Reasonable	Good <b>X</b>
Comments: <ul style="list-style-type: none"> <li>• Pool fence to toddler’s pool appears non compliant due to its height around the perimeter. Question to council – Why does the pool have an additional fence?</li> <li>• The pool appears to have been recently renovated with some type of fibreglass lining.</li> <li>• Depth and warning signage appears to be new but does not satisfy the RLSSA guidelines.</li> </ul>

- 30) Toddler's pool and pool fence. Fence in fair condition – probably not really required.
- 31) Toddler's pool with hand rail – could be deemed a tripping hazard and should be removed.

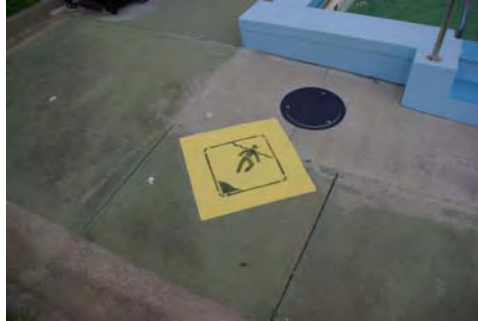
- 32) Signage to main pool concourse in fair condition.
- 33) Pool blankets – recommend being a minimum 1000mm further away from deep end for clear circulation.

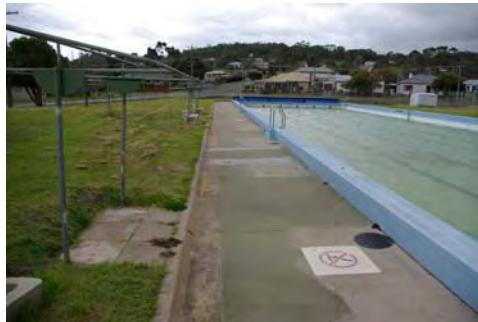
- 34) Main pool concourse in reasonable condition. Width complies with RLS minimum requirements.
- 35) Sections of the pool surface have been grinded, including around pit lids.

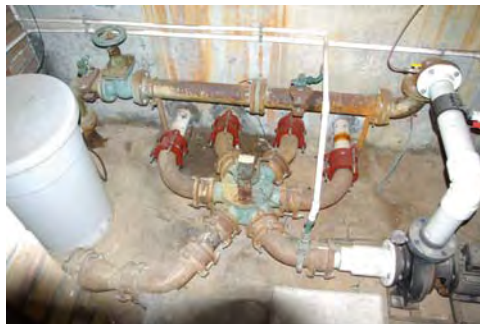
36) Typical pipe work condition.  
 37) External gravity sand filters in reasonable condition.

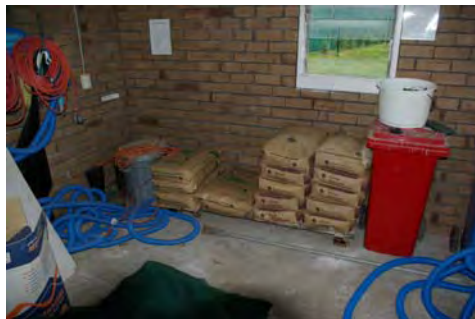
investigated. If they do not comply, the situation should be rectified immediately or the gas should be replaced with another form of chlorination.

38) Typical storage condition for pool chemicals – may be deemed dangerous.  
 39) Typical pipe work condition and filter.

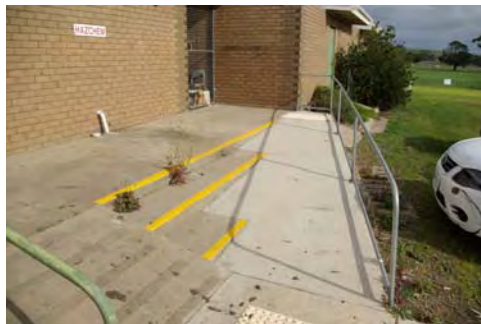
- Toilet cubicles not wide enough – recommend removing the brick work and replacing with nominal toilet partitions.
  - Ramp at entry not BCA (A/S 1428.1) compliant. Exposed steps to side of ramp are deemed a hazard and can be deemed a trip hazard.

- 40) Main entry – disabled ramp not compliant. Trip hazard evident and handrail not compliant.
- 41) Ground tactile indicators not installed as per AS 1428.4 .Tactile indicators face the wrong ramp.

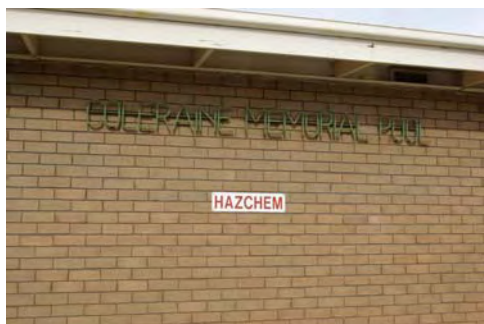
<b>Signage</b>						
General visual condition <i>(see definitions below)</i>	Poor	<b>X</b>	Fair		Reasonable	Good
<b>Comments:</b> <ul style="list-style-type: none"> <li>• Signage in fair condition. Recommend new signage around pool to comply with NARSSM.</li> <li>• Signage to entry – visible from entry, however not visible from rest of facility.</li> <li>• Amenity signage to change rooms and first aid room is in poor condition and does not comply with current regulations. All amenity signage is required to include Braille tactile.</li> <li>• No clear directional signage from the main road and at the site. Major sign at entry to pool is a HAZCHEM sign – ‘not inviting’.</li> </ul>

- 42) Main entry signage – not really inviting “HAZCHEM” versus Coleraine Swimming Pool
- 43) Directory signage to be replaced to comply with current requirements

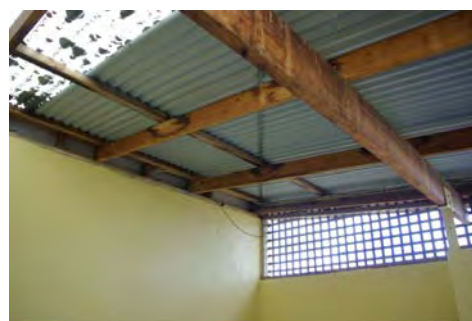
- 5) Change rooms – Typical layout in good condition – epoxy paint floor treatment and typical bench slat seating.
- 6) No insulation to roof.

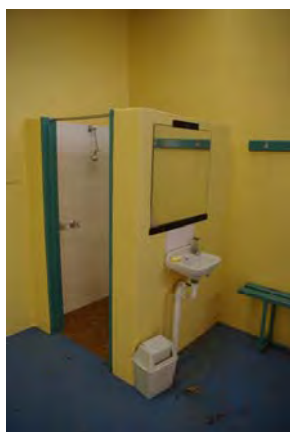
- 7) Showers too small to accommodate disabled requirements and BCA occupancy rates
- 8) Men's urinal in good condition.
- 9) Typical pan & toilet partition to change rooms.

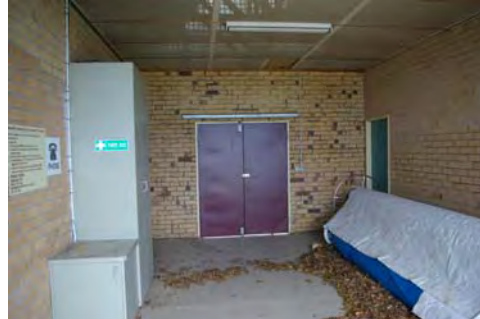
<b>Buildings – Entry &amp; First aid room</b>						
General visual condition (see definitions below)	Poor	<b>X</b>	Fair	Reasonable	Good	
<b>Comments:</b> <ul style="list-style-type: none"> <li>• No actual entry other than a fold down table.</li> <li>• No actual first aid room with the exception of a cupboard in the main entry. Not acceptable.</li> <li>• No privacy for patrons using this facility</li> <li>• No hands free basin or any sanitary fittings in close proximity other than the amenities.</li> <li>• Recommend to refurbish existing store room into first aid room.</li> </ul>

10) Main entry & first aid 'area' in large cup board – unacceptable. Exposed in main entry

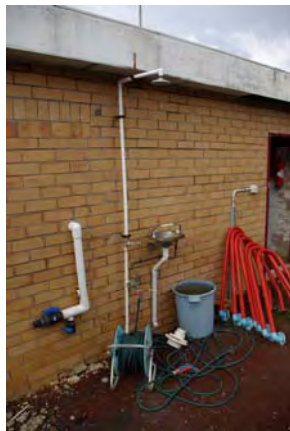
- 13) Safety shower and eye wash in close proximity to plant room entry – poor condition of roof
- 14) Gravity feed – sand filter in fair condition.

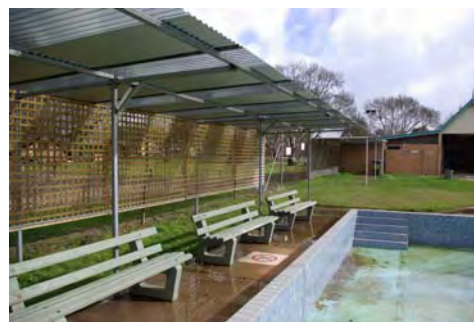
<b>Buildings – Sun shade structures</b>						
General visual condition (see definitions below)	Poor		Fair	<b>X</b>	Reasonable	Good
<b>Comments:</b> <ul style="list-style-type: none"> <li>There is no sun shading structure over the toddler’s pool.</li> <li>Main sun shade structure is located between the two pools and is in good condition and should remain.</li> <li>Perimeter sun shading to southern fence and adjacent to the toddler’s pool is not aesthetically pleasing and should be replaced with something more structurally sound and that could accommodate solar heating.</li> </ul>

- 15) Main sun shade structures to pool facility in good condition and should remain.
- 16) Light weight – southern perimeter shading – not aesthetically pleasing

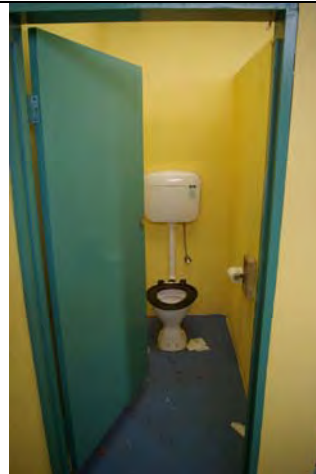
- 17) Water saving shower rose already installed. Showers in good condition – space restricted.
- 18) Typical pan and toilet partition. Note paper dispenser corroded.

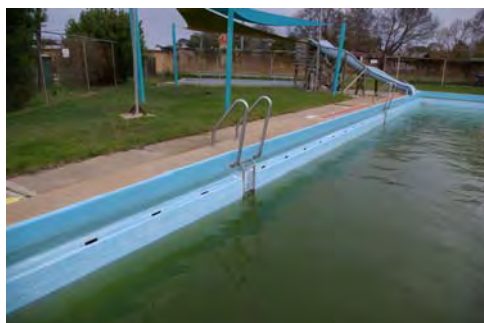
<b>Pool – Main pool</b>						
General visual condition (see definitions below)	Poor		Fair	<b>X</b>	Reasonable	Good
<i>Comments:</i>						
<ul style="list-style-type: none"> <li>• This pool is in fair condition and has no reported leaks.</li> <li>• The dry slide beside the main pool has a number of safety issues including sub-standard access and too high a delivery point to the pool because of the shallow water at that point. We recommend the slide be altered or removed.</li> <li>• Depth and warning signage is not up to RLSSA guidelines and should be upgraded.</li> <li>• Pool movement joints should be re-sealed.</li> <li>• There is evidence of expansion joints cracking and minor corrosion to exposed reinforcing to pool.</li> </ul>

- 21) Main 25m pool in good condition. Ladder access in good condition.
- 22) Main 25m pool – view over pool towards the change rooms.

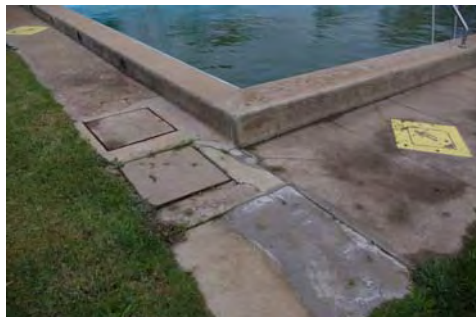
- 23) Pool signage in a poor condition. Recommend to be replaced. Pool concourse in poor condition at this corner.
- 24) Area adjacent to expansion joint where the reinforcing has been.

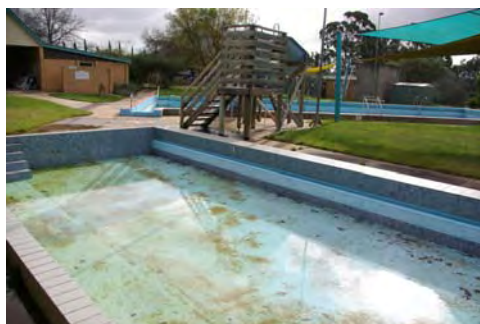
Pool – Toddler’s pool								
General visual condition (see definitions below)	Poor		Fair		Reasonable		Good	<b>X</b>
Comments: <ul style="list-style-type: none"> <li>• Pool appears in fair condition.</li> <li>• This small pool has been renovated</li> <li>• Depth and warning signage is not up to RLSSA &amp; NARSSM guidelines and should be upgraded.</li> <li>• No handrails at the steps. Handrails recommended at both ends of the pool</li> <li>• Wall tiling in a good condition. Requires general clean.</li> </ul>

- 25) Toddler's pool with step entry.
- 26) Minimal signage to around pool. Stair access requires handrails (to both ends of the pool).

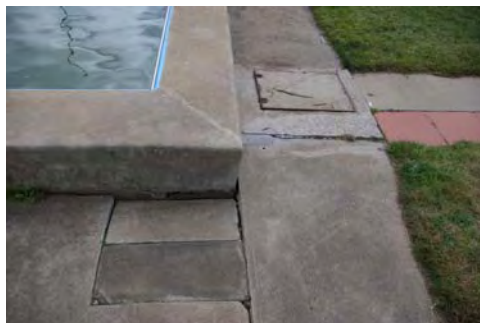
<b>Pool - Concourse</b>							
General visual condition (see definitions below)	Poor	<b>X</b>	Fair		Reasonable		Good
<p>Comments:</p> <ul style="list-style-type: none"> <li>• Main pool concourse is too narrow, approx 1200mm. This does not comply within RLS Facility Design section FD2.</li> <li>• Several sections of the paving surround the two pools show evidence of slip or settlement, as they have sunken from their original 'curing' location adjacent to the pool shell.</li> <li>• Concourse surrounding the toddlers pool not self draining – as evident in photo below.</li> <li>• Remove all seating off concourse – this restricted access and does not comply with RLS Facility design FD2</li> <li>• Pit lids appear in a reasonable condition.</li> <li>• Signage in a poor condition. Recommend new signage around pool to comply with NARSSM.</li> <li>• Concourse width around the toddler's pool is too narrow – 1000mm.</li> <li>• Paving from shallow pool to change rooms – gradient appears to comply with 1:20 fall.</li> <li>• Remove dry slide from concourse – this area of access is restricted (can not gain access to the main grassed / sun shade area directly from the change rooms; it restricts access directly around the pool). Recommended to be replaced with a new 'compliant' 'wet' slide and also located in a different location.</li> <li>• Access to dry slide not compliant due to high (ladder) step access and the slide does not overhang into the pool – also the drop is too high above the top of water line.</li> </ul>

- 27) Main path – grading to main pool concourse.
- 28) Section of pool concourse recently grinded to minimise trip hazards.

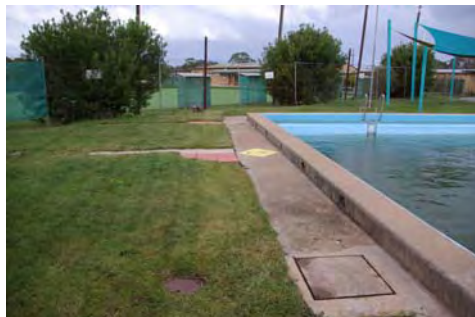
- 29) Existing light poles removed. Screened by seating. These areas restrict the pool concourse width.
- 30) Evidence of pool concourse cracking and expansion joint repairs.

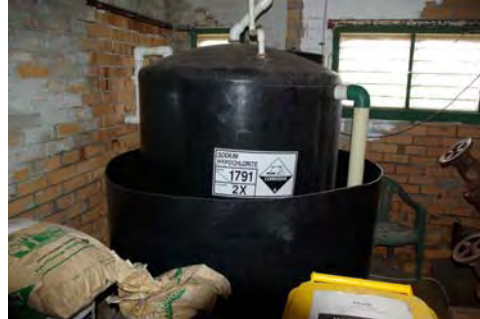
- 31) Hypo tank – restricted access around tank.
- 32) Additional chemical storage – directly adjacent to Hypo tank bund – not recommended.

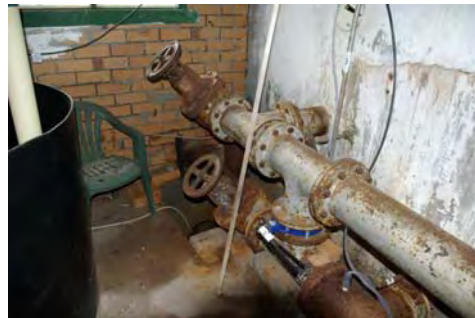
- 33) Typical condition of existing pipe work
- 34) Above ground – gravity fed sand filters – reasonable condition.

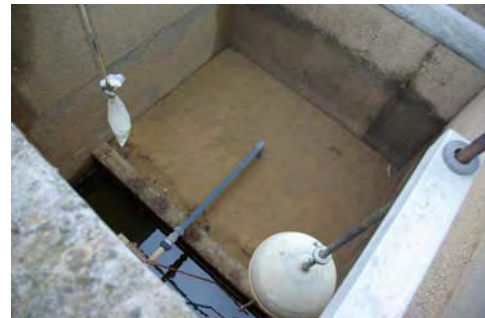
<b>Filtration Plant</b> (undertaken by David Powick & Associates)						
General visual condition (see definitions below)	Poor	<b>X</b>	Fair	<b>X</b>	Reasonable	Good
<b>Comments:</b>						
<ul style="list-style-type: none"> <li>• The gravity sand filter system is in need of renovation. It has a new pump and 1 new valve but requires further work. It should be re-furbished rather than replaced unless there are major issues with the cell structures.</li> <li>• The backwash routine requires manipulation of the float operated modulation valve to overfill the pool by around 300mm prior to backwashing as the balance tank appears to be too small to provide the necessary backwash water. We have not investigated this fully and rely on advice from the plant operator. This matter should be reviewed.</li> <li>• The bulk storage facility for the Sodium Hypochlorite is not up to standard and should be upgraded.</li> <li>• There is insufficient flow to the small pool and there may be a need to install a side stream pump to lift turnover rates to the small pool.</li> <li>• Automatic dosing control should be added – presently done by a test kit plus guesswork and this contravenes health regulations.</li> <li>• The Hypo pump is too high and as such presents an OH&amp;S issue. We presume the height is based on an attempt to stop syphoning, but this can be controlled by other means.</li> </ul>

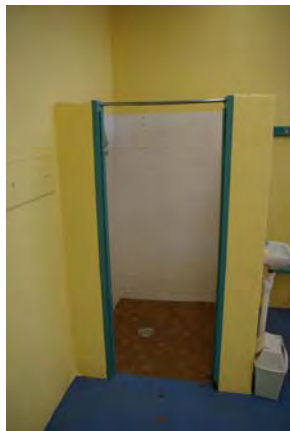
- 35) Restricted access into showers.
- 36) Basins not compliant for assisted access.

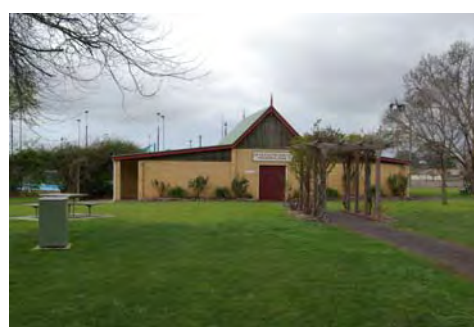
- 37) Signage to store room in a poor condition. Recommend to be replaced with new.
- 38) Main signage to entry of pool facility – directly visible from park only. No direct signage from street (highway).

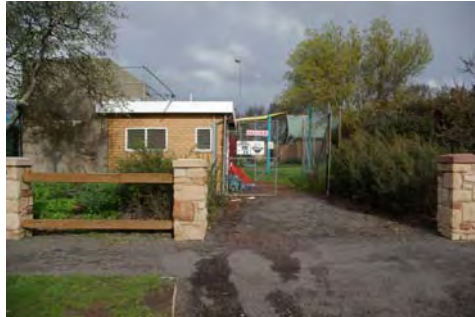
39) Main signage of pool from main highway – not inviting.

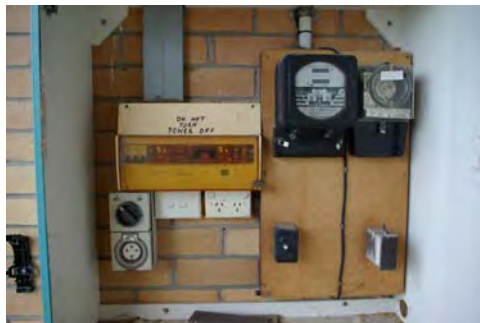
- On visual review of the electrical meter board and switch board located in the pool filtration plant room and the approximate age of the structure, it is very likely that asbestos may be located.

40) Backing to switchboard may contain asbestos.

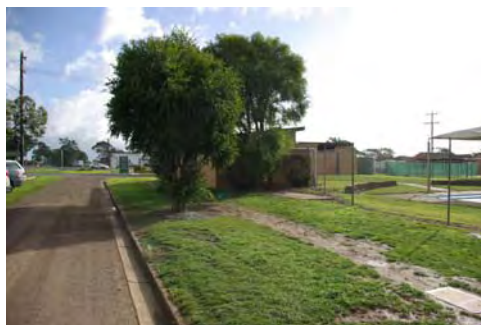
- 1) Main view from service road to main entry. No visible path to pool entry.
- 2) Adjacent Lions Club Park next to Glenthompson pool.

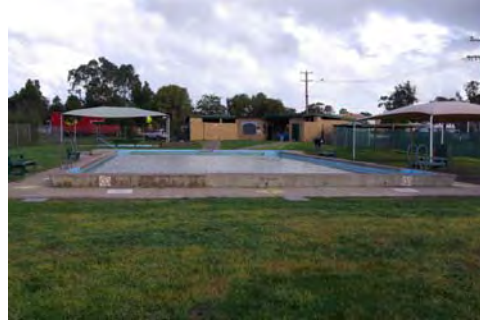
- 3) Main view from plant room to the rest of the swimming pool facility.
- 4) Southern view (from main entry) – overview of the 25m pool towards the plant room.

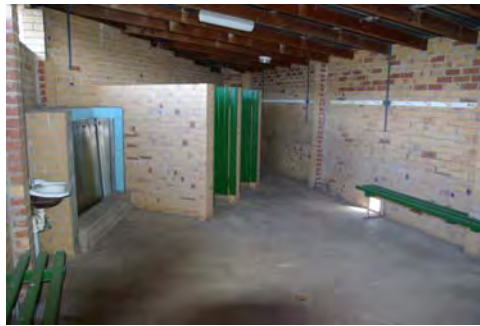
- 5) Change rooms – Male. Clean brickwork, exposed concrete slab and exposed roof (no insulation)
- 6) Corroded urinal and high step. Step is not BCA compliant.

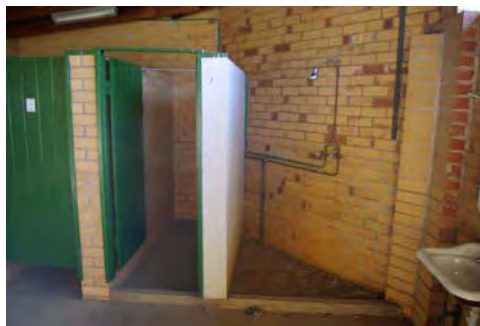
- 7) Female change – very restricted showers (with step).
- 8) Female Change rooms – very similar to male change. Very basic finishes.

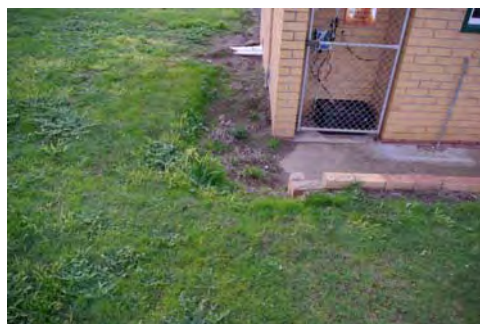
- 11) Pool plant room – main access from pool grounds and plant room. Sloped ground and no clear path from pool.
- 12) Pool plant room – with external sand filters, and main gate access.

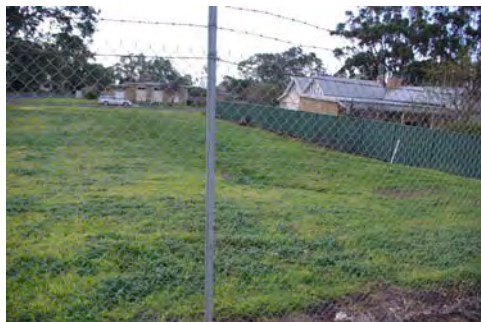
- 13) Main plant room access driveway (the raised grassed area).

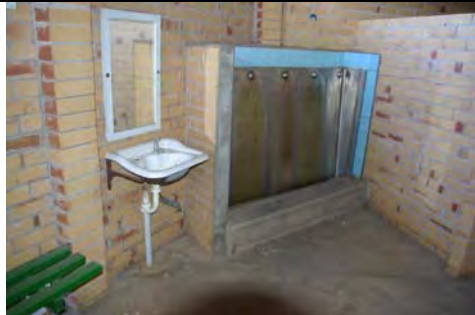
- 16) Corroded men's urinal and original cast iron / enamel basin (basins typical to both change rooms)
- 17) Gas hot water unit – not sure on its condition. General appearance – reasonable.

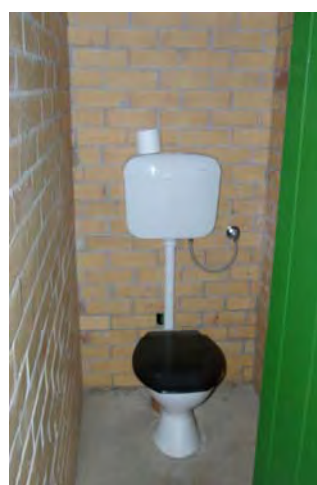
- 18) Showers to both change rooms – poor condition. Both not BCA compliant and no disabled access.
- 19) Typical pans with new cisterns.

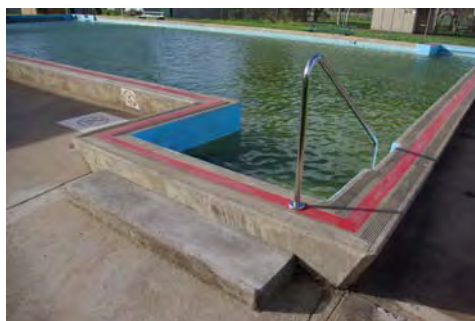
- Painted concrete pool shell appears in good condition. There is no reported leakage from this pool.
- Main pool concourse too narrow, approx 1500mm. A large section of the concourse has been reinstated – possibly due to settlement.
- Pool ladders appear in good condition.
- No disability access into the pools.
- Depth and warning signage does not comply with RLSSA recommendations and should be upgraded.
- Handrails are fitted but should be of more modern design recognising the step edge and extending back to be within reach of those using the concourse step.

- 20) Main 25m pool in good condition. Handrail to main steps compliant.
- 21) Main 25m pool – signage around pool – reasonable condition. Recommend to be upgraded

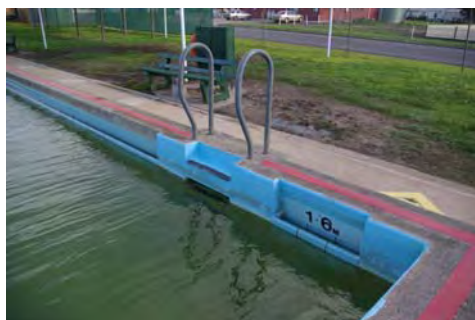
- 22) Clear pool signage. Step ladder appears in good condition.
- 23) Deep end to pool and hand rail – in good condition. Pool shell has held water (minimal water lost).

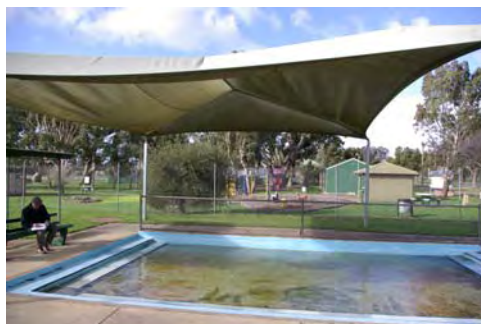
Pool – Toddler’s pool							
General visual condition (see definitions below)	Poor		Fair	<b>X</b>	Reasonable		Good
<b>Comments:</b> <ul style="list-style-type: none"> <li>• Pool appears in fair condition.</li> <li>• This pool appears to have water overflow outlets at the corners of the internal steps making a very shallow pool. The outlet covers appear loose and present a sharp edge that could cause cuts and other injuries.</li> <li>• There are no depth or warning signs in or around this pool. This matter should be addressed.</li> </ul>

24) Toddler's pool with step entry.  
25) Minimal signage to around pool.

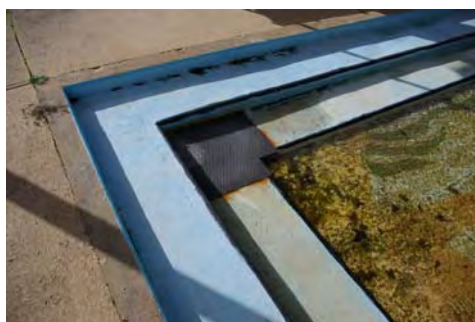
26) Grate plates – corroded. May create trip hazard.  
27) Corroded plates to overflow grate to toddler's pool.

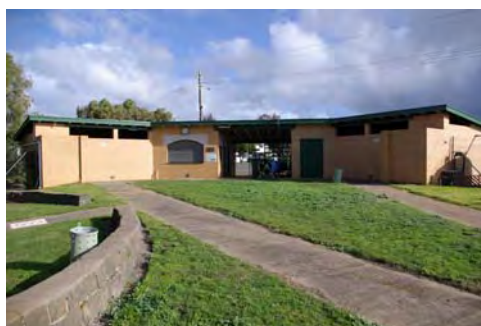
<b>Pool - concourse</b>							
General visual condition (see definitions below)	Poor		Fair	<b>X</b>	Reasonable		Good
<p>Comments:</p> <ul style="list-style-type: none"> <li>• Main pool concourse too narrow, approx 1500mm. This does not comply within RLS Facility Design section FD2.</li> <li>• Several sections of the paving surrounding the two pools show evidence of slip or settlement, as they have sunken from their original 'curing' location adjacent to the pool shell.</li> <li>• Several expansion joints on the concourse have been recently grinded to minimise trip hazards.</li> <li>• Pit lids appear in reasonable condition.</li> <li>• Signage in fair condition. Recommend new signage around pool to comply with NARSSM.</li> <li>• Concourse width around the toddler's pool is too narrow – 1200mm.</li> <li>• Paving from change rooms to main pools in reasonable condition. Gradient appears compliant to a 1:20 fall (BCA &amp; AS 1428.1 compliant).</li> <li>• Light tower bases should be removed and capped off at ground level and not 300mm above creating a trip hazard.</li> <li>• Seating to concourse - recommended to be replaced with new.</li> </ul>

- 28) Main path – grading to main pool concourse.
- 29) Section of pool concourse recently grinded to minimise trip hazards.

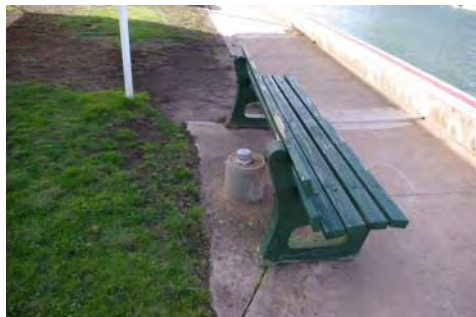
- 30) Existing light poles removed. Screened by seating. These areas restrict the pool concourse width.
- 31) Evidence of pool concourse cracking and expansion joint repairs.

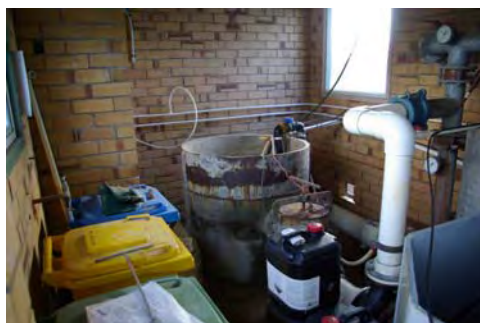
<b>Filtration Plant</b> (undertaken by David Powick & Associates)							
General visual condition (see definitions below)	Poor		Fair	<b>X</b>	Reasonable		Good
<b>Comments:</b> <ul style="list-style-type: none"> <li>The bulk storage tank for the liquid chlorine sits in a chipboard bund partly over pipe work and a pump. This bund is of no benefit at all as it could not withstand a collapse of the Hypo tank and it is too close to the Hypo tank to contain outflow from any penetration type failure. The tank should be re-positioned in a new enclosure in a bund that complies with current regulations.</li> <li>There is no automated control of water chemistry and this contravenes health department regulations. Automatic controllers should be fitted.</li> <li>There appears to be inadequate flow to the toddler's pool. Provision to adjust the flow is not apparent and this should be addressed.</li> <li>The pump and hair and lint strainer should be replaced in the short term.</li> </ul>

- 32) Pool Filtration plant – typical chemical storage area and sump.
- 33) Main pool filter with main pump (notice half the pump is located under 'hypo – tank').

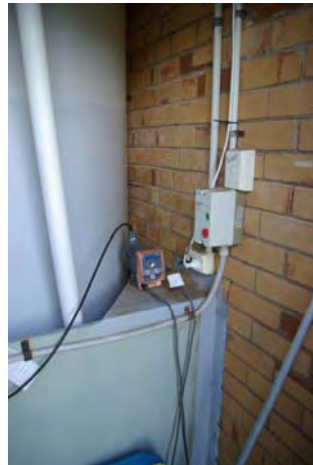
- 34) Hypo tank – close proximity to electrical switch / circuits illegal, including chlorine pump.
- 35) Hypo – tank bund – consists of 18mm plywood with fibre-glass resin (with no base) – not compliant and illegal. Not Safe.
- 36) Hypo-chloride supply tap to tank located adjacent to sand filter.

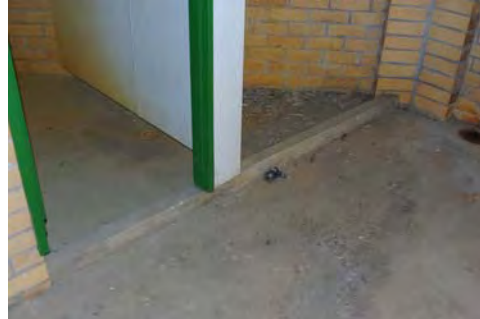
Access conditions - Disability					
General visual condition (see definitions below)	Poor	<b>X</b>	Fair	Reasonable	Good
Comments: <ul style="list-style-type: none"> <li>• No disabled / assisted facilities are located within the facility.</li> <li>• No disabled designated car park.</li> <li>• No paved pathway from the car park to the pool facility.</li> <li>• Pathway within the change rooms and entry is too narrow. This path should be at least 1500mm wide to allow for minimum 2 way pedestrian traffic.</li> <li>• All amenity and directory signage to comply with relevant codes.</li> <li>• No disabled access into the pools.</li> <li>• No disabled access into the first aid room.</li> <li>• Toilet cubicles not wide enough – recommend removing the brick work and replacing with nominal toilet partitions.</li> <li>• Door hardware to change rooms not disabled compliant (with removal hinges, indicator bolts, self closers, door handles).</li> </ul>

- 37) Restricted access to showers – remove step.
- 38) Change area large enough to allow for refurbishment and disabled compliance.

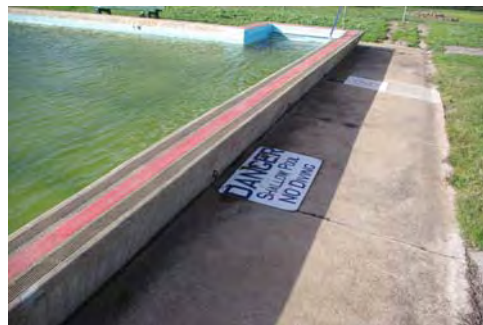
<b>Signage</b>						
General visual condition (see definitions below)	Poor	<b>X</b>	Fair	Reasonable	Good	
<b>Comments:</b> <ul style="list-style-type: none"> <li>• Typical entry signage – not clearly visible from street. HAZCHEM signage very prominent – not inviting.</li> <li>• No clear signage – stating first aid room.</li> <li>• Signage in fair condition. Recommend new signage around pools to comply with NARSSM.</li> <li>• Amenity signage to change rooms and first aid room is in a poor condition and does not comply with current regulations. All amenity signage is required to include Braille tactile.</li> <li>• Warning / HAZCHEM signage to plant room in a fair condition. Recommend new.</li> </ul>

- 39) Signage to store room in a poor condition. Recommend to be replaced with new.
- 40) Signage to change rooms in a poor condition.

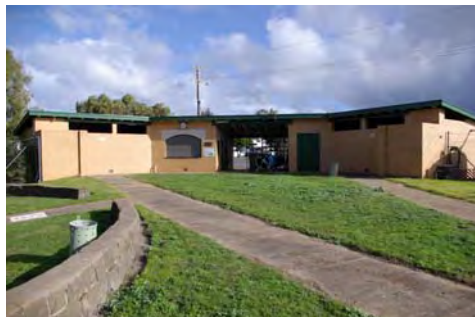
41) Signage to change rooms in poor condition.

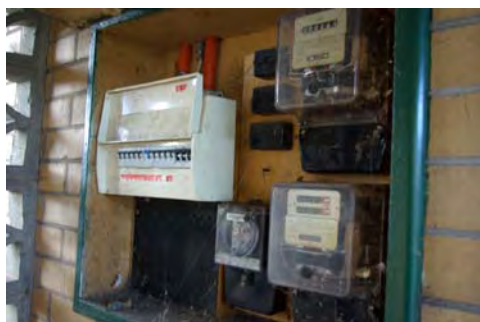
- On visual review of the electrical meter board and switch board located in the pool entry and the approximate age of the structure, it is very likely that asbestos may be located.

42) Main switch board and meter board backing may contain asbestos.

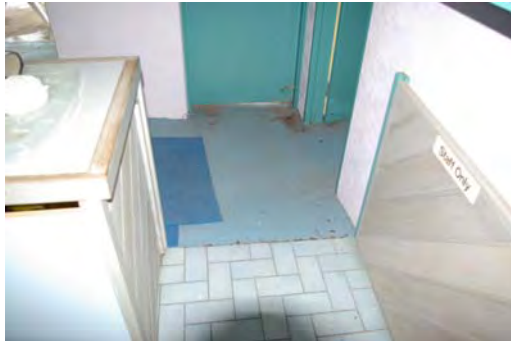
- 5) Floor into change rooms, dangerous, too steep and no colour variance. (typical to both)
- 6) Female Change room – typical view showing 'private change areas and slat bench seating.

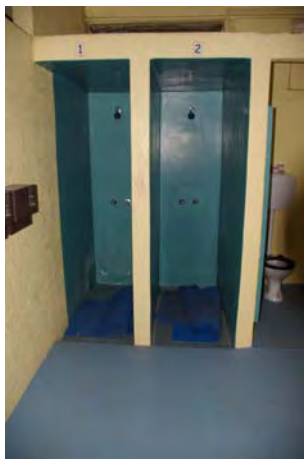
- 7) Typical showers – no door and too narrow
- 8) Exposed hot water unit in both change rooms – may be deemed dangerous
- 9) Typical change room entry – note cannot really see variance in floor slope.

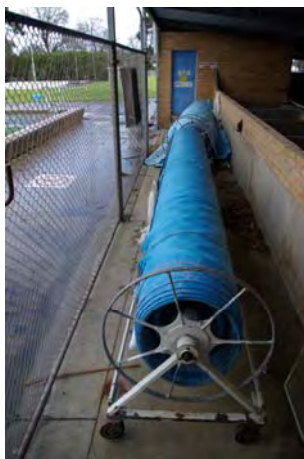
- 17) Pool blankets appear in a reasonable condition
- 18) Timber access steps – reasonable condition – poor design and construction.
- 19) Plant room switch board appears in good condition.

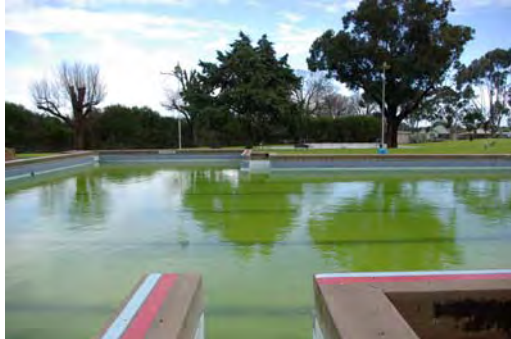
- 31) Hand rails required to steps.
- 32) The 50m pool with plant room in the back ground.

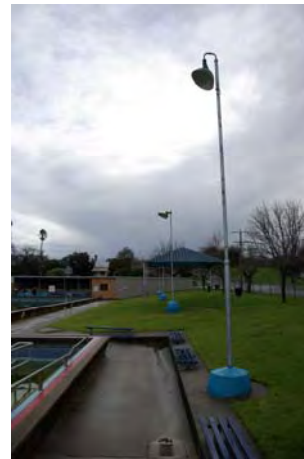
- 43) Main pool concourse in reasonable condition. Width complies with RLS minimum requirements
- 44) Pool lighting in poor condition.

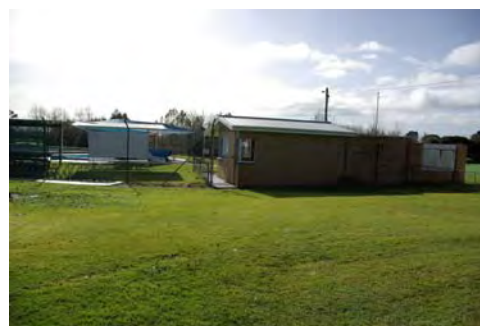
- 1) Penshurst pool – open parkland adjacent to swimming pool site (view from car park).
- 2) Main entry to pool – no clear signage or direct path from main car park.

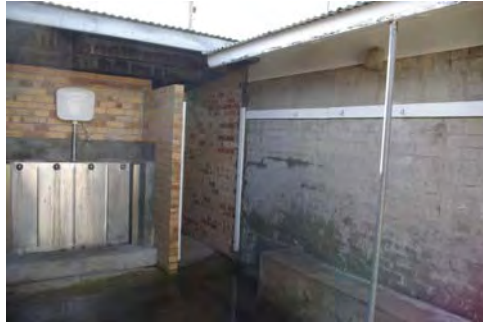
- 5) Change rooms – mixture of clean and rendered brickwork.
- 6) Concrete seating and exposed concrete slab.

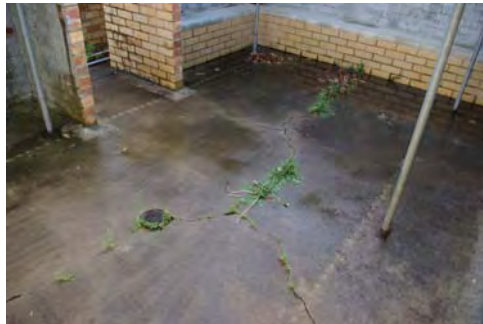
- 7) Concrete flooring to female change – cracked. Potential structural cracking and settlement to slab.
- 8) Corroded steel lintel and damaged lighting.

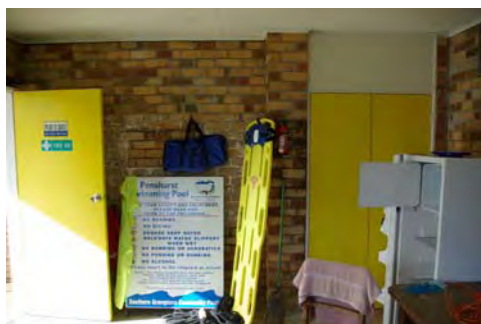
- 9) Main entry / office/ first aid room & Kiosk? Internally not well labelled.
- 10) External access to main office. No signage stating first aid (other than door – when closed (see above image)

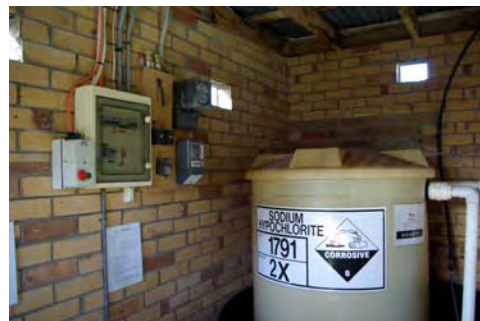
- 11) Pool plant room – with external sand filters.
- 12) Pool plant rooms internally with Hypo tank.

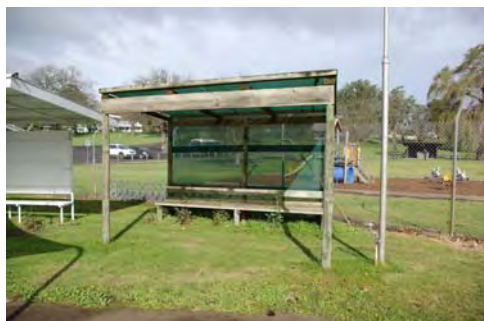
<b>Buildings – Sun shade structures</b>						
General visual condition (see definitions below)	Poor		Fair	<b>X</b>	Reasonable	Good
<b>Comments:</b> <ul style="list-style-type: none"> <li>• Main toddler’s pool sun shade in reasonable condition. Fabric cover appears stretched and has sagged over time – recommend to be replaced.</li> <li>• Steel structure.</li> <li>• Main fixed sun shade structure is a mixture of steel and timber framed with a fixed metal sheet roof. Overall in a fair condition, however not aesthetically pleasing. Recommend to be replaced.</li> </ul>

- 13) Fixed timber sun shade structures adjacent to pools – poor condition. Look ugly.
- 14) Sun shade structure to toddler’s pool.

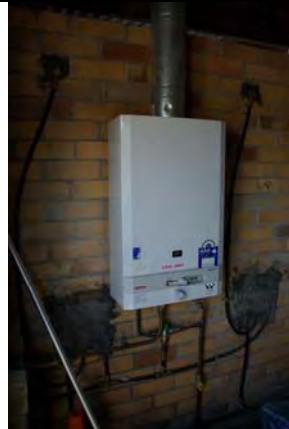
- 17) Gas hot water unit – good condition.
- 18) Boiling water unit – adjacent to sink and joinery unit.

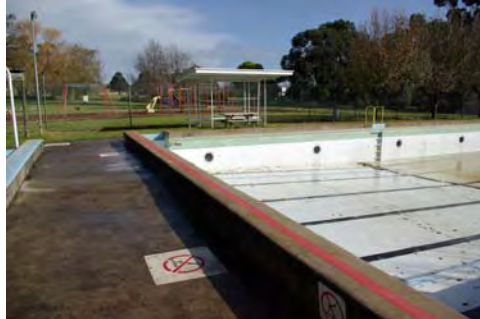
- 19) Main 25m pool – signage around pool – reasonable condition. Recommend to be upgraded.
- 20) Pool evident of leaking.

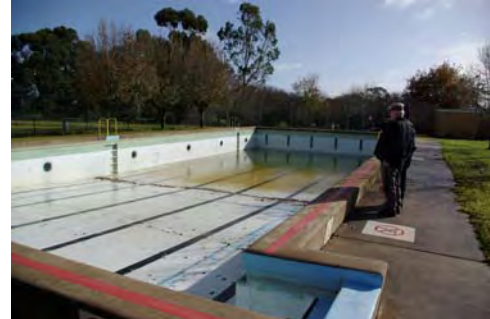
Pool – main pool						
General visual condition (see definitions below)	Poor	<b>X</b>	Fair	Reasonable	Good	
Comments: <ul style="list-style-type: none"> <li>Painted concrete pool shell appears in fair condition. Council representatives have confirmed that the pool is leaking. (evident by the amount of water ‘not’ residing in the pool compared to the other council outdoor pools).</li> <li>Main pool concourse is too narrow, approx 1800mm. A large section of the concourse has been reinstated – possibly due to settlement.</li> <li>Pool ladders appear in fair condition – bases of the ladders are corroded.</li> <li>No disability access into the pools.</li> <li>No handrail to steps from pool.</li> <li>Signage in a reasonable condition.</li> <li>The main pool has been reported as leaking significantly. Apart from this, the structure is in good condition. It shouldn’t be assumed that the leakage comes from the structure as the most likely point of leakage will be pipe work.</li> <li>In any event, repair of the leakage is the main priority for this pool facility.</li> <li>The glass portholes housing lights should be filled-in if the opportunity presents itself as they don’t work and may only offer an opportunity for water loss.</li> <li>The depth and warning signage should be upgraded as it does not comply with RLSSA guidelines.</li> <li>External steps should be provided at the back of the entry steps to facilitate access to the pool as the step up to the beam around the perimeter of the pool is too high.</li> </ul>

- This swimming pool should not be reopened until tank replacement and major works are completed due to the following reasons:
  - The 25m pool shell is leaking and will require major capital works.

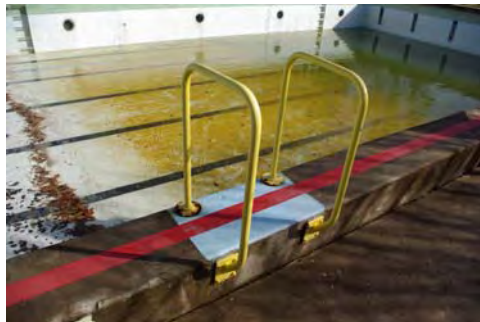
- 21) Access ladders – corroded at base. Recommend to be replaced with new.
- 22) No handrail to narrow steps

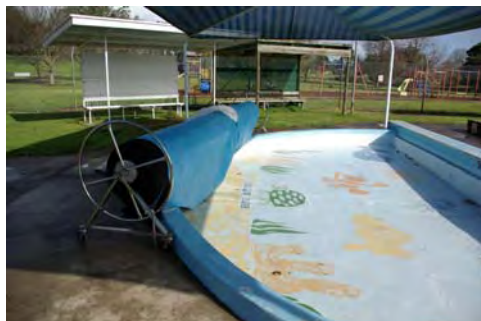
- 23) Toddler's pool with main pool solar blanket
- 24) Minimal signage to pool.

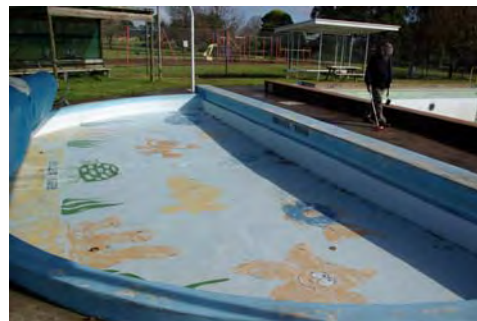
<b>Pool – Toddler’s pool</b>							
General visual condition (see definitions below)	Poor		Fair	<b>X</b>	Reasonable		Good
<b>Comments:</b> <ul style="list-style-type: none"> <li>Pool appears in fair condition.</li> <li>The depth and warning signage should be upgraded as it does not comply with RLSSA guidelines. Note that the toddler’s pool has no visible depth markings at all.</li> <li>A separation barrier should be installed between the main and toddler’s pools to restrict access by toddlers to the deep water in the main pool.</li> <li>The toddler’s pool should have an internal step to facilitate access by small children. This should be supplemented by the addition of a rail at the step entry.</li> </ul>
