## Aquatic Development Strategy

## Volume 1: Technical Assessments & Probable Capitals Costs

## Site Investigation Report

Site:	<b>Balmoral &amp; District Swimming Pool</b>	Date visited:	30 <sup>th</sup> June 2009 PRELIMINARY ISSUE
Project:	South Grampians Council – Aquatic Facility Development Strategy	Project No:	EJ-0763
Client:	Southern Grampians Shire Council	Representative:	Mr Craig Halley
Investigation undertaken by:	Sean Stone Mike Pettigrew	Company:	Etch Architectural Solutions David Powick & Associates
Copies to:	Steve Pallas	Company:	@Leisure
Weather Conditions:	Overcast conditions, high winds and frequent showers. Cold.		
Pages	<b>15 (including this page)</b>

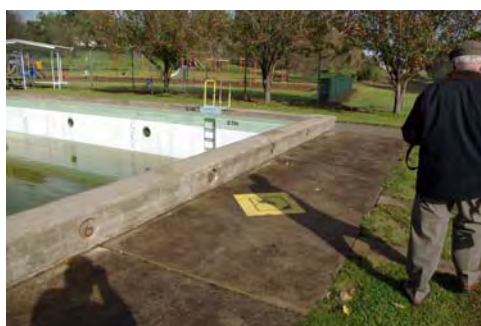
<b>Pool - Concourse</b>						
General visual condition (see definitions below)	Poor		Fair	<b>X</b>	Reasonable	Good
<b>Comments:</b> <ul style="list-style-type: none"> <li>Main pool concourse is too narrow, approx 1800mm. This does not comply within RLS Facility Design section FD2.</li> <li>A large section of the concourse has been reinstated – possibly due to settlement.</li> <li>Several sections of the paving surrounding the two pools show evidence of slip or settlement, as they have sunken from their original 'curing' location adjacent to the pool shell.</li> <li>Pit lids appear in reasonable condition.</li> <li>Signage in fair condition. Recommend new signage around pool to comply with NARSSM.</li> <li>Concourse width around the toddler's pool is too narrow – 1200mm.</li> <li>Paving from shallow pool to change rooms – gradient is too steep to comply for disability access.</li> </ul>

- 25) Typical signage around pool. Portion of this concourse has settled 'down' from main pool.
- 26) Section of pool concourse replaced with new (very recently).

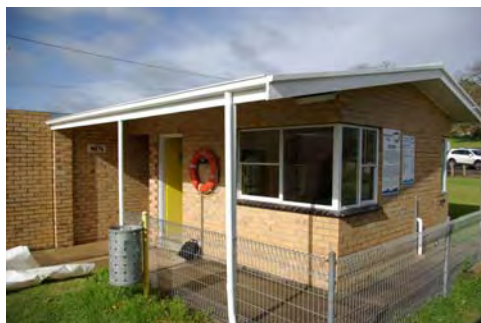
General visual condition (see definitions below)	Poor	<b>X</b>	Fair	Reasonable	Good
<p><b>Comments:</b></p> <ul style="list-style-type: none"> <li>• No disabled / assisted facilities are located within the facility.</li> <li>• No disabled designated car park.</li> <li>• No paved pathway from the car park to the pool facility</li> <li>• Entry too narrow to service wheel chair access.</li> <li>• Pathway within the change rooms and entry is too narrow. This path should be at least 1500mm wide to allow for minimum two-way pedestrian traffic.</li> <li>• No ground tactile indicators to all steps and ramps above water line of pools.</li> <li>• All amenity and directory signage to comply with relevant codes.</li> <li>• No disabled access into the pools.</li> <li>• No disabled access into the first aid room due to the steps and door width.</li> <li>• Toilet cubicles not wide enough – recommend removing the brick work and replacing with nominal toilet partitions.</li> <li>• Door hardware to change rooms not disabled compliant (with removable hinges, indicator bolts, self closers, door handles).</li> <li>• Main step from pool concourse to pool – too high (over 200mm). Not BCA compliant (maximum height for a riser is 190mm).</li> <li>• No handrail from main pool steps.</li> </ul>

- 31) Restricted access adjacent to entry – too narrow for wheel chair or two-way pedestrian access.
- 32) Pavement from toddler’s pool to change rooms too steep as gradient appears excessive to BCA.

- All signage – as noted in the above section should be refurbished.
- All disability compliance issues as briefly noted in the above section should be undertaken as part of a capital works program – if this pool is to remain open.

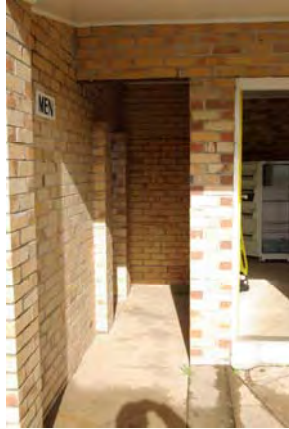
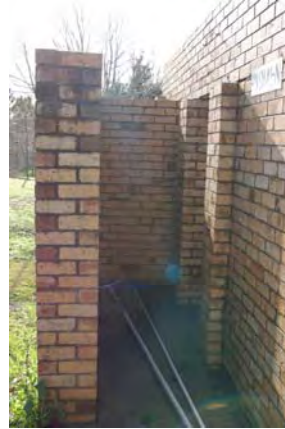
33) Access width to both Male & Female Change rooms – too narrow. Does not comply with BCA or AS 1428.1 (door width and door landings)

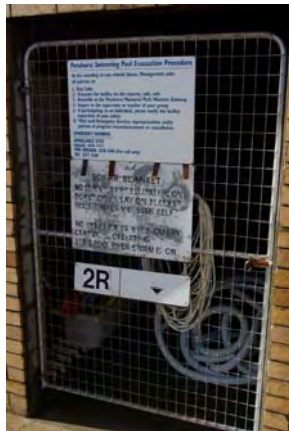
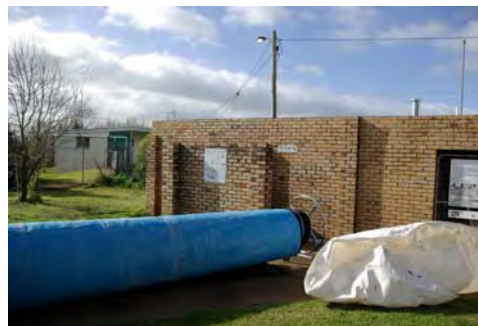
Signage						
General visual condition (see definitions below)	Poor	<b>X</b>	Fair	Reasonable	Good	
<b>Comments:</b> <ul style="list-style-type: none"> <li>No clear directional signage from the main road and at the site.</li> <li>Signage in a fair condition. Recommend new signage around pools to comply with NARSSM.</li> <li>Amenity signage to change rooms and first aid room is in a poor condition and does not comply with current regulations. All amenity signage is required to include Braille tactile.</li> <li>Warning / HAZCHEM signage to plant room in fair condition. Recommend new.</li> </ul>

34) Signage to store room in poor condition. Recommend to be replaced with new.

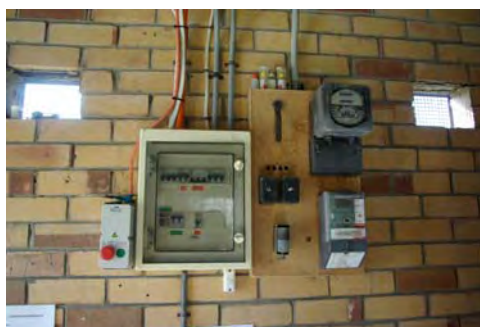
- On visual review of the electrical meter board and switch board located in the pool filtration plant room and the approximate age of the structure, it is very likely that asbestos may be located.

36) *Electrical switch / meter board may contain traces of asbestos.*
