# Risk Assessment

Closed Landfills  
Southern Grampians  
Shire

Barwon South West  
Waste and Resource  
Recovery Group

February 2020

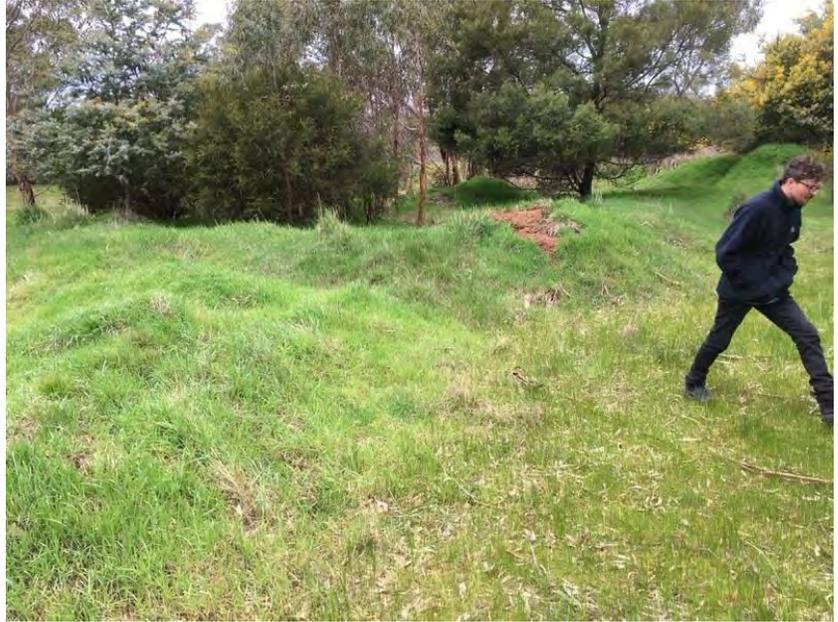
Mounded soil (road cuttings?) at northwestern side of site

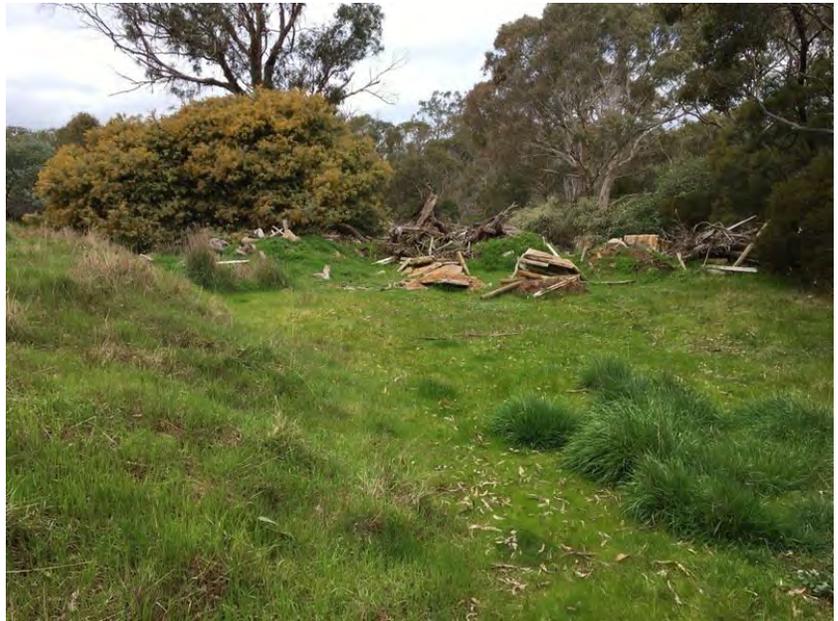
Concrete waste on western side of site

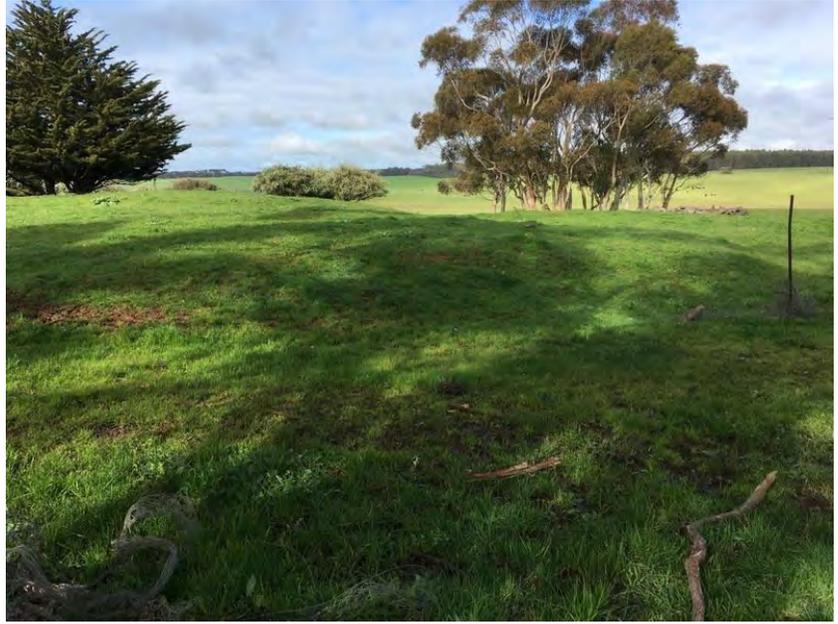
Mounding in centre of site

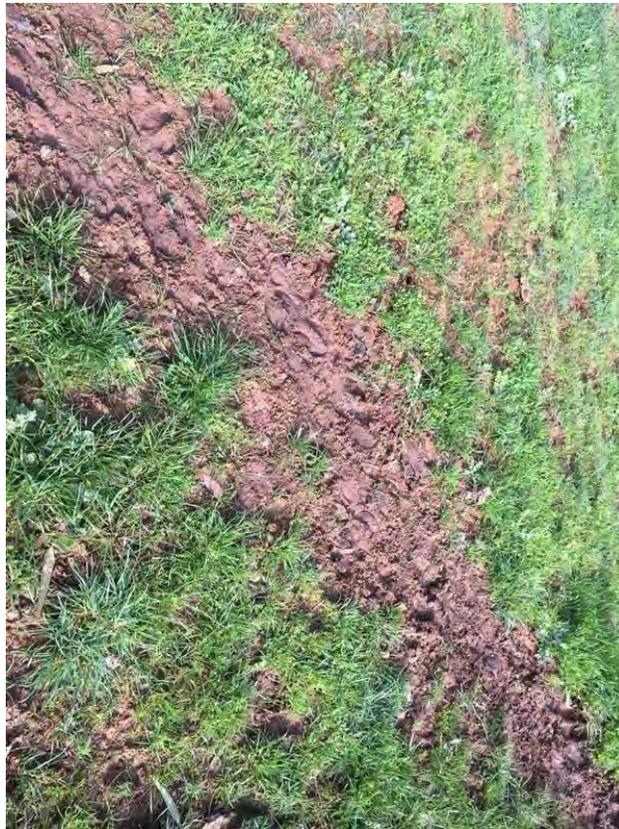
Clayey soil cover exposed by cattle track

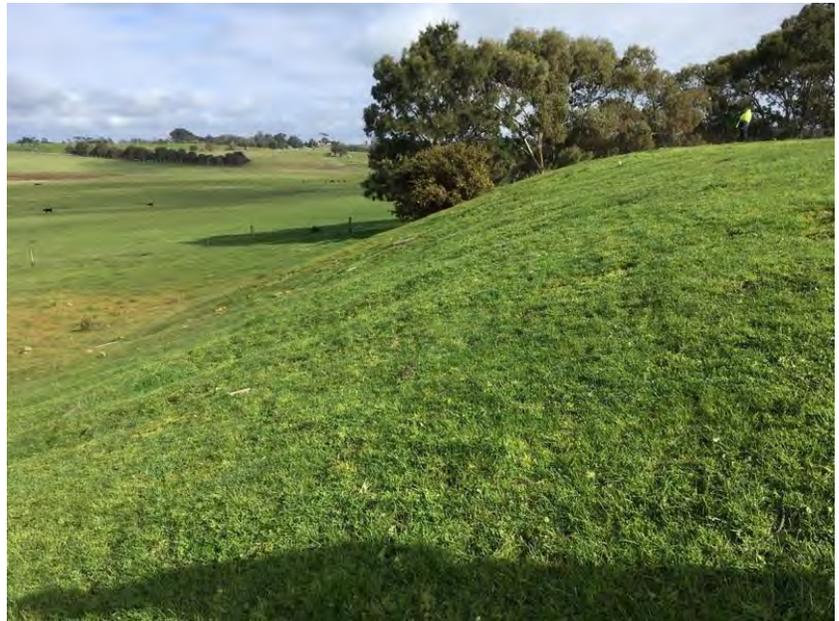
Southwestern embankment - encroached onto adjacent land

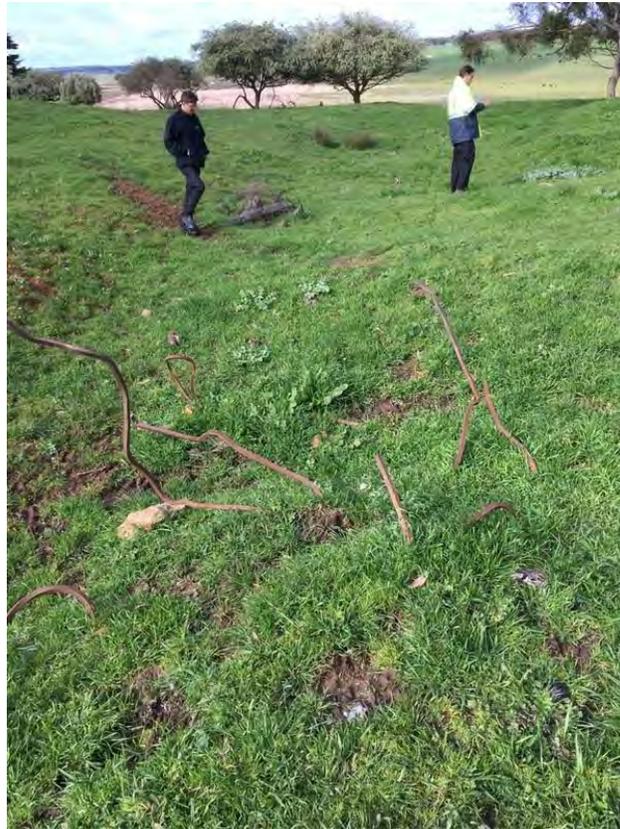
Protruding waste at low point in centre of site

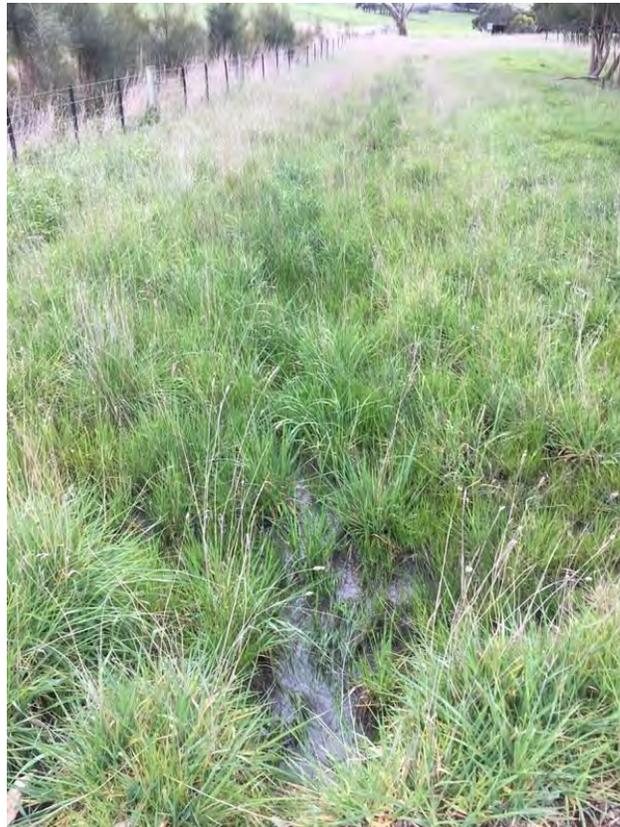
Flowing swale drain (diverted creek?) along northeastern edge of eastern portion of site

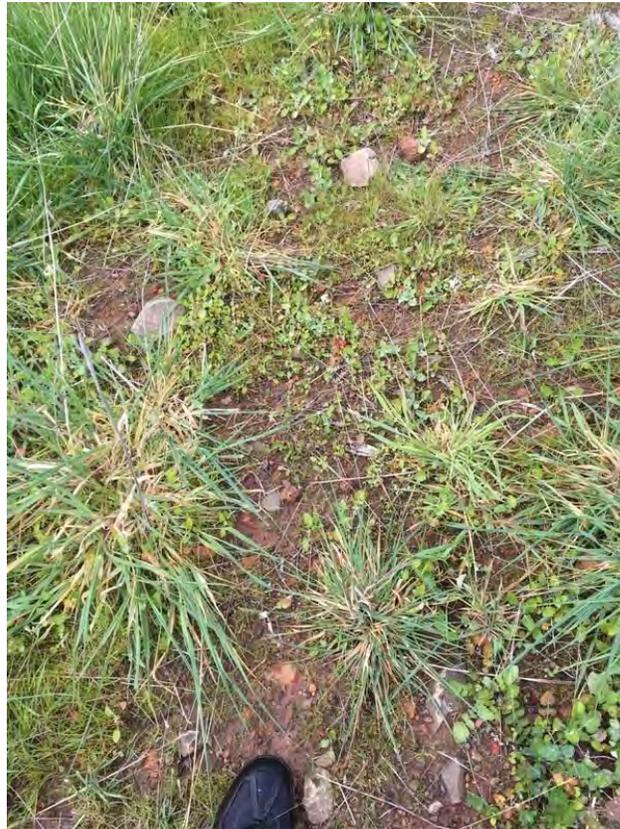
Gravelly soil cover on western side (older portion) of site

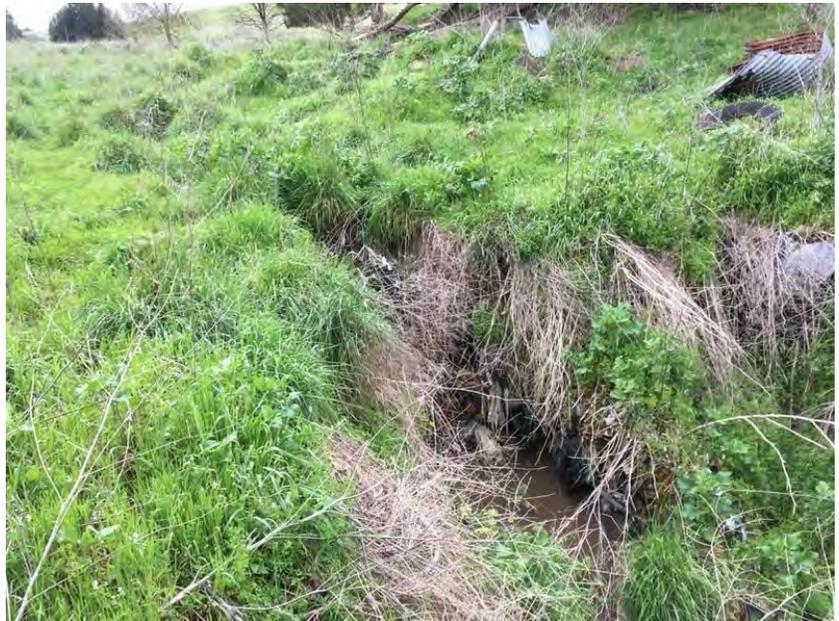
Flow through eroded waste at western portion of site

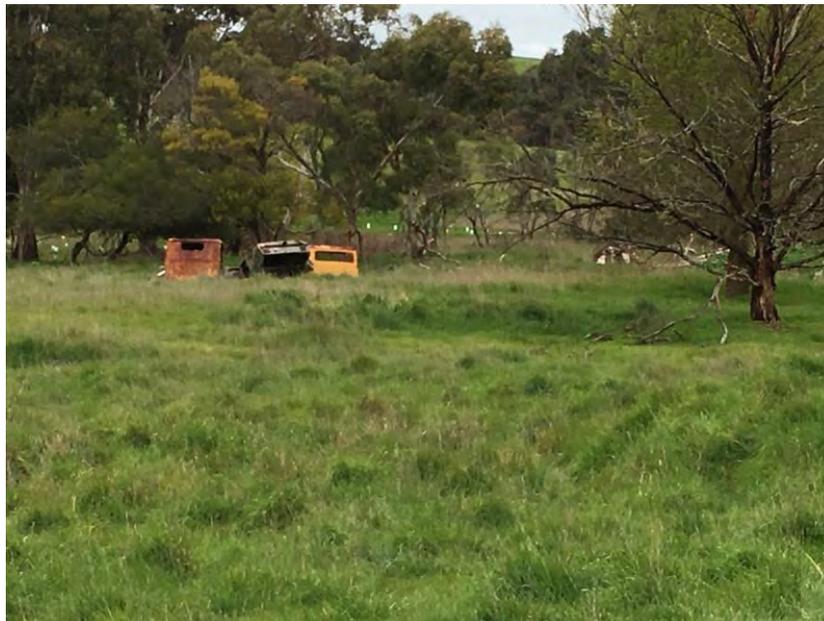
Car bodies at eastern portion of site

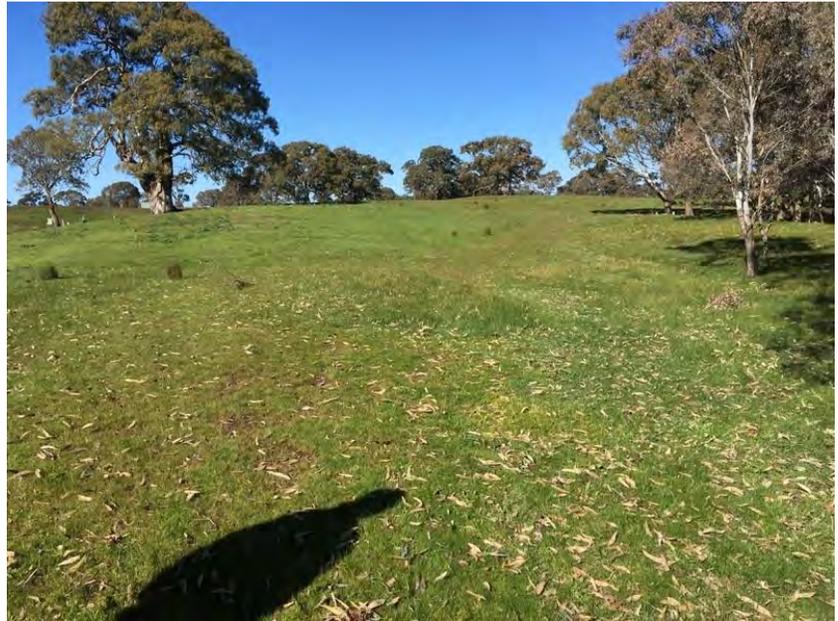
View south from northern site boundary - mounding

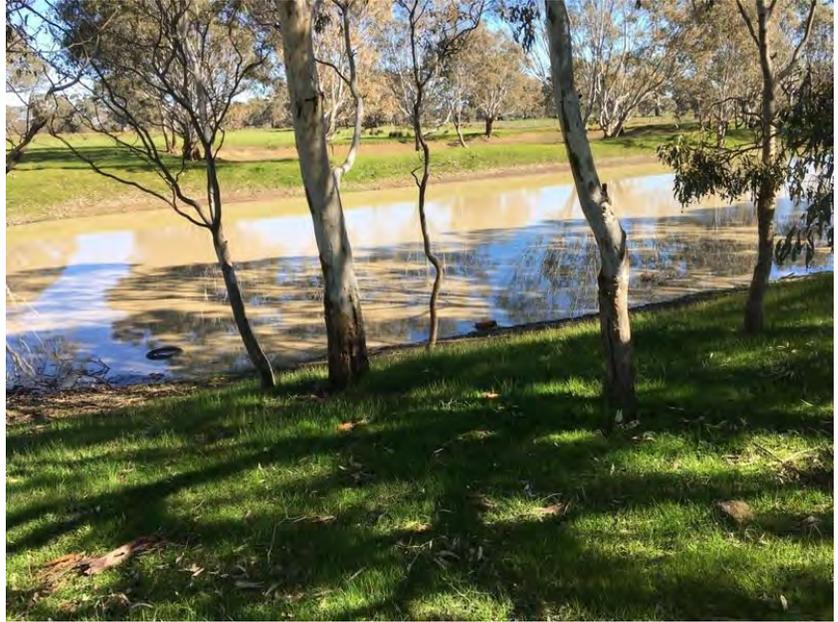
Dams at northwestern edge of landfill area

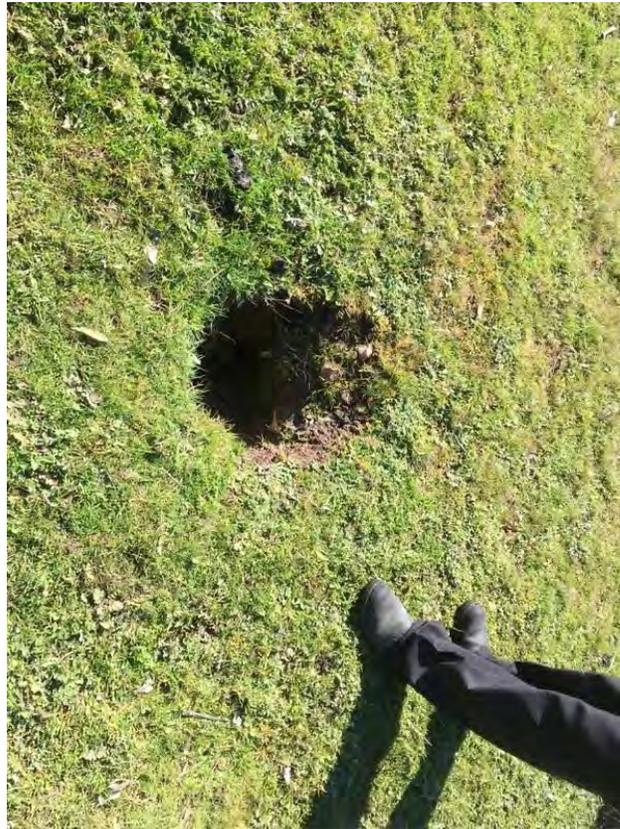
Opening on southern mound

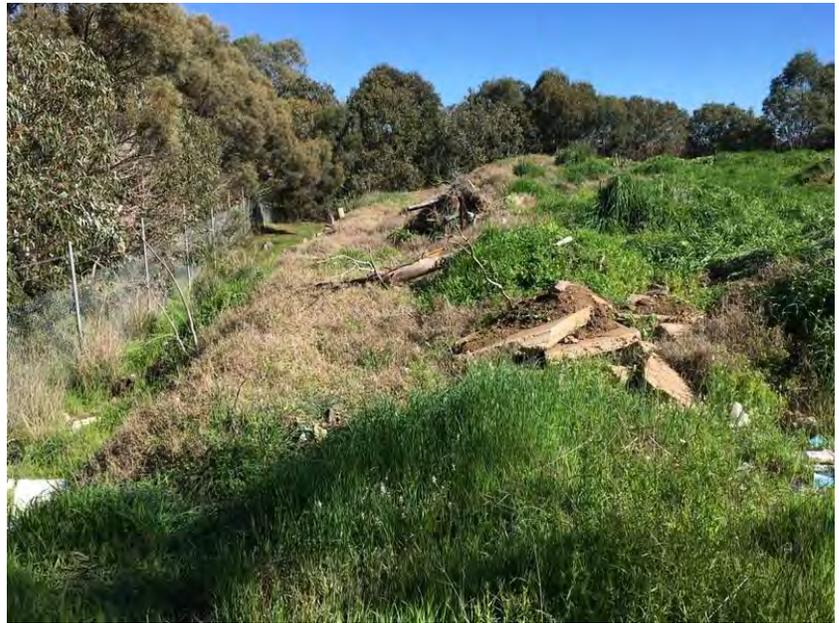
Southwest corner of site - view west

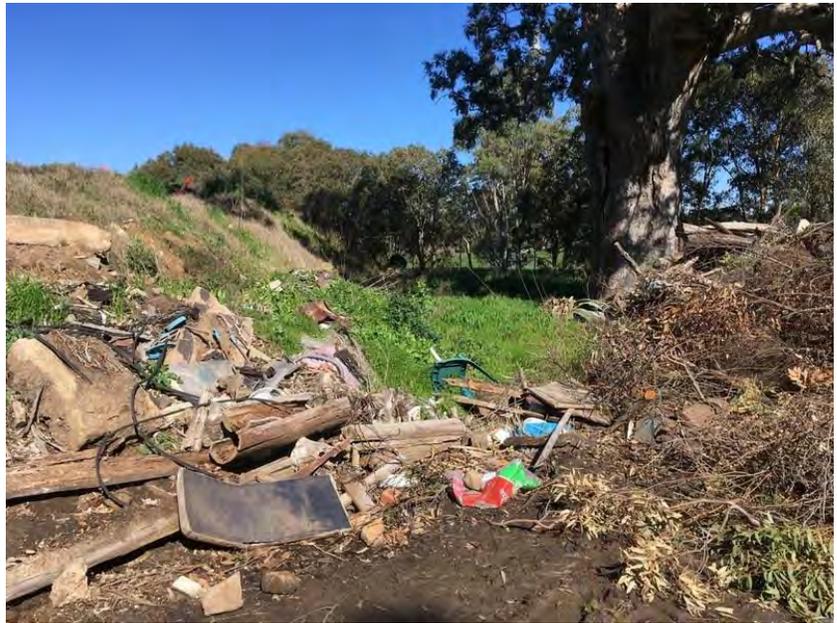
Western edge of former landfill - view southwest

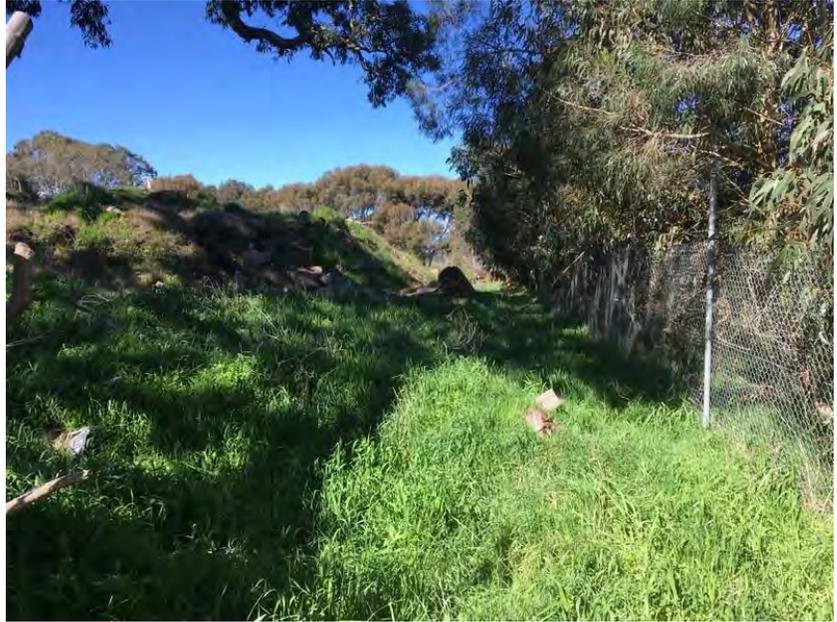
View south of western edge of old landfill

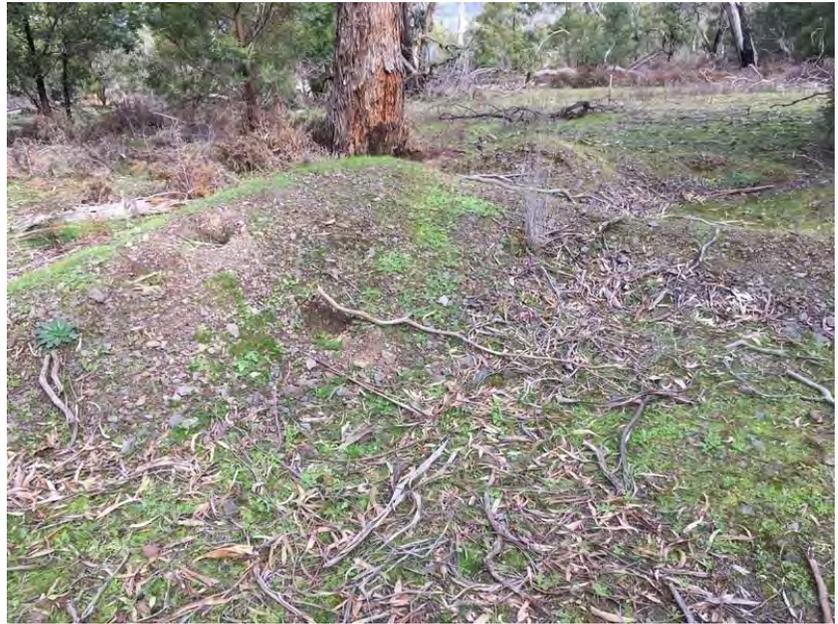
Small mound of road base at southern end of site

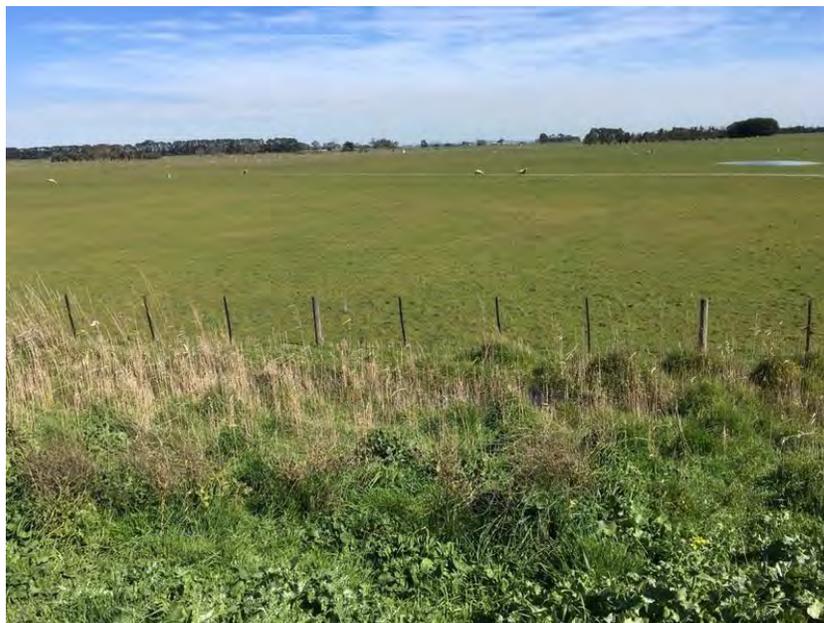
Paddock - note swale drain along toe of western embankment

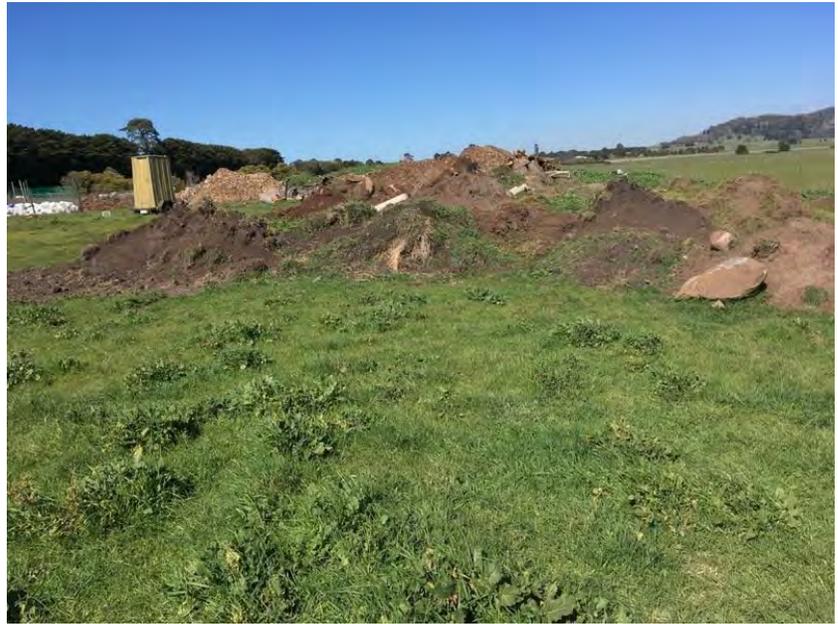
Soil and mulch mounds at centre of site

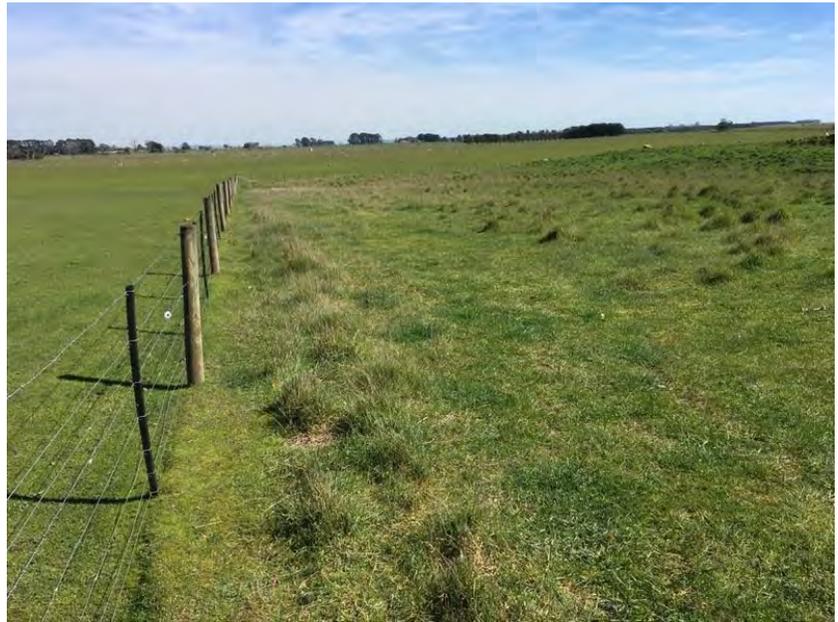
View west along southern boundary of site - filling appears not to have extended to southern boundary

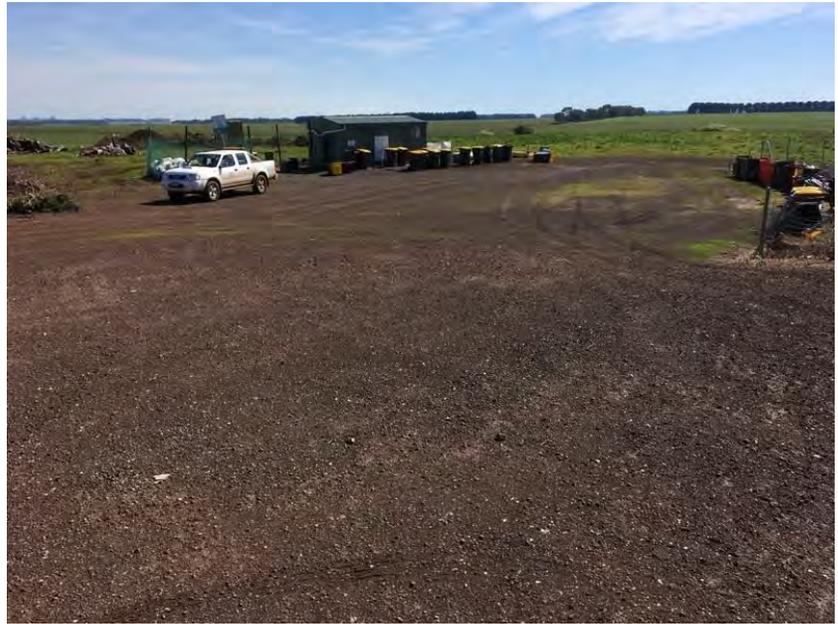
Surface Feature Photo

- Transfer station operations started after capping of landfill.
- Northern portion of the site is undisturbed by transfer station operations.
- Central portion of site is disturbed by transfer station operations with various waste stockpiles including asbestos containing materials.
- Waste stockpiles are uncontrolled.
- Site is accessible by sheep that enter from adjacent paddocks through breaks in adjacent fences.
